FLORIDA DEPARTMENT OF TRANSPORTATION
BRIDGE MANAGEMENT SYSTEM

Inspection/CID Report with PDF attachment(s)

BRIDGE ID: 124114
DISTRICT: 01 Bartow

BY: VOLKERT, INC.	STRUCTURE NAME: STRUCTURE C SANIBEL CAUSEWAY
OWNER: 2 County Hwy Agency	YEAR BUILT: 2007
MAINTAINED BY: 2 County Hwy Agency	SECTION NO.: 12 000 000
STRUCTURE TYPE: 6 P/S Conc Continuous - 02 Stringer/Girder	MP: 0
LOCATION: 3RD STRUCT S OF TOLL PLAZ	ROUTE: 00867
SERVICE TYPE ON: 1 Highway	FACILITY CARRIED: CR-867
SERV TYPE UND: 5 Waterway	FEATURE INTERSECTED: SAN CARLOS BAY

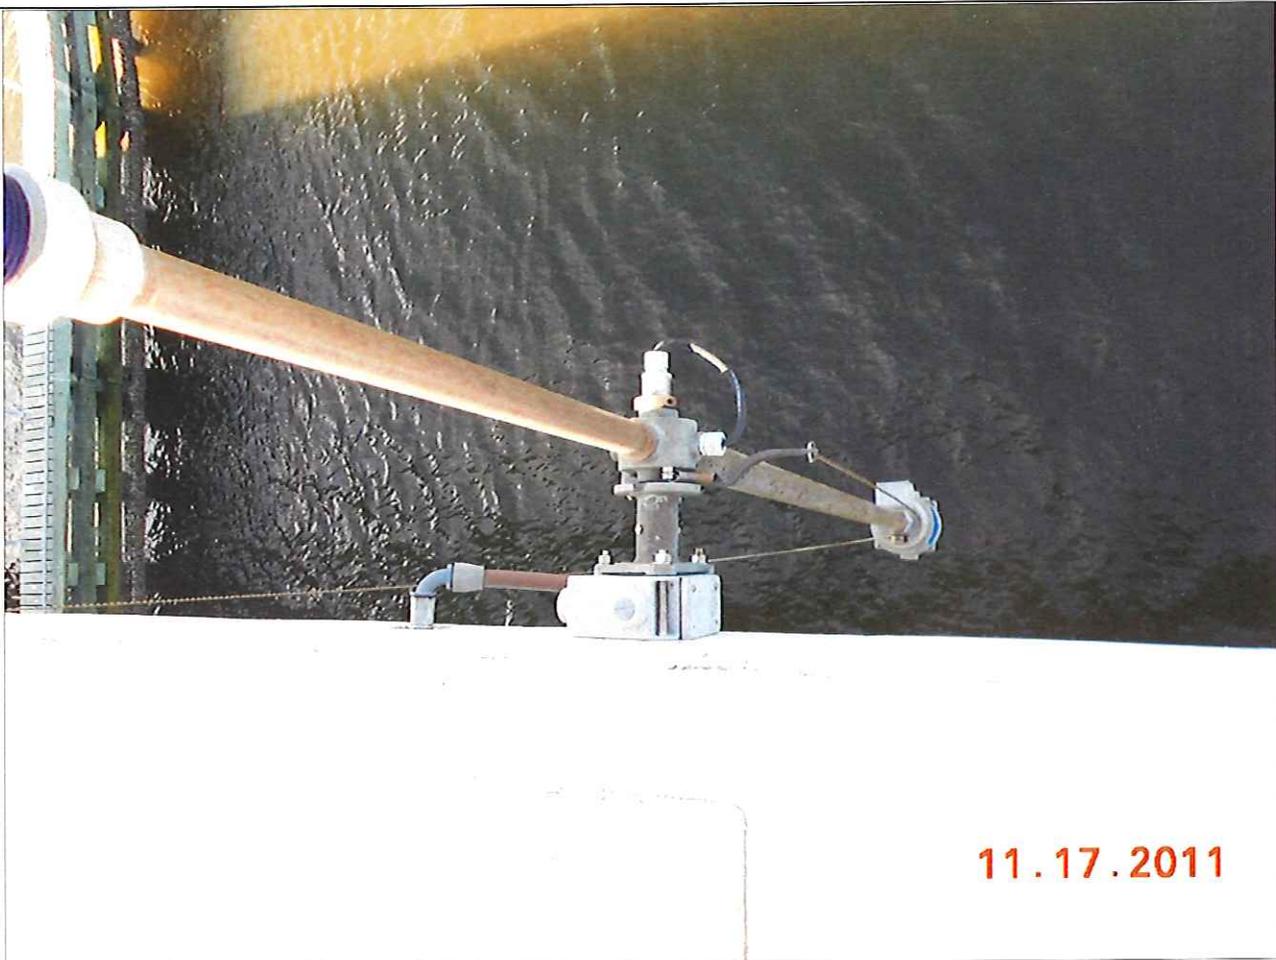
PHOTO 1: 12 BARE CONCRETE DECK

There is a navigational swing light attached to the left and right fascia of span 11 by three undetermined type of anchors. Refer to Photo 1.

Navigational swing light attached to deck fascia of Span 11.

REPAIR RECOMMENDATION:
None

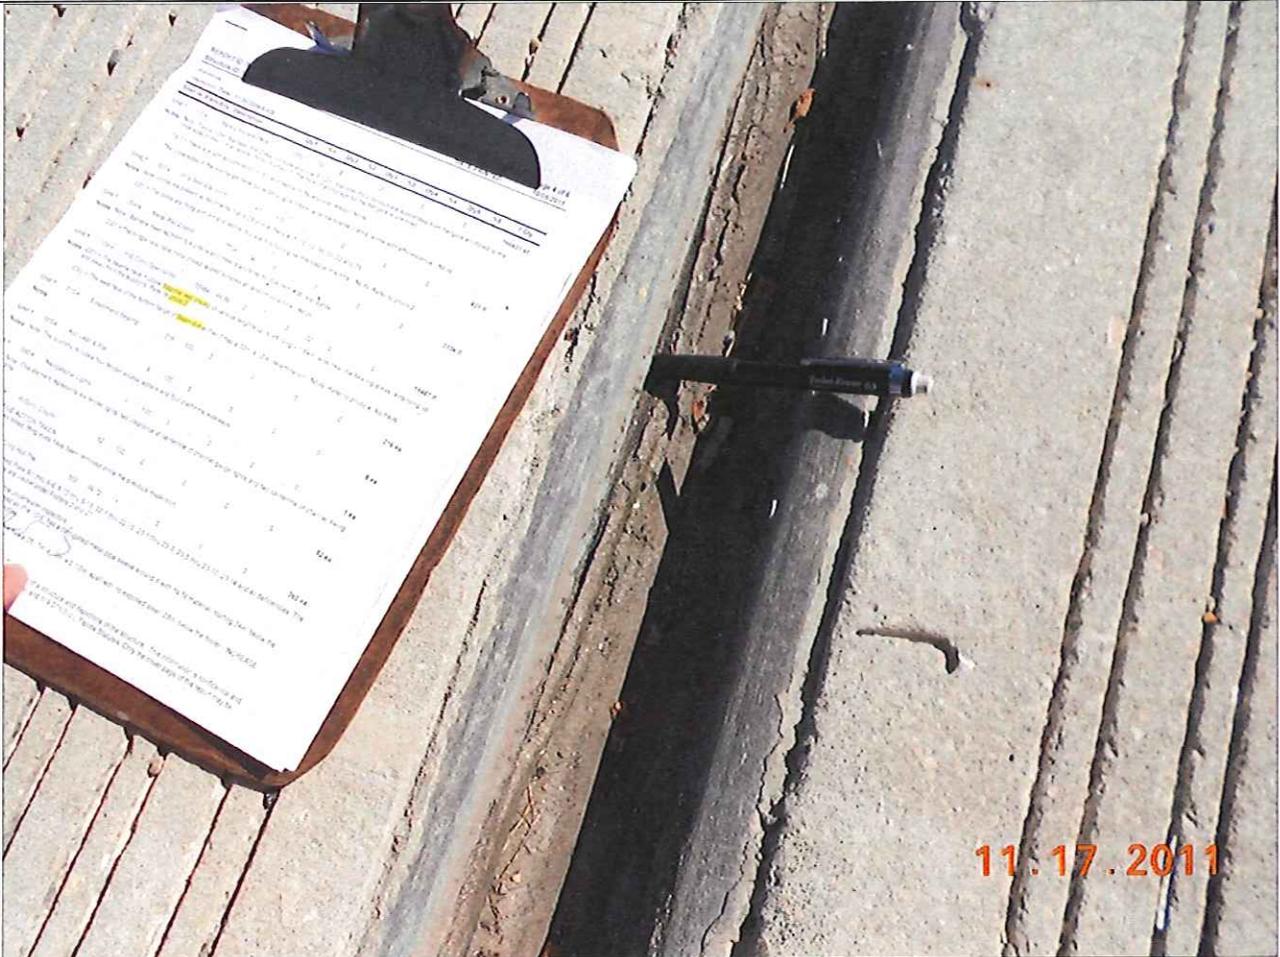
PHOTO 2: 300 STRIP SEAL EXP JOINT

CS2: There is a 16in long area where the gland has pulled out of its slot in the left shoulder over Pier 10 - NEW. Refer to Photo 2.

Strip seal pulled out of slot on joint over Pier 10, in left shoulder.

REPAIR RECOMMENDATION:
None

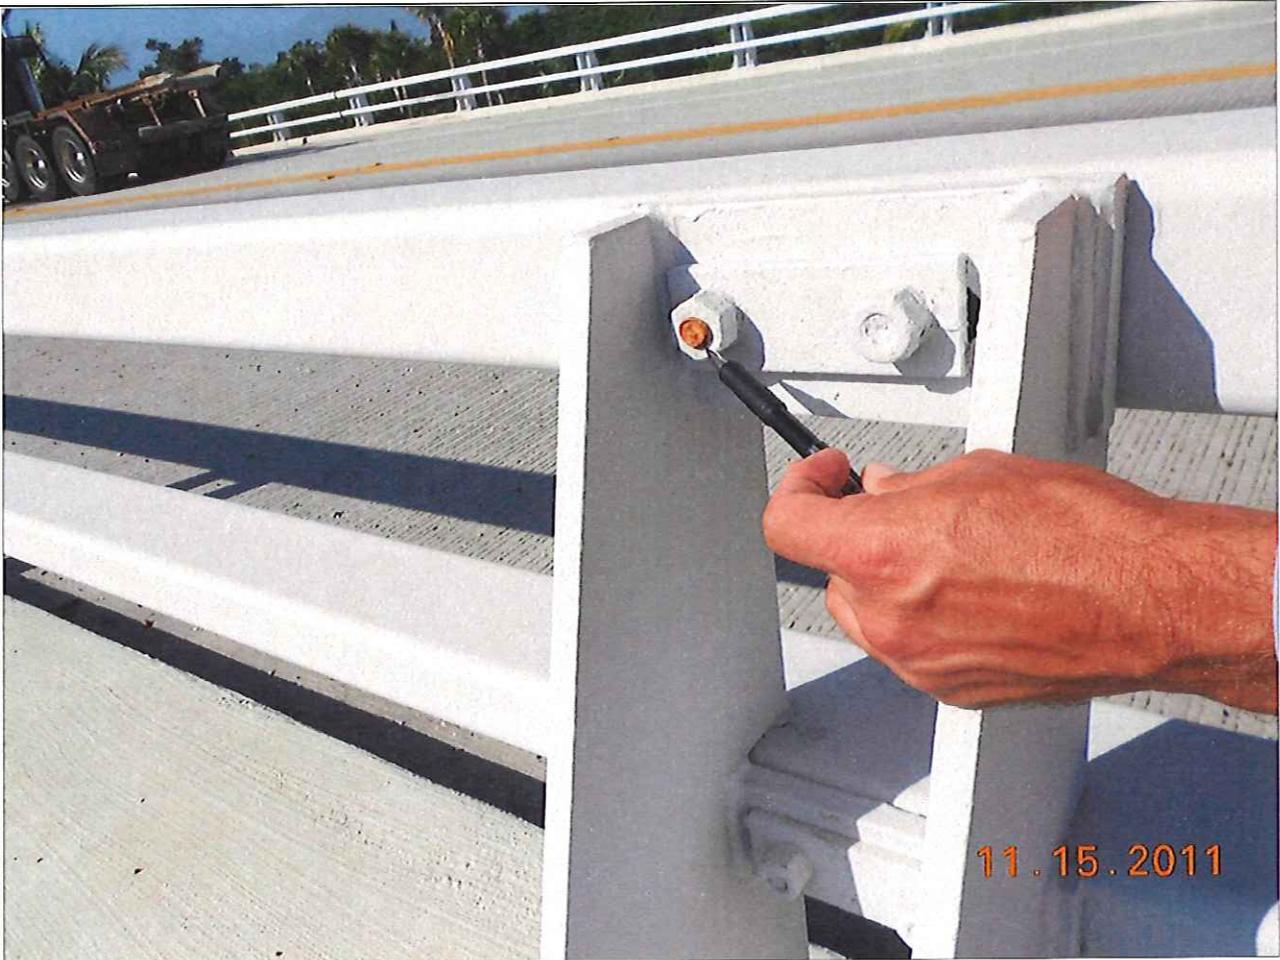
PHOTO 3: 334 METAL RAIL COATED

Several of the rail to post fasteners on both bridge rails have minor surface corrosion - NEW. Refer to Photo 3. REPAIR

Minor surface corrosion on bridge rail to post fasteners.

Clean corrosion and spot paint on bridge rail to post hardware on exterior face of both bridge rails.

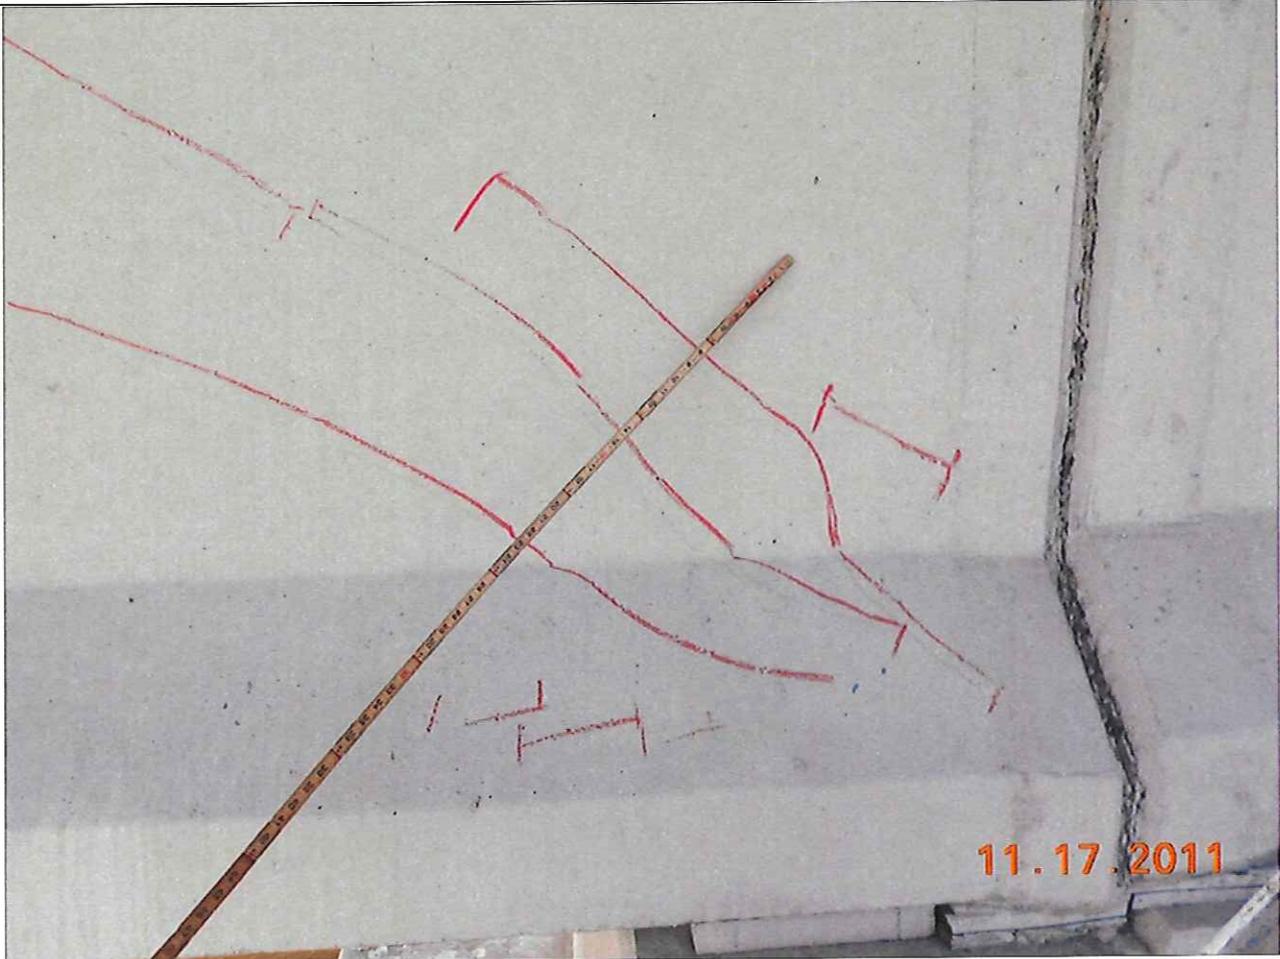
PHOTO 4: 109 P/S CONC OPEN GIRDER

CS1: The beams have multiple hairline diagonal cracks in the lower flange and webs up to 10ft. predominately in the exterior beams near the bearing areas, extending up and away from the supports - INCREASED.

These cracks vary in length, number of cracks and exact location and are predominately in the exterior beams. The cracks on Beam 8-4 were marked with a red paint stick to track the general trend in crack lengths. Refer to Photo 4.

Typical diagonal cracks in bottom flange and web of the exterior beams (Beam 8-4 marked in red shown).

REPAIR RECOMMENDATION:
None

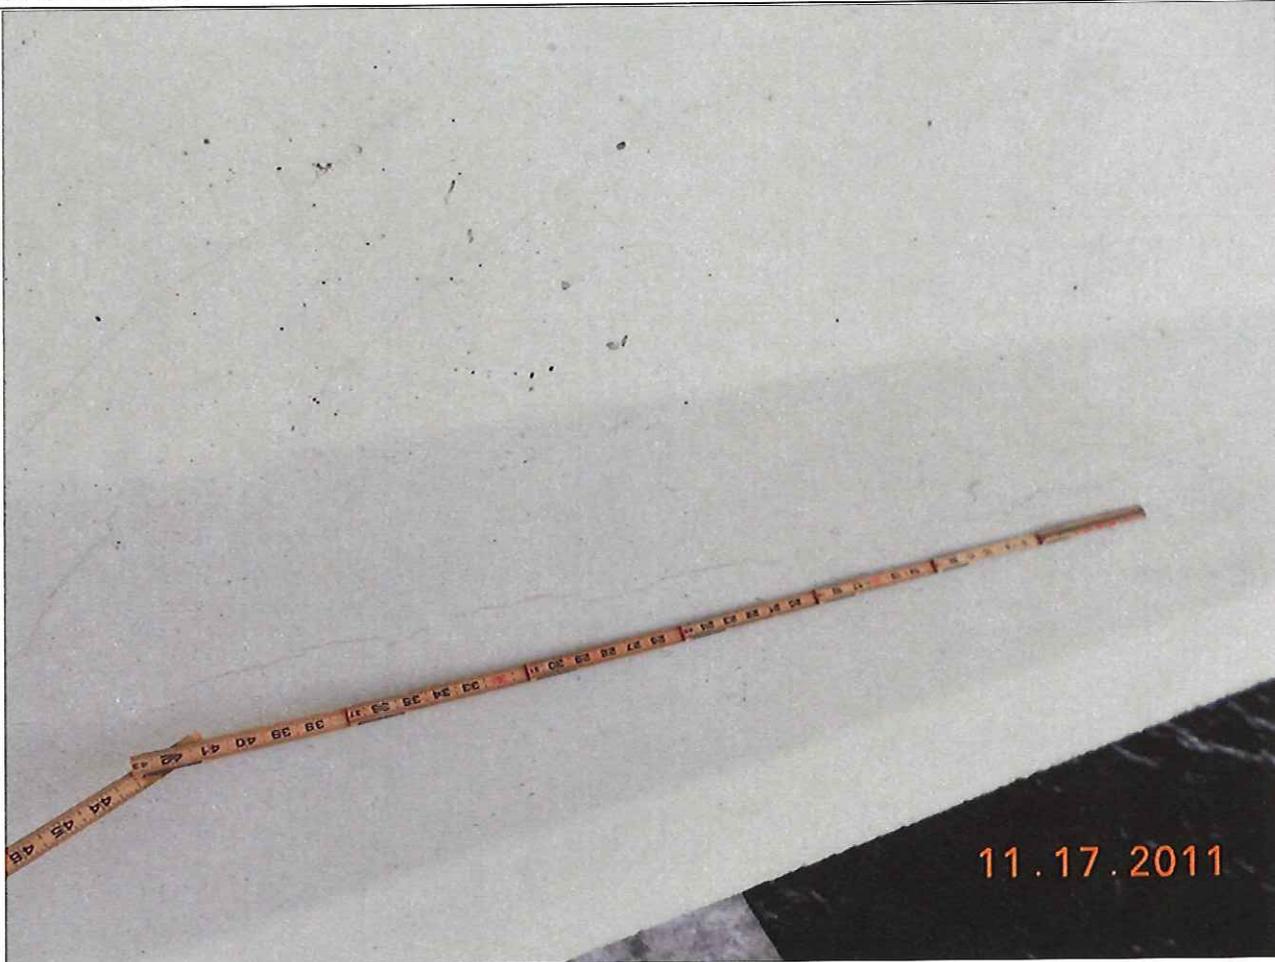
PHOTO 5: 109 P/S CONC OPEN GIRDER

The outside faces of the exterior beams have numerous hairline horizontal cracks up to 30in long throughout the length - NEW. Refer to Photo 5.

Typical horizontal cracks in bottom flange of the exterior beams.

REPAIR RECOMMENDATION:
None

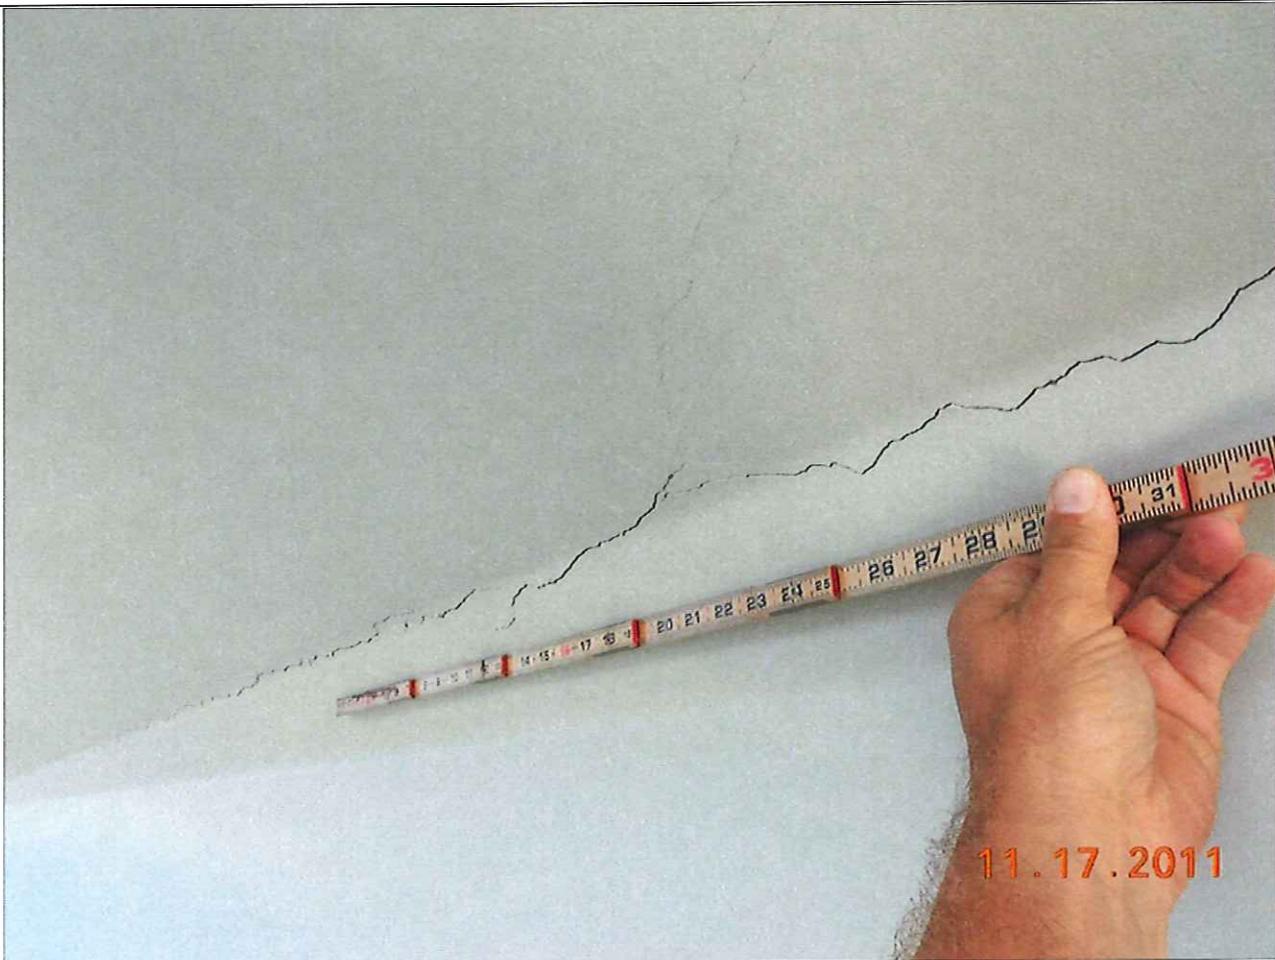
PHOTO 6: 109 P/S CONC OPEN GIRDER

CS2: The exterior face of Beam 11-1 at the top flange to web chamfer has a 1/32in wide horizontal crack starting at Pier 11 extending to mid-span - NEW. Refer to Photos 6 and 7. REPAIR

Horizontal crack in exterior face of Beam 11-1 at top flange to web transition.

Inject horizontal crack in exterior face of Beam 11-1 at top flange to web transition to protect reinforcement.

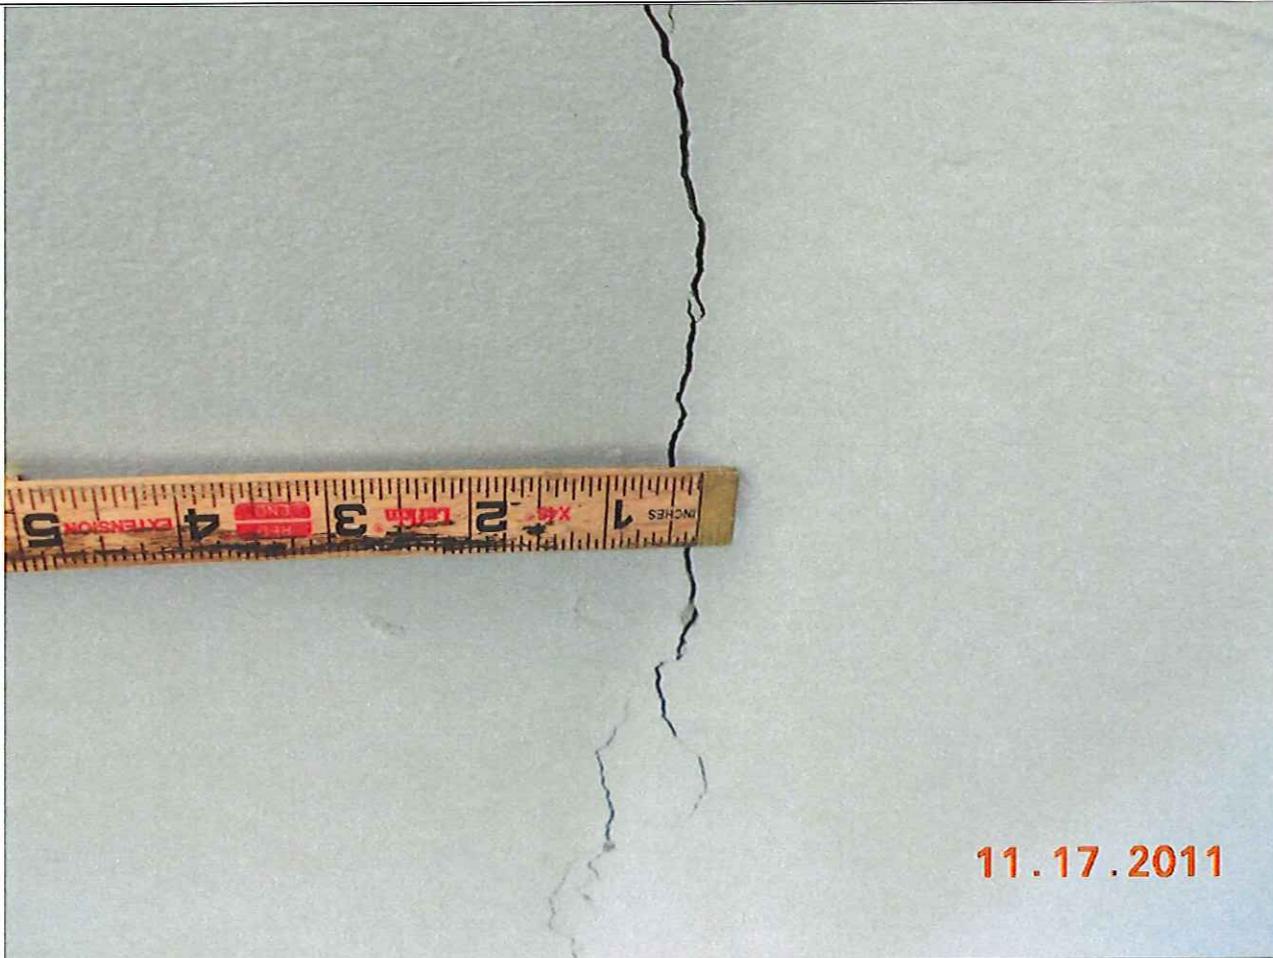
PHOTO 7: 109 P/S CONC OPEN GIRDER

Close up of crack in top flange/web of Beam 11-1.

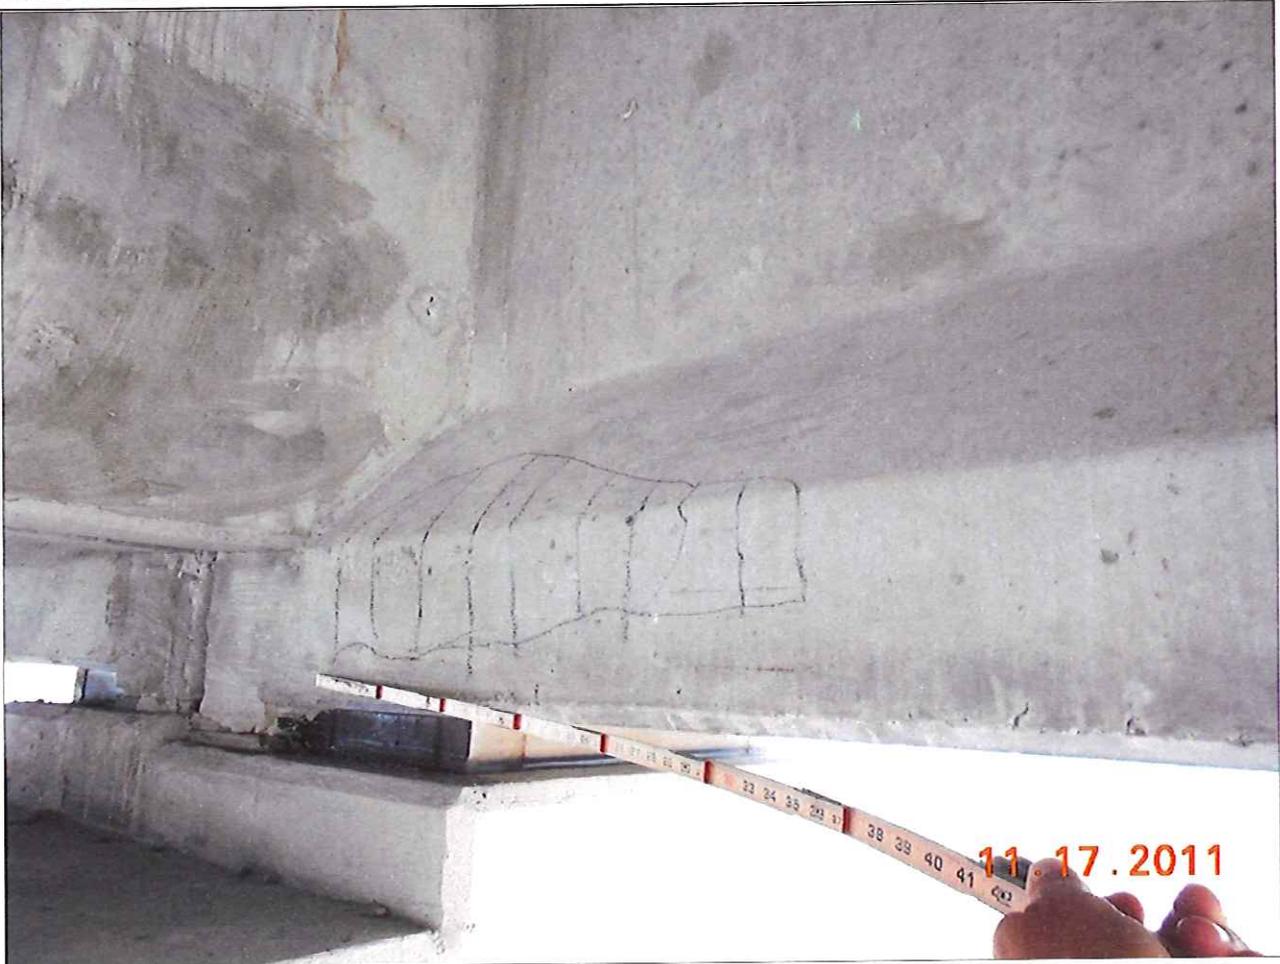
PHOTO 8: 109 P/S CONC OPEN GIRDER

CS3: The west face of the bottom flange of Beam 6-4 at Pier 7 has a 30in. x 12in. delamination. Refer to Photo 8. REPAIR

Delamination in the west face of the bottom flange of Beam 6-4 at Pier 7.

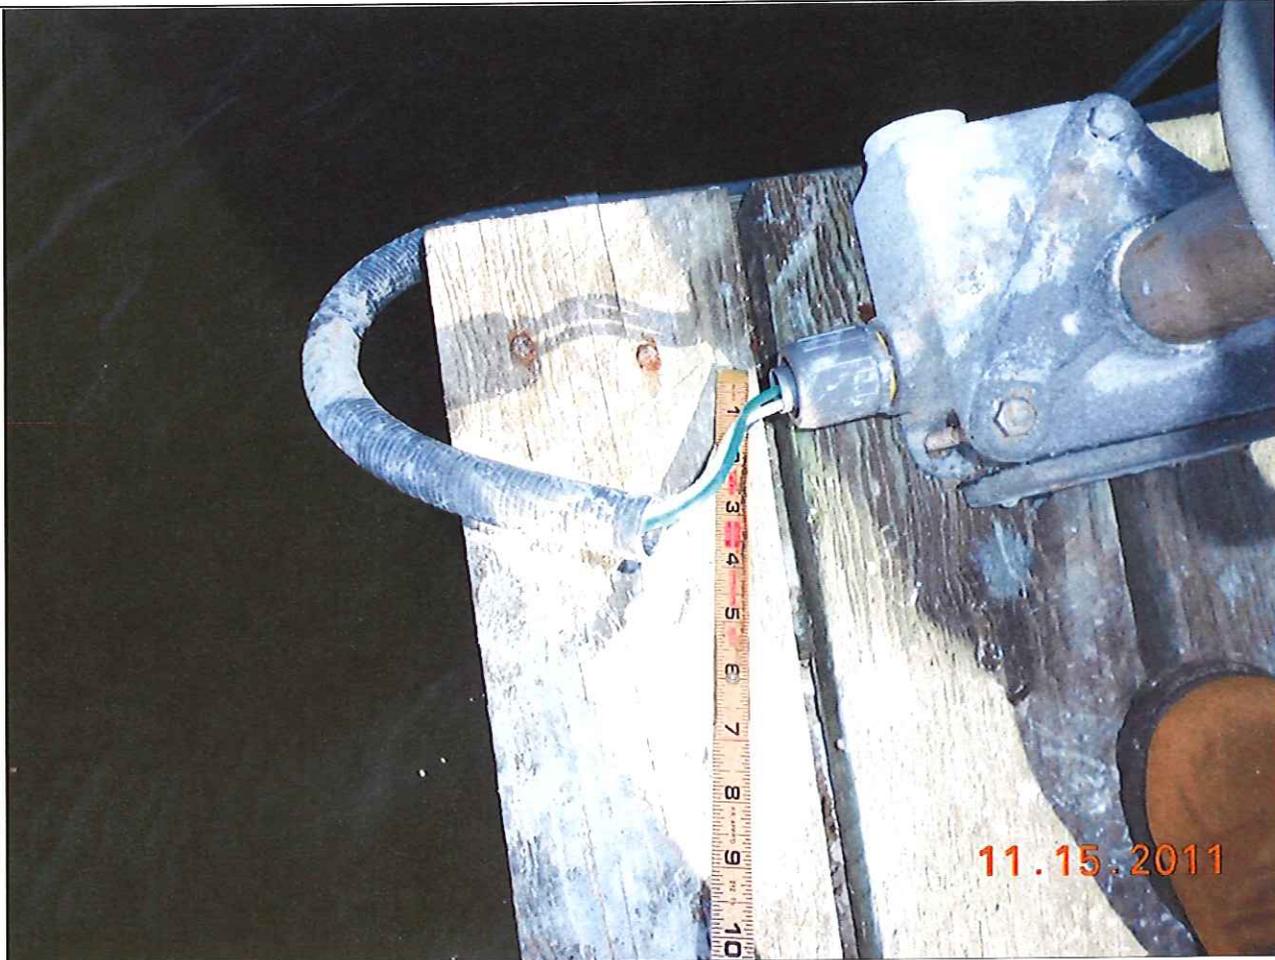
PHOTO 9: 580 NAVIGATIONAL LIGHTS

CS1: The conduit at the southwest navigational light on the south fender is separated - NEW. Refer to Photo 9. REPAIR

Separated conduit on south fender at southwest navigational light.

Repair separated conduit on south fender for southwest navigational light.

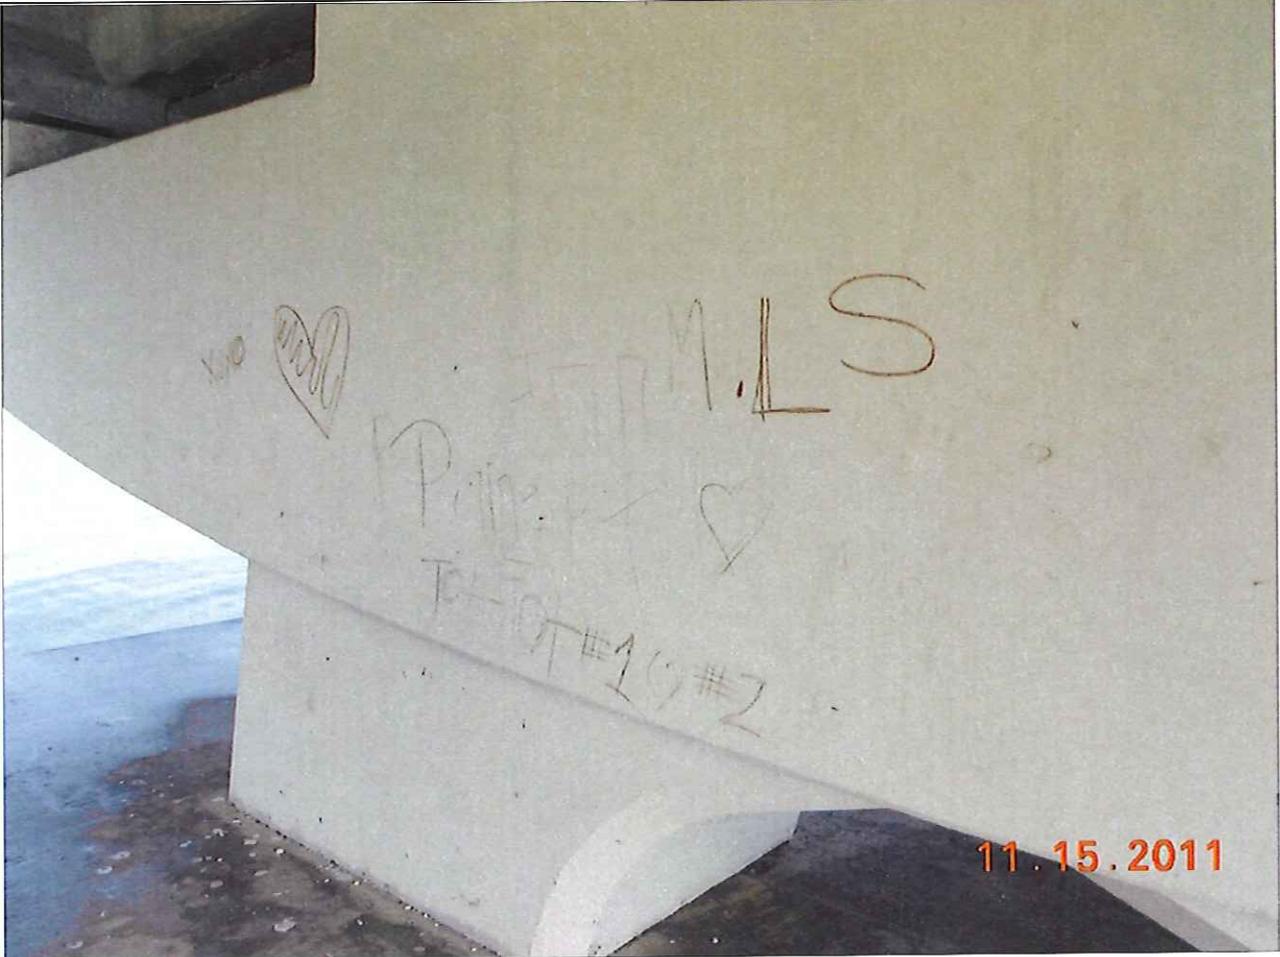
PHOTO 10: 234 R/CONC CAP

CS1: There is non-offensive graffiti on the south and north faces of Pier cap 2 - NEW. Refer to Photo 10. REPAIR

Graffiti on Pier Cap 2.
