FLORIDA DEPARTMENT OF TRANSPORTATION
BRIDGE MANAGEMENT SYSTEM

Inspection/CID Report with PDF attachment(s)

BRIDGE ID: 124115
DISTRICT: 01 Bartow

BY: VOLKERT, INC.	STRUCTURE NAME: STRUCTURE B SANIBEL CAUSEWAY
OWNER: 2 County Hwy Agency	YEAR BUILT: 2007
MAINTAINED BY: 2 County Hwy Agency	SECTION NO.: 12 000 000
STRUCTURE TYPE: 6 P/S Conc Continuous - 02 Stringer/Girder	MP: 0
LOCATION: 2ND STRUCTURES OF TOLL PLAZA	ROUTE: 00867
SERVICE TYPE ON: 1 Highway	FACILITY CARRIED: CR-867
SERV TYPE UND: 5 Waterway	FEATURE INTERSECTED: SAN CARLOS BAY

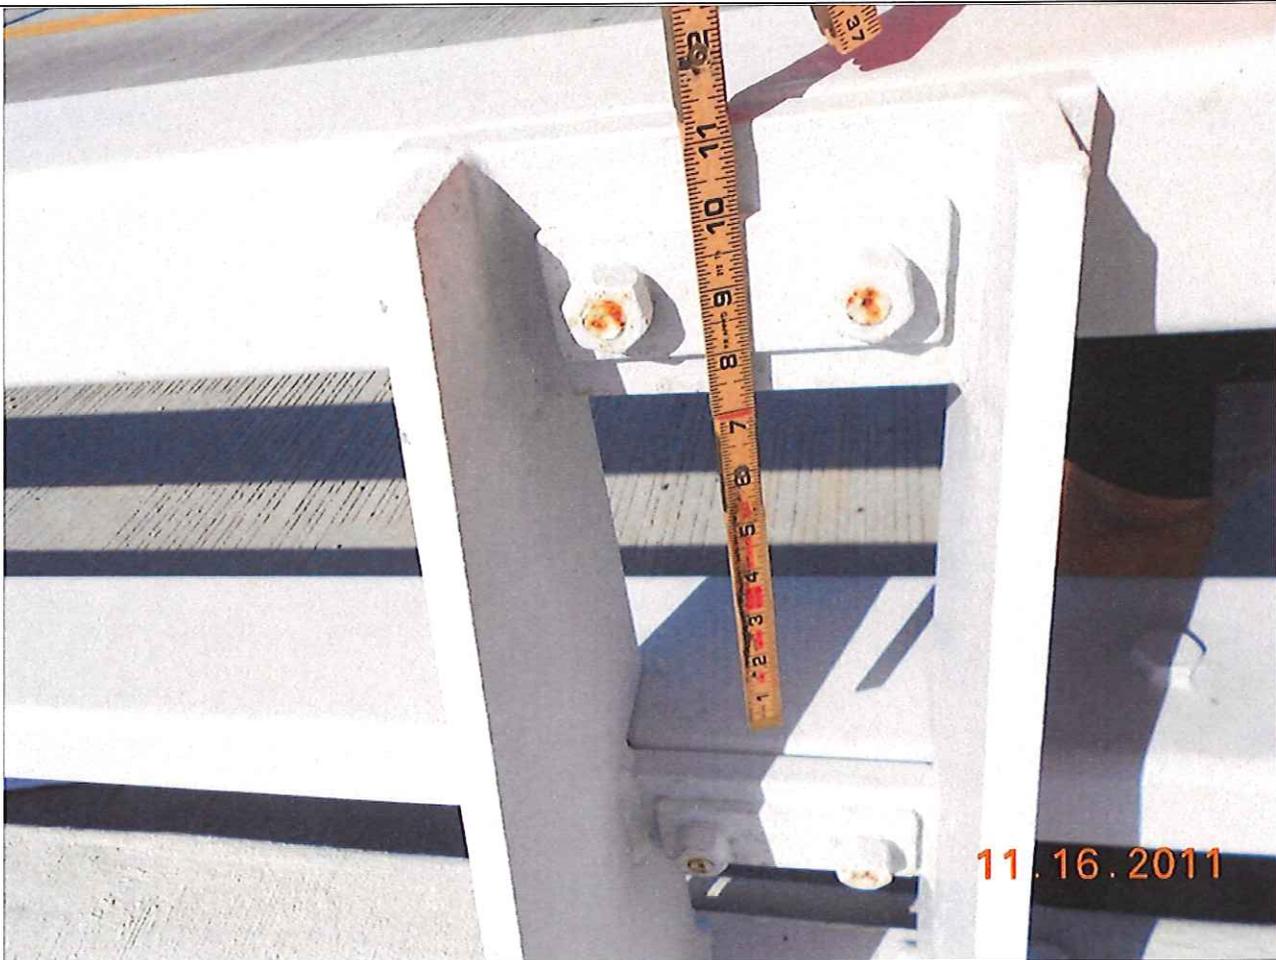
PHOTO 1: 334 METAL RAIL COATED

CS2: The rail to post attachment hardware has light surface corrosion on approximately half of the posts - NEW. Refer to Photo 1. REPAIR

Light surface corrosion on bridge rail to post hardware.

REPAIR RECOMMENDATION:

Spot paint bridge rail to post hardware throughout both bridge rails.

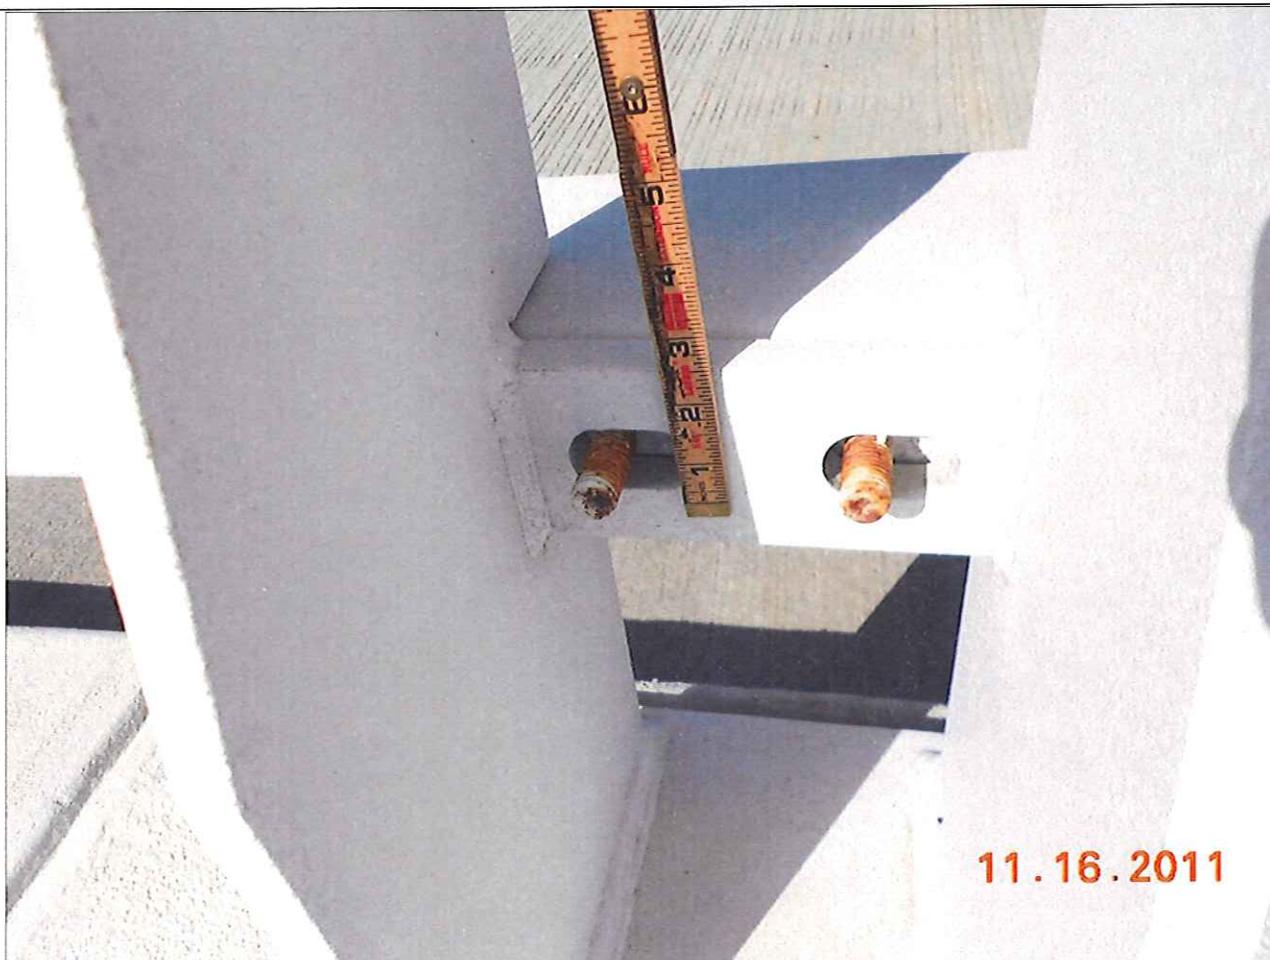
PHOTO 2: 334 METAL RAIL COATED

Post 1-5 right is missing both lower rail to post attachment nuts and the top two nuts are loose - NEW. Refer to Photo 2. REPAIR

Post 11-8 right is missing one of the lower rail to post attachment nuts - NEW. REPAIR

Missing bridge rail to post attachment nuts.

REPAIR RECOMMENDATION:

Replace missing rail to post attachment nuts on bridge rail posts 1-5 and 11-8 right and tighten loose nuts on post 1-5.

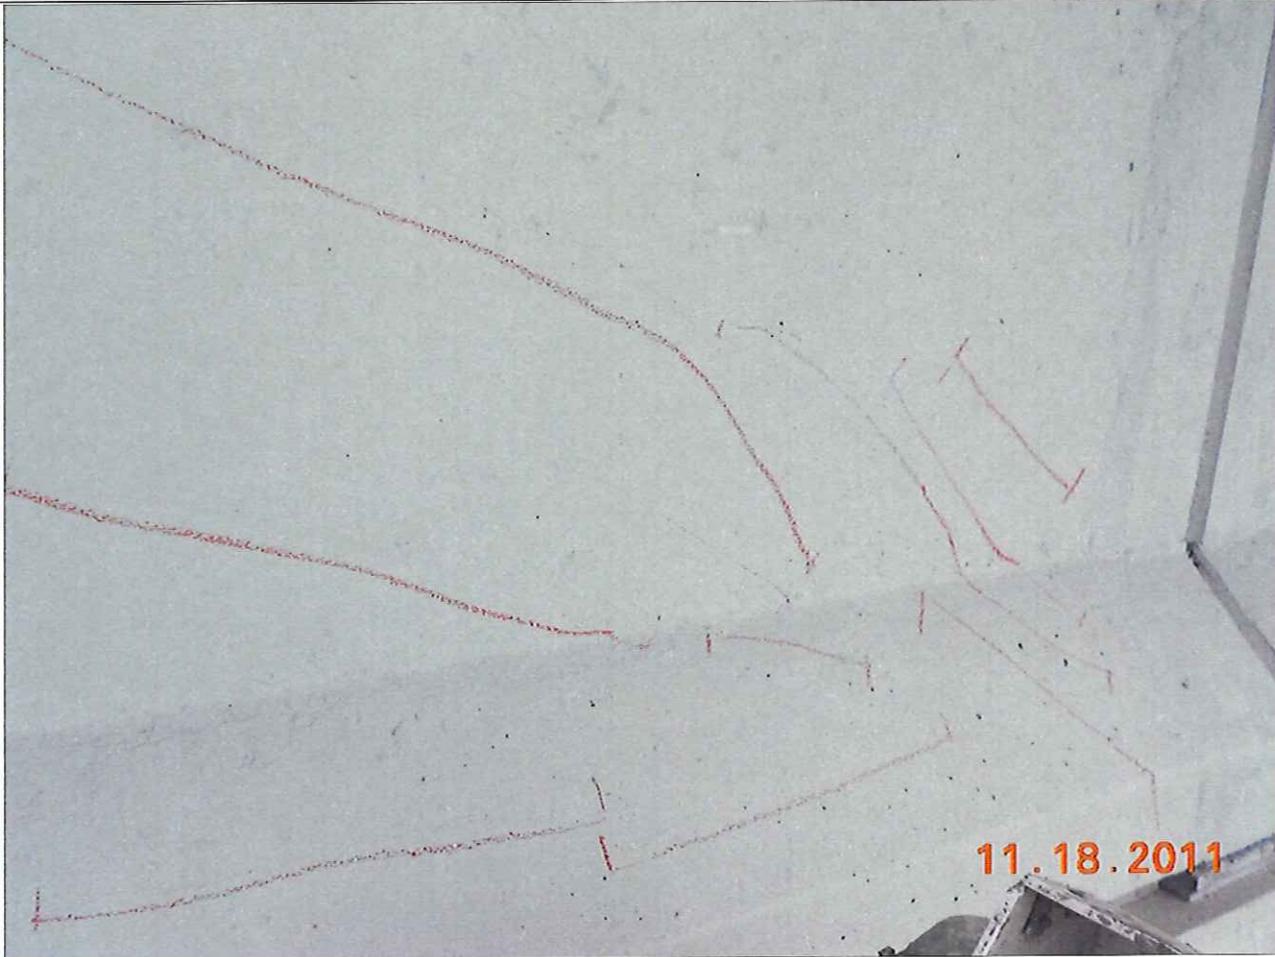
PHOTO 3: 109 P/S CONC OPEN GIRDER

CS1: The beams have multiple hairline diagonal cracks in the lower flange and web up to 8ft. long near the bearing areas, extending up and away from the supports - INCREASED. These cracks vary in length number of cracks and exact location and are predominately in the exterior beams. The cracks on Beam 12-1 were marked with a red paint stick to track the general trend in crack lengths. Refer to Photo 3.

Typical diagonal cracks in the exterior beams (Beam 2-1 marked in red shown).

Notes CS1: The beams have multiple hairline diagonal cracks in the lower flange and web up to 8ft. long near the bearing areas, extending up and away from the supports - INCREASED. These cracks vary in length number of cracks and exact location and are predominately in the exterior beams. The cracks on Beam 12-1 were marked with a red paint stick to track the general trend in crack lengths. Refer to Photo 3.

REPAIR RECOMMENDATION:
None

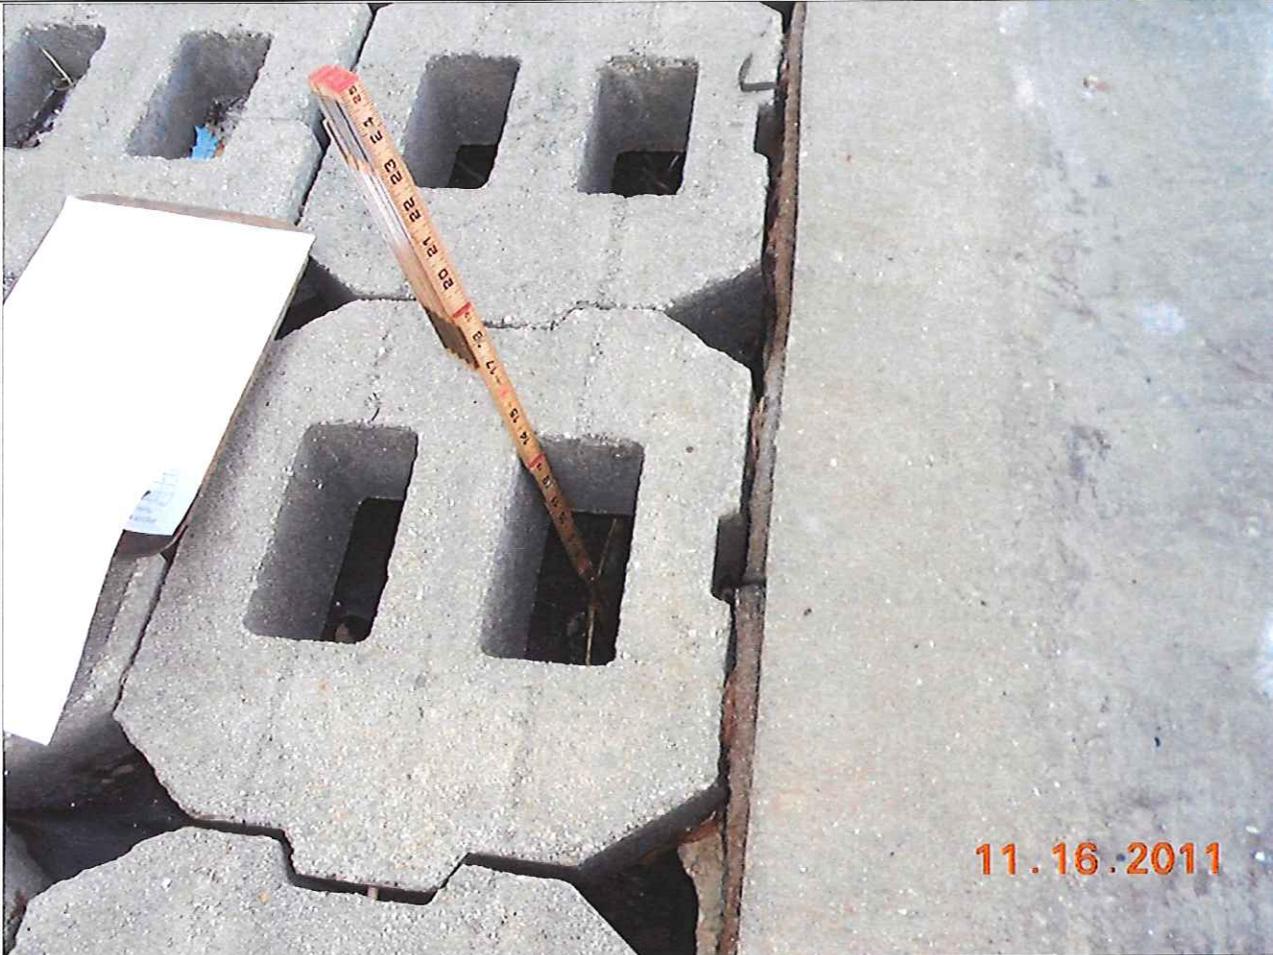
PHOTO 4: 396 OTHER ABUT SLOPE PRO

CS2: The south slope protection is intermittently undermined up to 18in wide x 10in deep along the bulkhead cap - NEW. Refer to Photo 4. REPAIR

Undermined block mail slope protection along the south bulkhead cap.

CS2: The south slope protection is intermittently undermined up to 18in wide x 10in deep along the bulkhead cap - NEW. Refer to Photo 4.
 REPAIR

REPAIR RECOMMENDATION:

Fill in undermining under south slope protection along the south bulkhead cap.
