FLORIDA DEPARTMENT OF TRANSPORTATION
BRIDGE MANAGEMENT SYSTEM

Inspection/CID Report with PDF attachment(s)

BRIDGE ID: 124116
DISTRICT: 01 Bartow

BY: VOLKERT, INC.	STRUCTURE NAME: STRUCTURE A SANIBEL CAUSEV
OWNER: 2 County Hwy Agency	YEAR BUILT: 2007
MAINTAINED BY: 2 County Hwy Agency	SECTION NO.: 12 000 000
STRUCTURE TYPE: 6 P/S Conc Continuous - 02 Stringer/Girder	MP: 0
LOCATION: 1ST STRUC S OF TOLL PLAZA	ROUTE: 00867
SERVICE TYPE ON: 1 Highway	FACILITY CARRIED: CR-867
SERV TYPE UND: 5 Waterway	FEATURE INTERSECTED: SAN CARLOS BAY

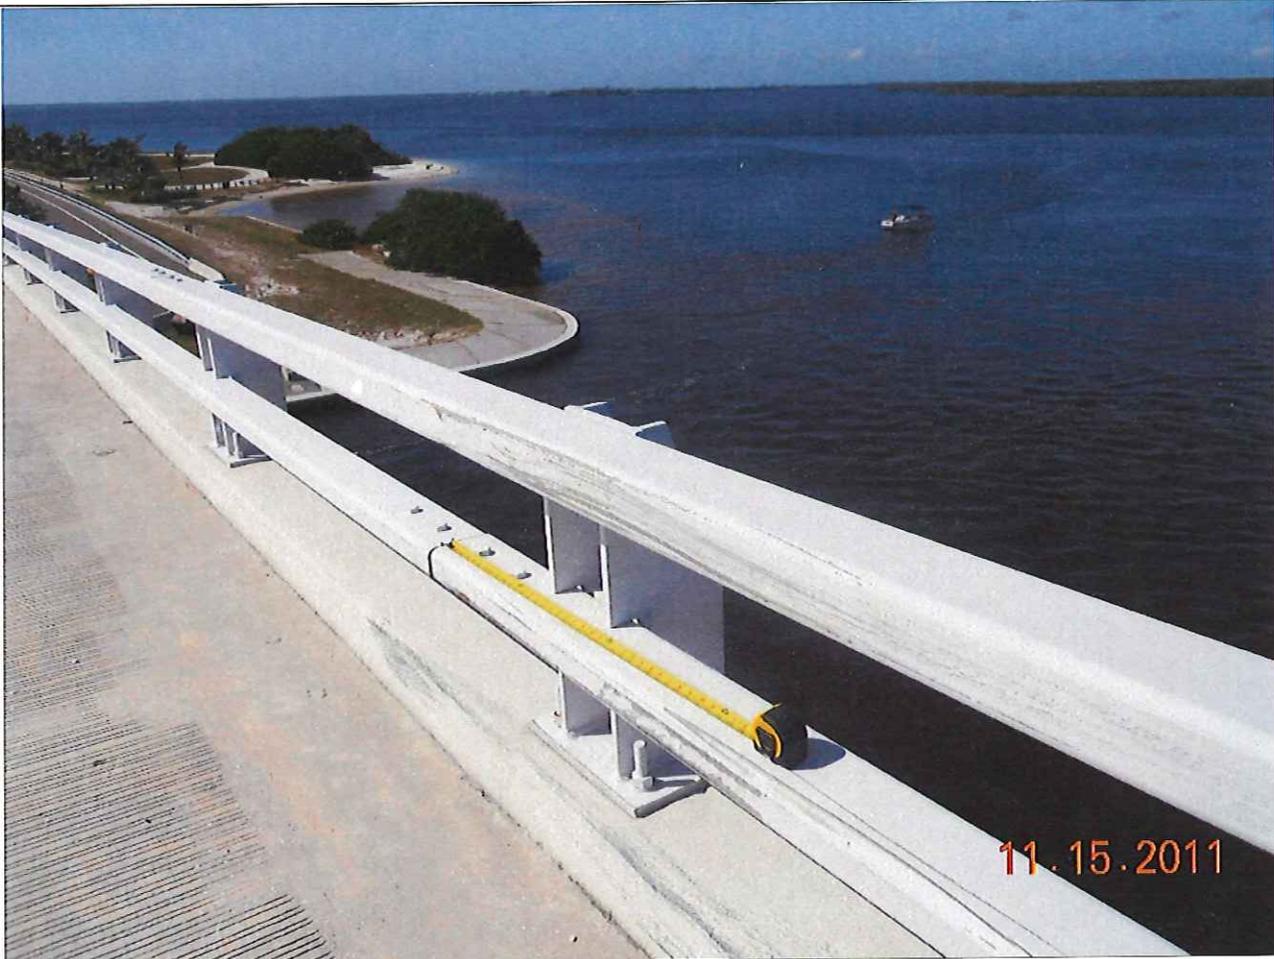
PHOTO 1: 334 METAL RAIL COATED

CS2: There are several areas of impact scrapes to the left bridge rail up to 8ft long at the following locations - NEW. Refer to Photo 1. REPAIR ALL

Impact scrapes on bridge railing Span 4 left near Pier 5.

Repair impact scrapes to left bridge railing up to 8ft long in Spans 4, 5, 6, 12, 13, 14, 16 and 18.

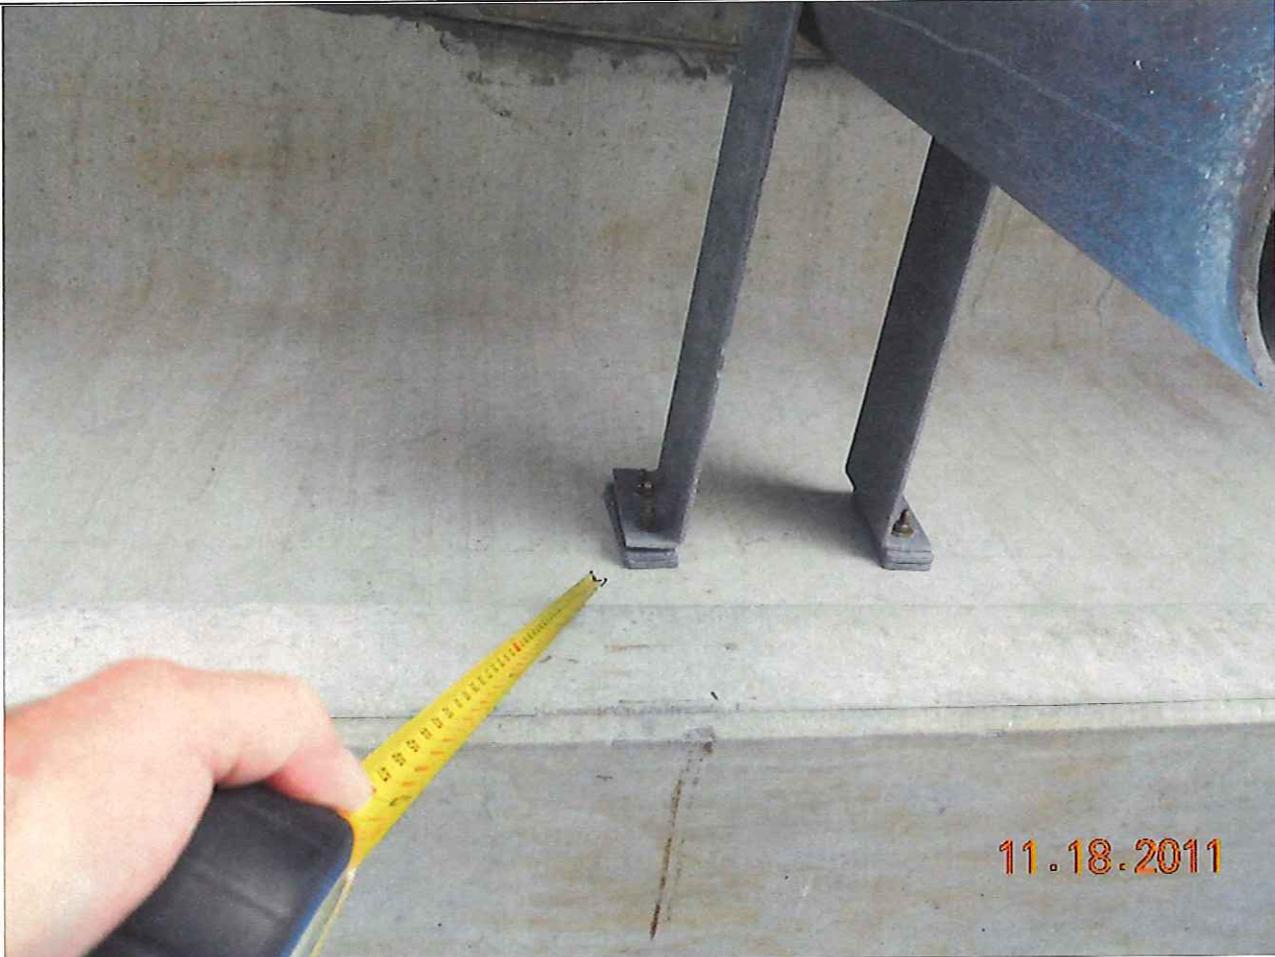
PHOTO 2: 397 DRAIN SYST METAL

CS2: The anchor hardware for the scupper down pipe attached to the inside face of Beam 8-1 at the 2/3 point is loose - NEW. Refer to Photo 2. REPAIR

Loose anchor hardware for scupper down pipe attached to inside face of Beam 8-1.

Repair loose anchor hardware for scupper down pipe attached to Beam 8-1 at the 2/3 point.

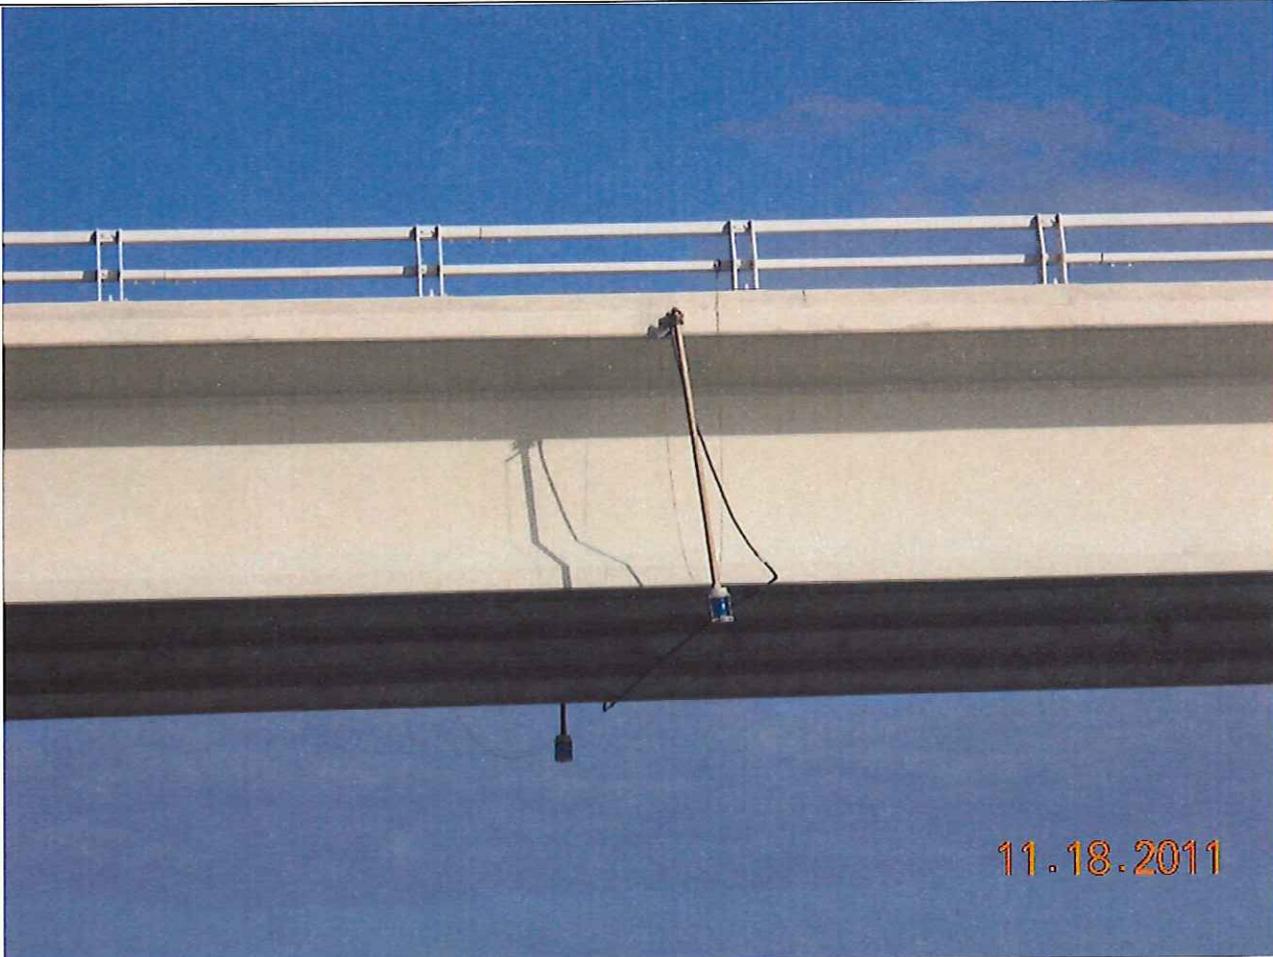
PHOTO 3: 580 NAVIGATIONAL LIGHTS

Center span navigational swing lights attached to bridge fascias.

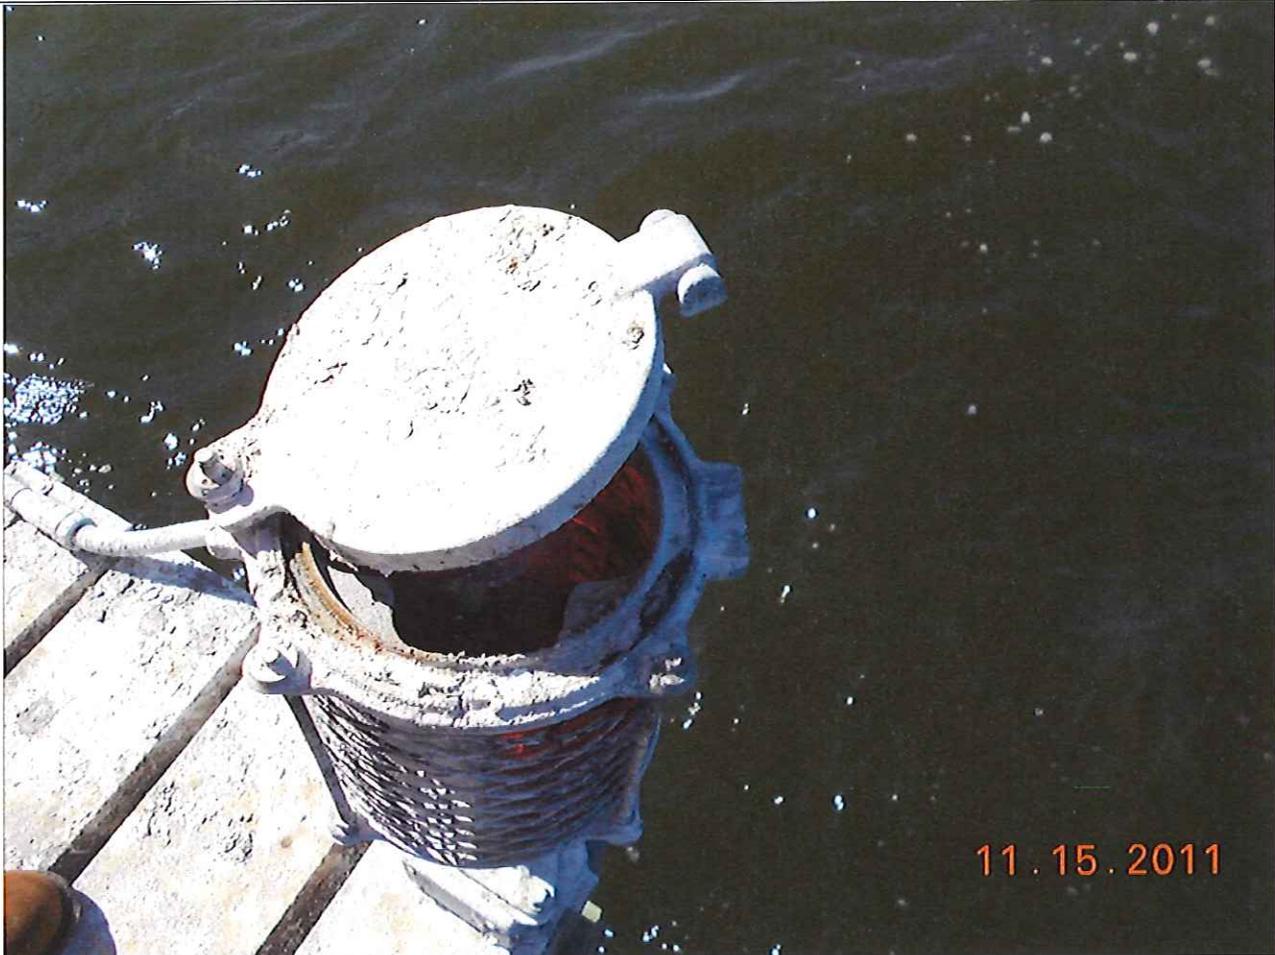
PHOTO 4: 580 NAVIGATIONAL LIGHTS

CS2: The hinges for top access cover on the southeast and northwest fender lights are broken - NEW. Refer to Photo 4. REPAIR

Broken access cover plate hinge for the northwest fender light.

Repair 2 broken access cover plate hinges for the southeast and northwest fender lights.

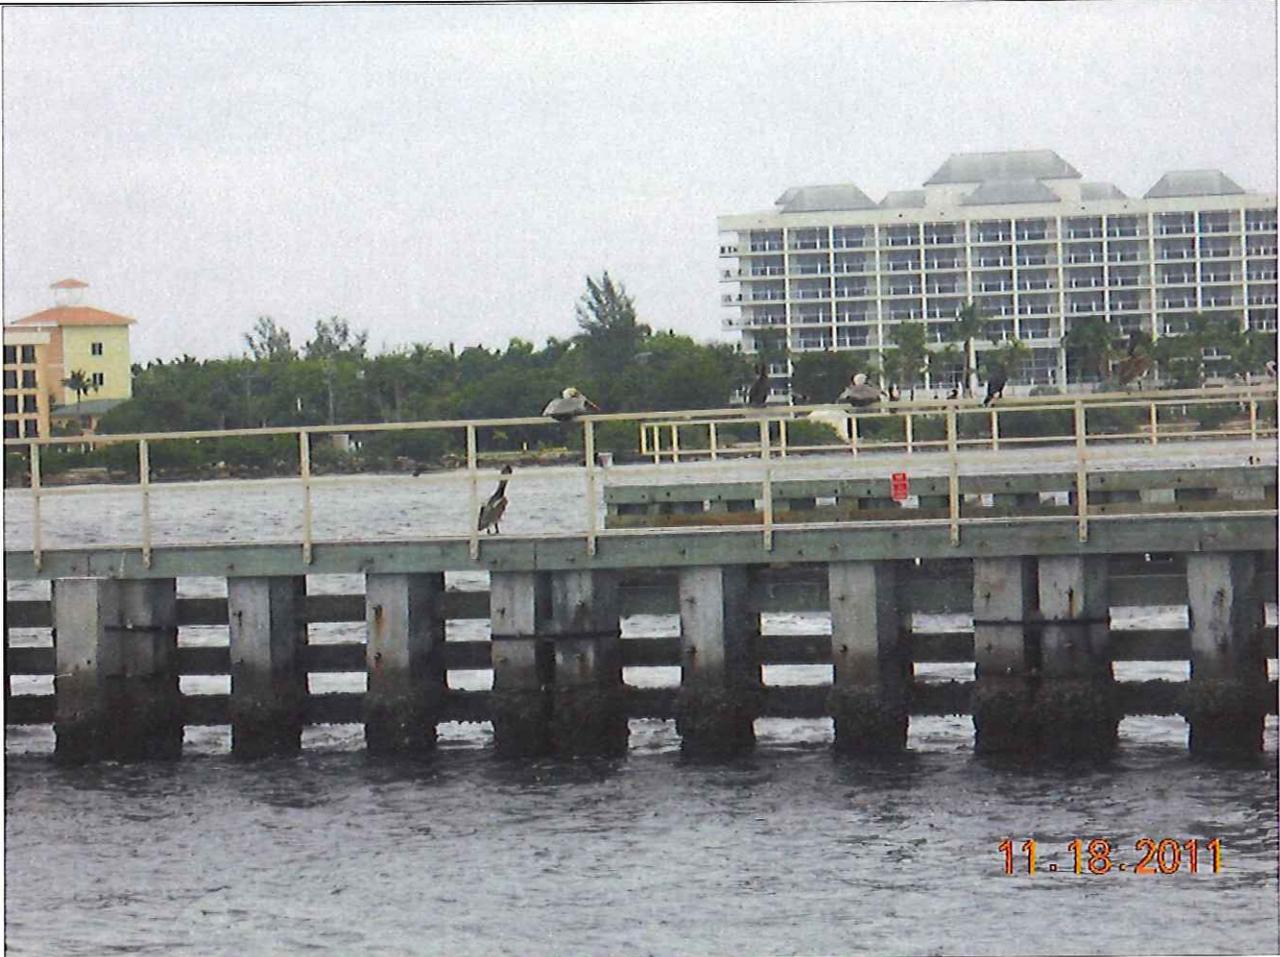
PHOTO 5: 387 P/S FENDER/DOLPHIN

Area of exposed driving tips on the southwest fender top side (from 12th cluster from west to 25th cluster).

CS3: The south fender starting at the 1st single plumb pile (12th cluster) from the west for the next 13 piles (55ft long), the steel driving tips are exposed up to 30in to 3ft height - NEW. Refer to Photo 5 and Diagram 1. REPAIR

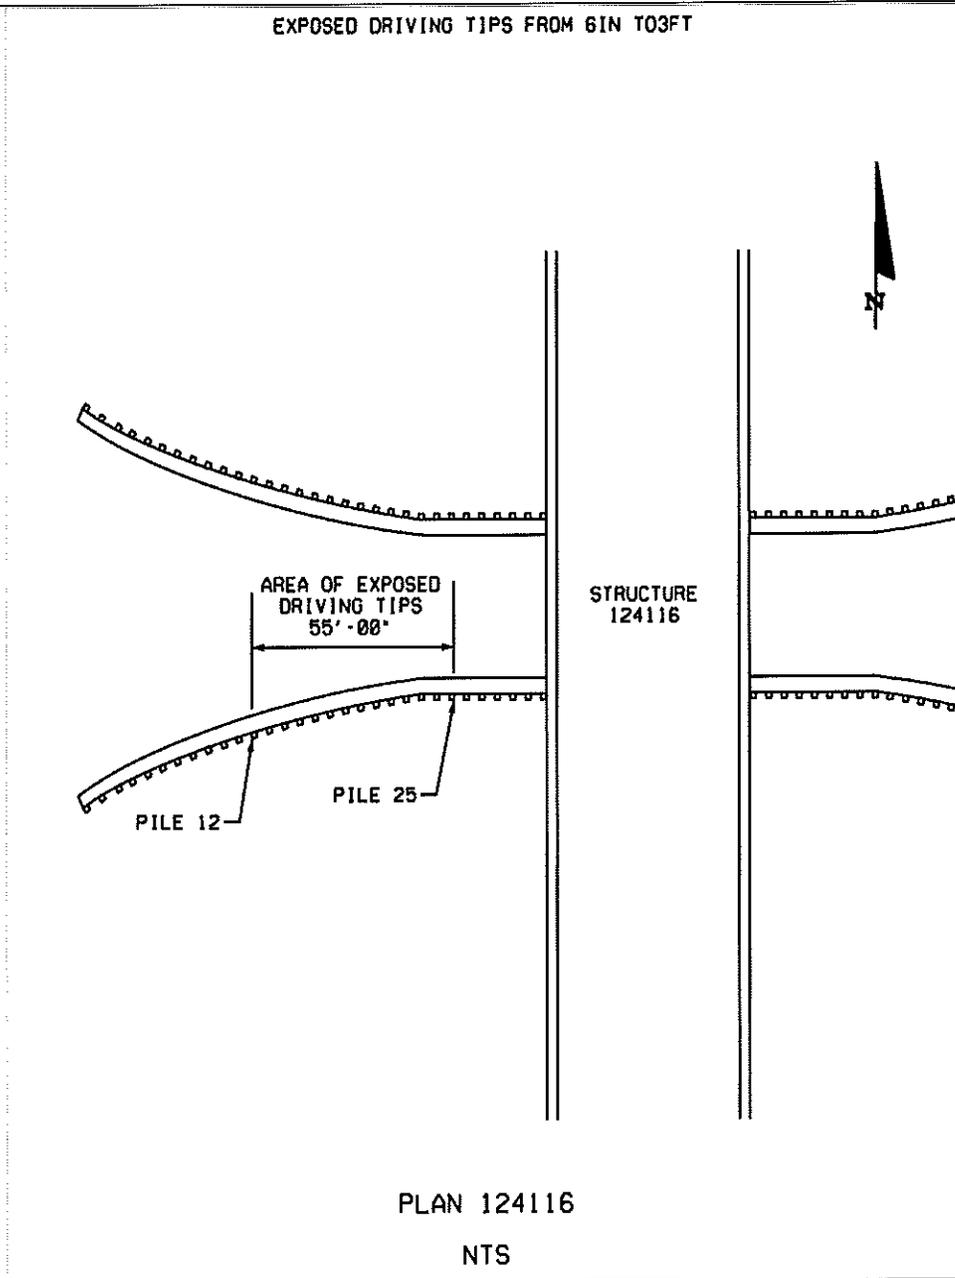
DIAGRAM 1: 387 P/S FENDER/DOLPHIN

Piles with exposed driving tips.

REPAIR RECOMMENDATION:
Refer to Photo 5.

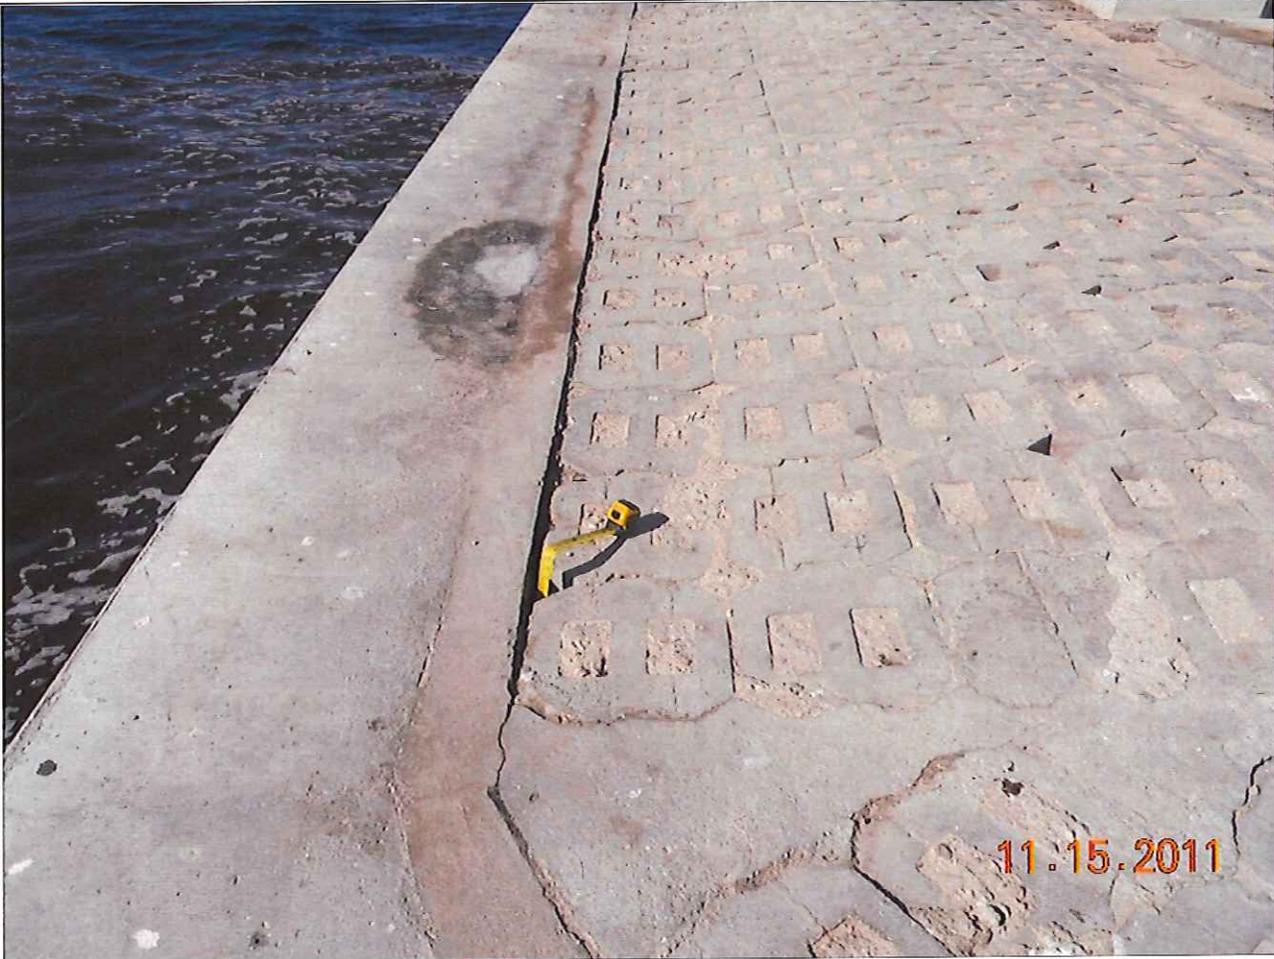
PHOTO 6: 396 OTHER ABUT SLOPE PRO

CS3: The rock inside the concrete block mat on the north slope protection 8ft adjacent to the seawall cap has settled up to 16in and has undermined the slope in a 4ft x 3ft area - NEW. Refer to Photo 6.
REPAIR

Settled rock fill with undermining to the concrete block mat 8ft south of the southeast corner of Pier 18.

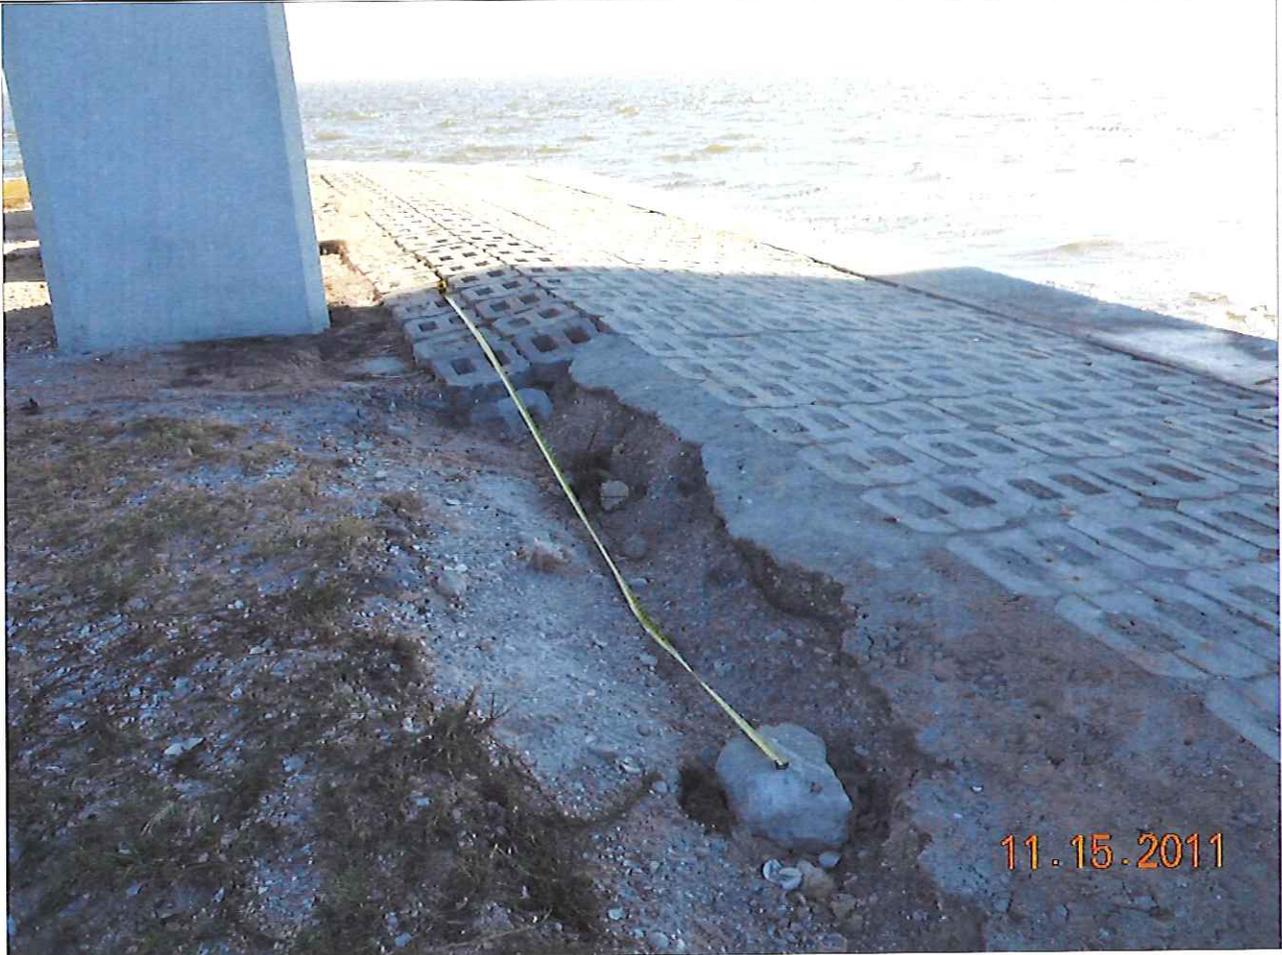
PHOTO 7: 396 OTHER ABUT SLOPE PRO

There is a 20ft x 4ft x 1ft of settlement to the concrete block mat on the southwest corner of footing 18 - NEW. Refer to Photo 7. REPAIR

Settled slope and erosion of the concrete block mat on the southwest corner at footing 18.
