Miscellaneous Structural Engineering Services
Sanibel Bridge Beam Inspections

Bridge No. 124114 - Structure C Sanibel Causeway over San Carlos Bay
3rd Structure South of Toll Plaza

Prepared For:
Lee County

BRIDGE INSPECTION REPORT

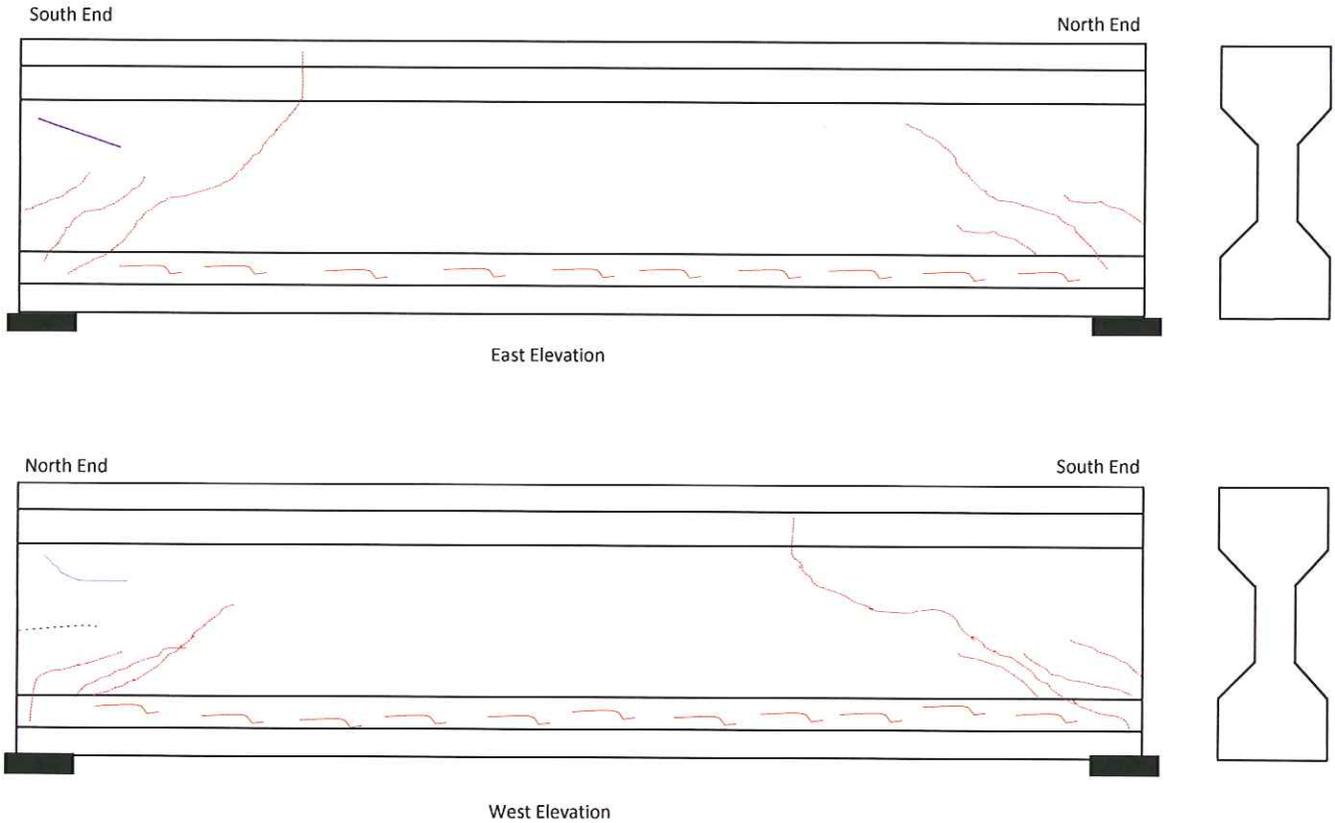
BEAM SKETCHES

Note: The following shows the general direction and locations of the cracks in the beam webs and flanges:

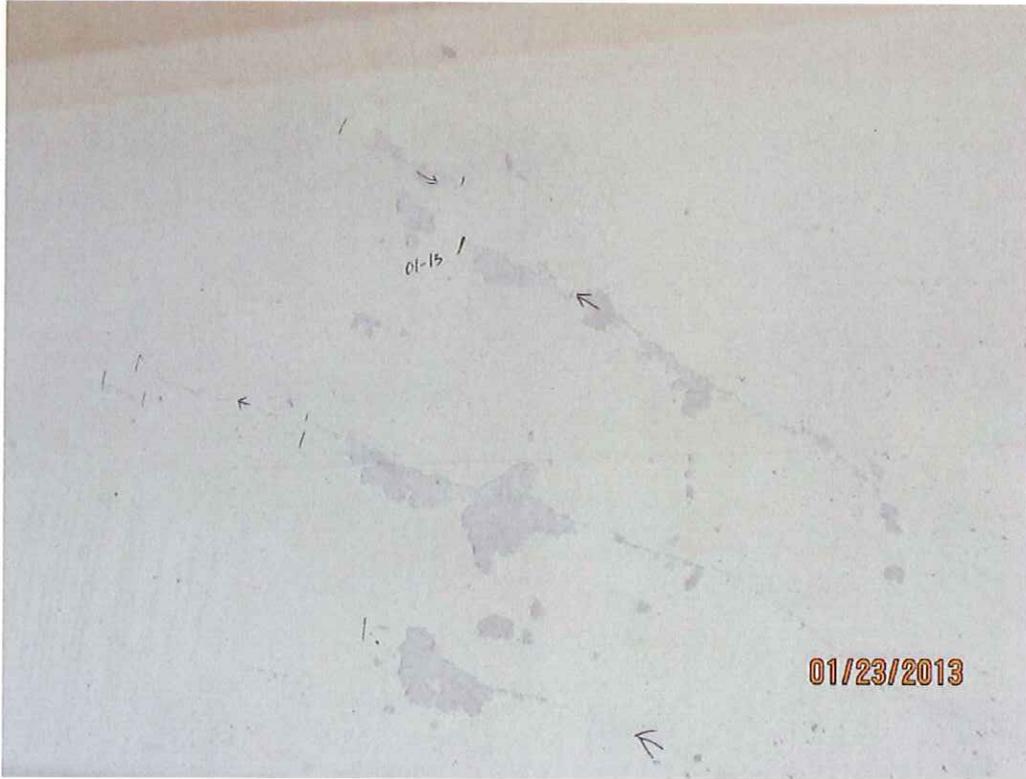
The exterior face of Beams 1 and 4 have a paint system. There are some isolated areas of peeling paint, mostly adjacent to the cracks along the bottom flanges. Refer to Photo 1.

Photo 1 – Typical areas of peeling paint (east face of Beam 25-4 at north end shown)

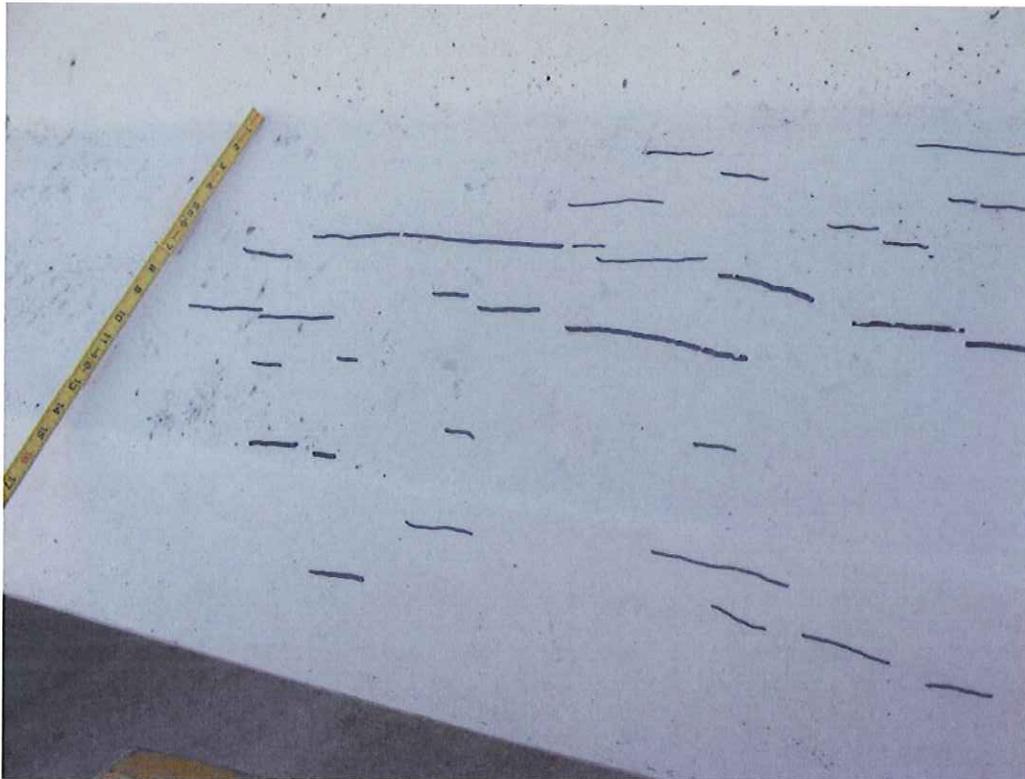
The bottom flange has intermittent length longitudinal cracks that are less than 0.01in. wide throughout. These cracks are most evident in the exterior beams possibly from exposure to adverse weather conditions. Refer to Photo 2.

Photo 2 – Typical longitudinal cracks in the bottom flanges of the exterior faces

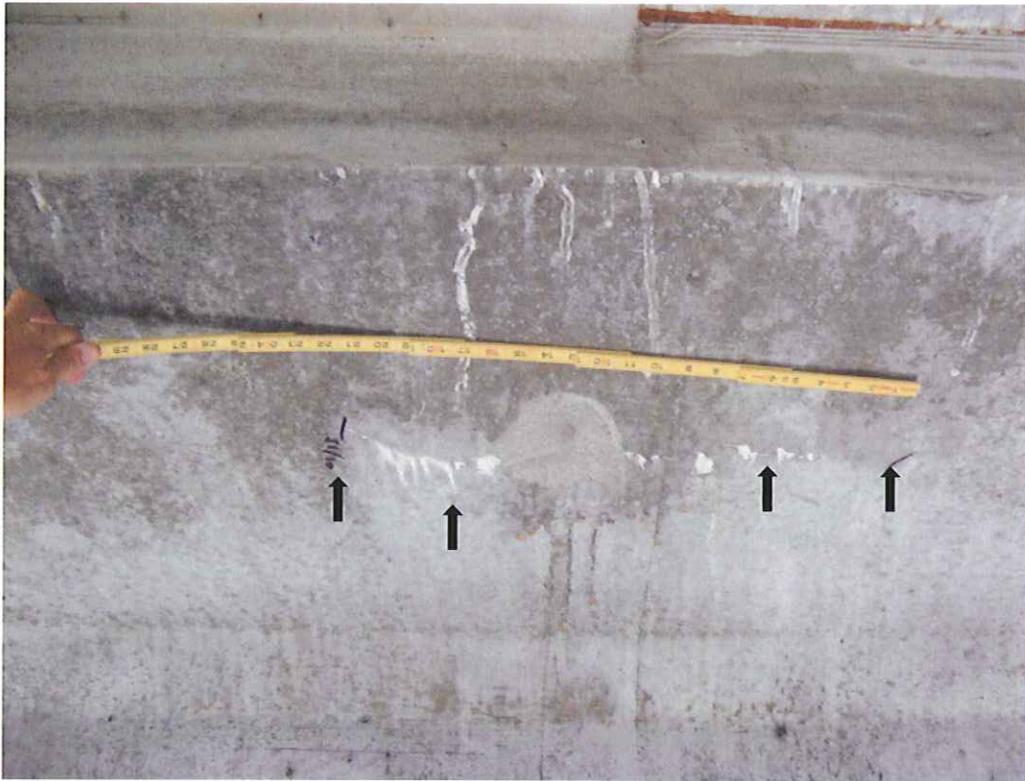
The underside of the top flange has transverse and isolated longitudinal cracks less than 0.010in. wide x up to full flange width (24in. long) with some having light efflorescence. Refer to Photo 3.

Photo 3 – Typical of crack with light efflorescence in underside of the top flanges

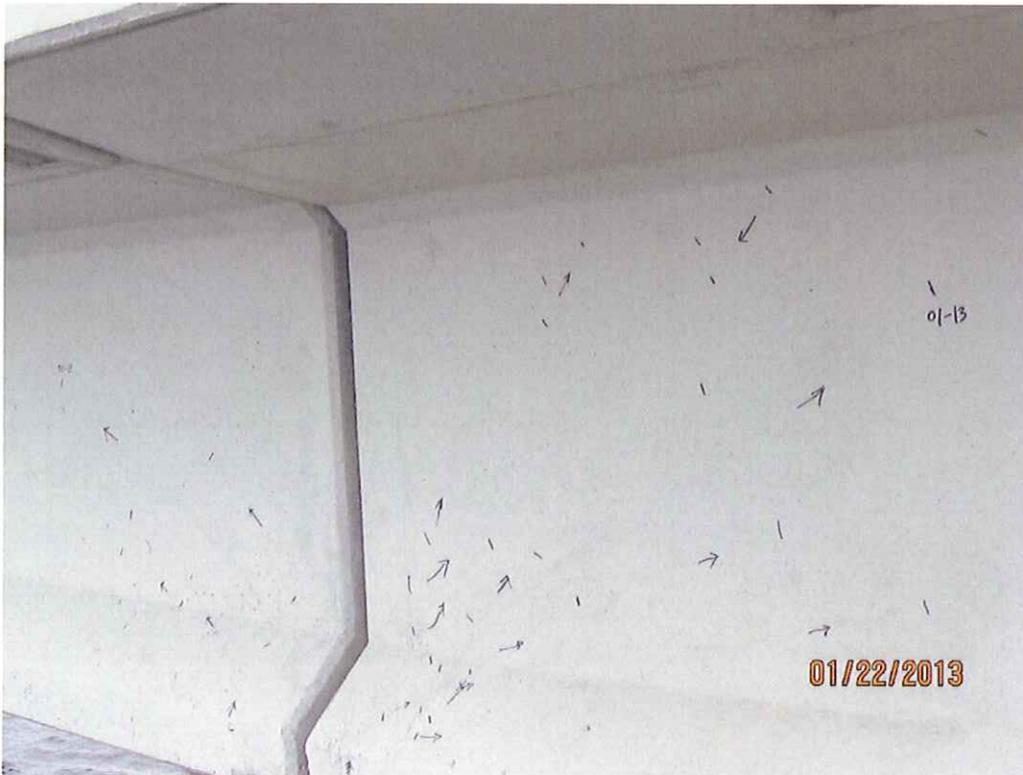
The beam webs typically have intersecting diagonal cracks which begin in or near the bearing area of the bottom flange extending up and away giving them a shear crack appearance. These cracks are less than 0.010in. wide and typically are less than 4ft. long. A few of the previously marked cracks in the 2007 inspection have increased up to 24in. in length; however, the cracks did not grow in width. Adjacent to these cracks are multiple shorter length diagonal, horizontal and some pattern/map style cracks, all being less than 0.010in. wide. There are random beams having longer and more evident diagonal/shear cracks from up to 10ft. long and less than 0.01in. wide. Several cracks were marked with a permanent black marker and dated 01/13 for future reference. Refer to Photos 4 and 5. Also refer to the charts on Pages 6 through 8 for crack quantities and the sketch on Page 10 showing typical crack locations.

Photo 4 – Typical diagonal/shear cracks in exterior beams extending from bearing areas

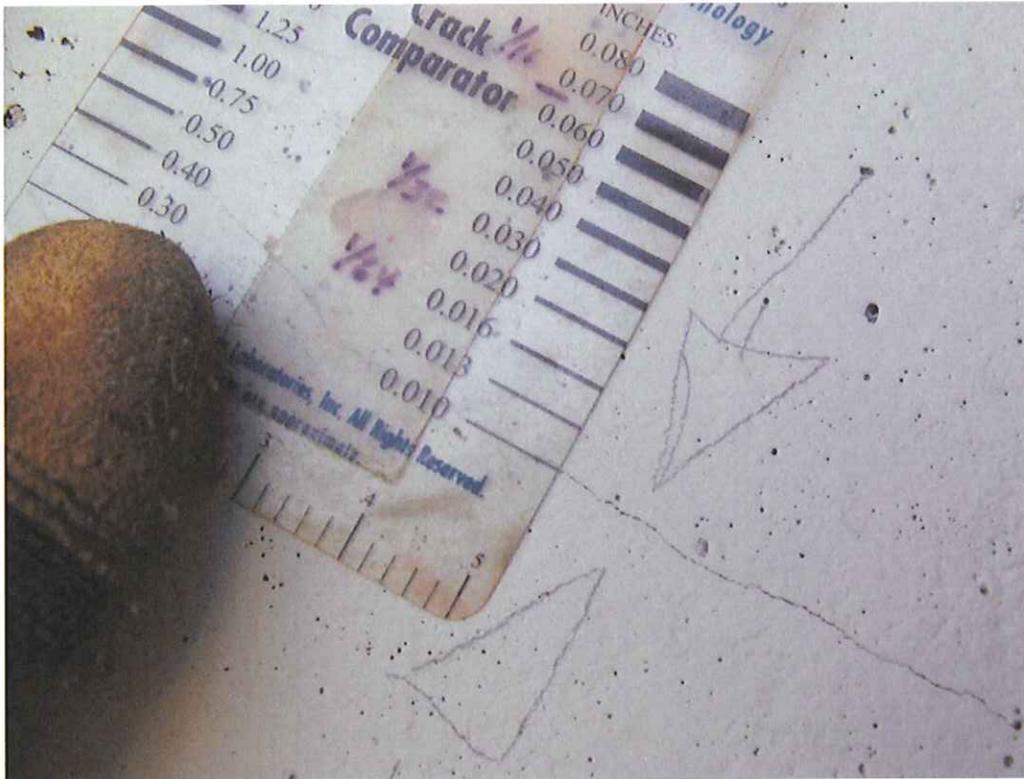
Photo 5 – Typical width of diagonal/shear crack in beam webs near the bearing areas

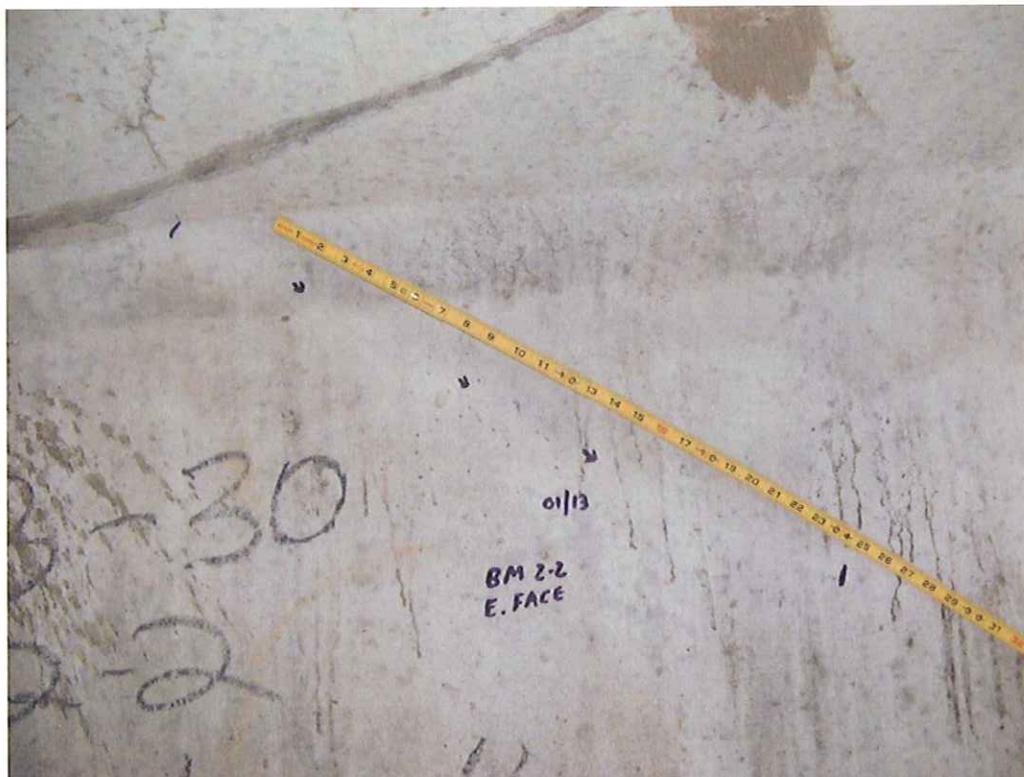
A single diagonal crack less than 0.010in wide is present in a few beams in the upper web areas. These cracks begin near the upper portion of the beam end and extend down and away from the top flange varying in length from 6 1/2in. to 37in. Refer to Photo 6. Also refer to the chart on Page 9 for crack lengths and the sketch on Page 10 showing typical crack locations.

Photo 6 – Typical diagonal crack in beam web extending down and away from top flange

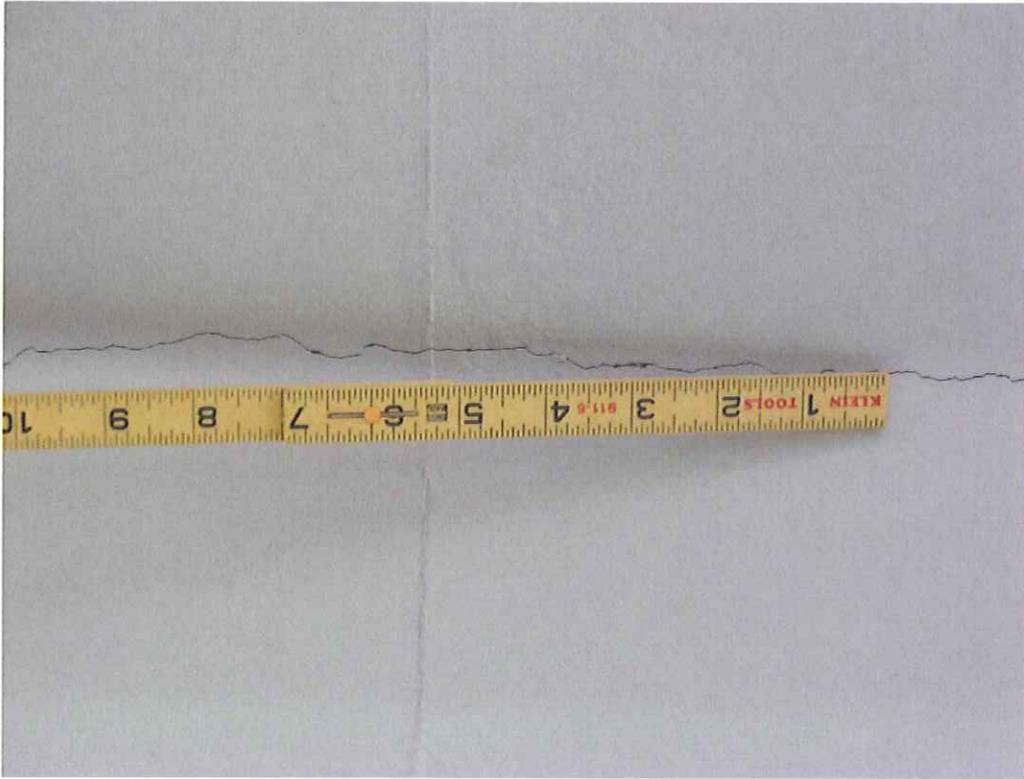
Beam 2-1 west face beginning 30ft. from north end along the top flange to deck juncture has a 0.025in. wide x 45ft. longitudinal crack. Refer to Photo 7.

Photo 7 – Longitudinal crack along west face of Beam 2-1 at web to top flange juncture

- (1) Continue to monitor cracks in the beams for any increase in severity by performing a follow up inspection in six months.
- (2) Apply a protective coating over all cracks in the beam webs extending from beam ends.
- (3) Repair 45ft. longitudinal crack along west face of Beam 2-1 at top flange to deck juncture beginning 30ft. from north end.
- (4) Repair 46 1/2ft. longitudinal crack along east face of Beam 4-4 at top flange to deck juncture beginning 10ft. from south end.
- (5) Repair 30in. x 12in. delamination in west face of Beam 6-4 bottom flange at the north end.

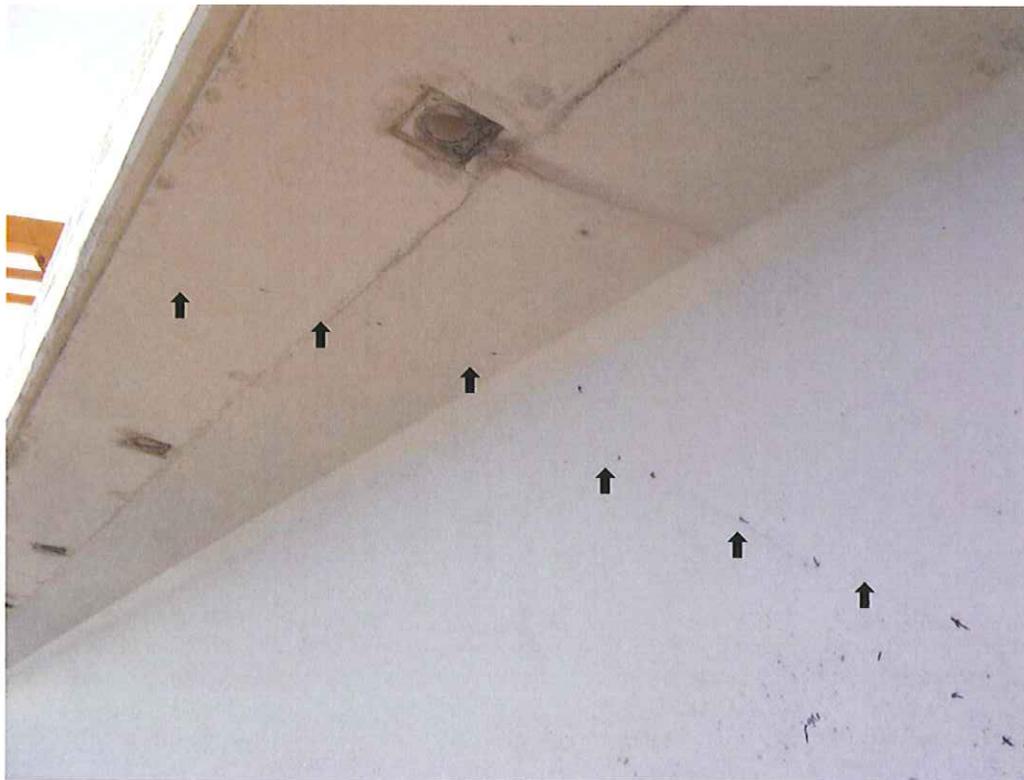
Beam 4-4 east face at north end in addition to the adjacent diagonal/shear cracks has one crack which extends 8ft. from the beam end across the bottom face of the top flange and across the deck over hang. Refer to Photo 8.

Photo 8 – Beam 4-4 east face north end diagonal crack across top flange and deck overhang

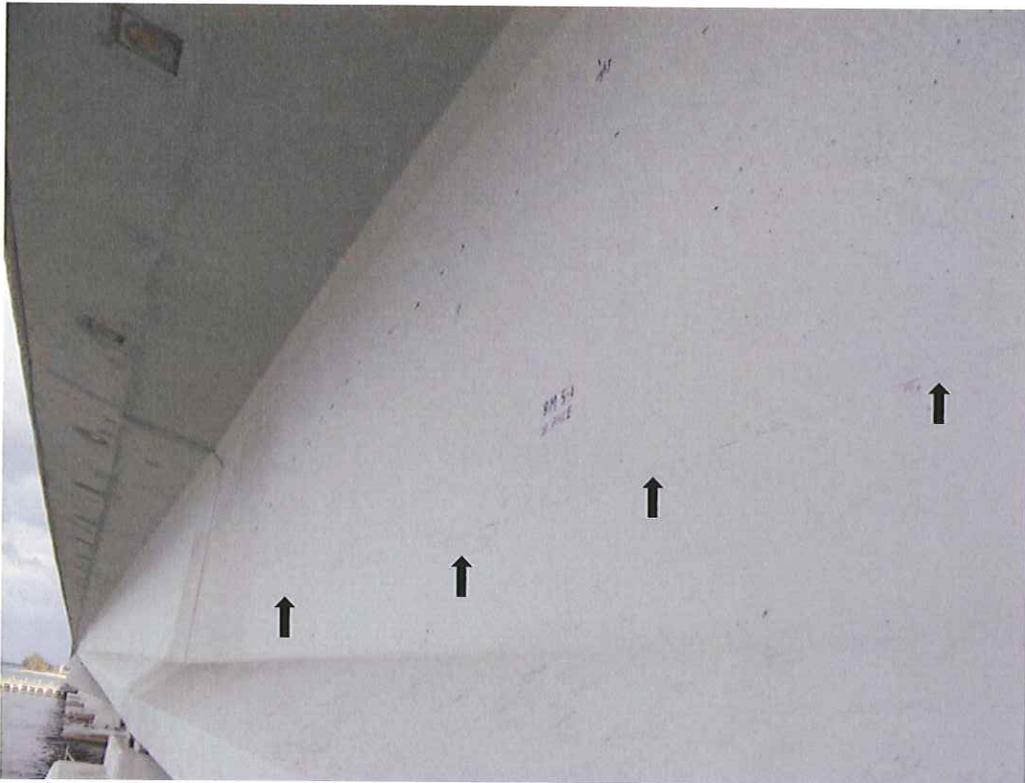
Beam 5-1 west face at north end has a diagonal/shear crack beginning at the beam end and extending 15ft. to the south. Refer to Photo 9.

Photo 9 – Beam 5-1 west face at north end diagonal/shear crack extending 15ft. to the south

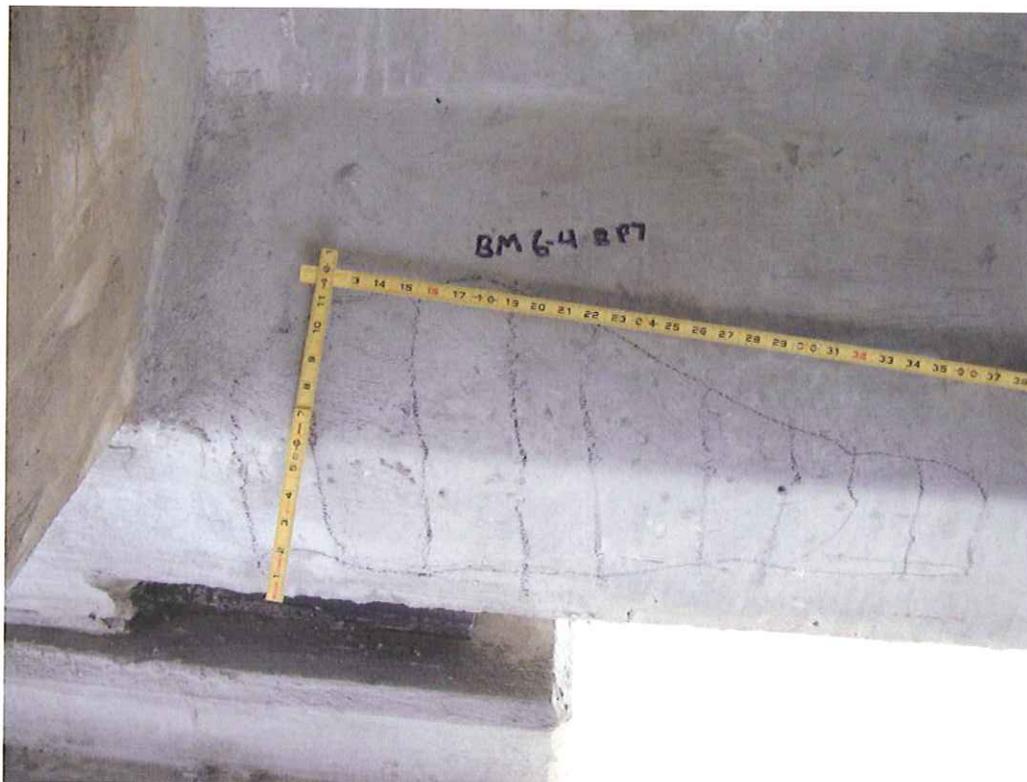
Beam 6-4 west face at north end has a delamination on the bottom flange 30in. long x 12in. high. Refer to Photo 10.

Photo 10 – Delamination on west face of Beam 6-4 at north end

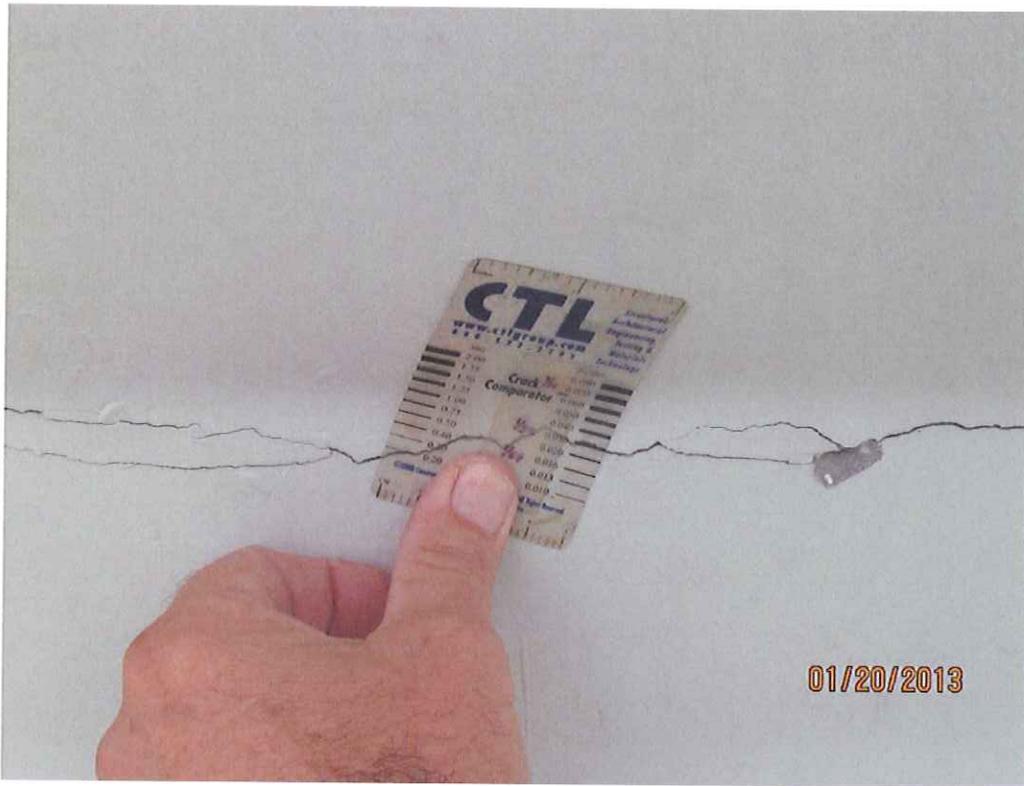
Beam 8-4 east face beginning 10ft. from the south end along the top flange to deck juncture has a longitudinal crack 0.030in. wide extending 46 1/2ft. to the north. Along this crack is minor edge spalls less than 1/4in. deep. Refer to Photo 11.

Photo 11 – Longitudinal crack along east face of Beam 8-4 at web to top flange juncture

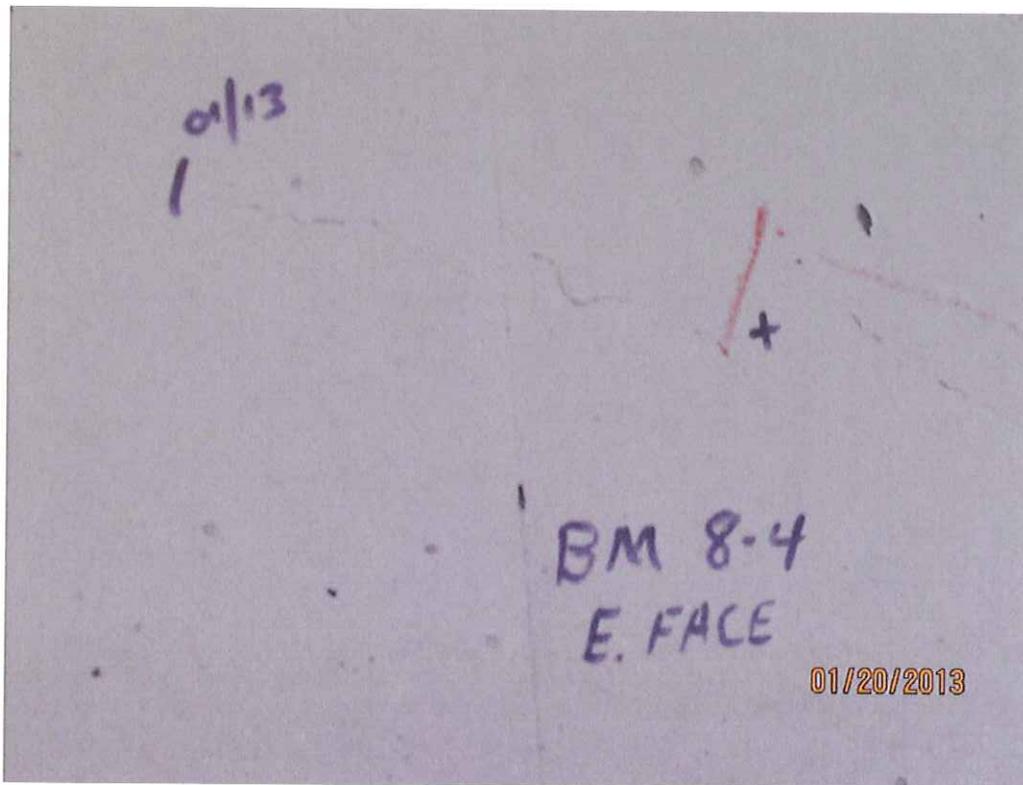
Beam 8-4 east face at north end has similar diagonal/shear cracks which were previously marked during the 2011 inspection. This crack has grown 7in. in length and the quantity has increased from four to six cracks. Refer to Photo 12.

Photo 12 – View showing length of crack increase in east face of Beam 8-4
