Miscellaneous Structural Engineering Services  
Sanibel Bridge Beam Inspections

Bridge No. 124115 - Structure B Sanibel Causeway over San Carlos Bay  
2nd Structure South of Toll Plaza

# BRIDGE INSPECTION REPORT

Type of Inspection:     Routine     Interim     Special Evaluation – Beams Only

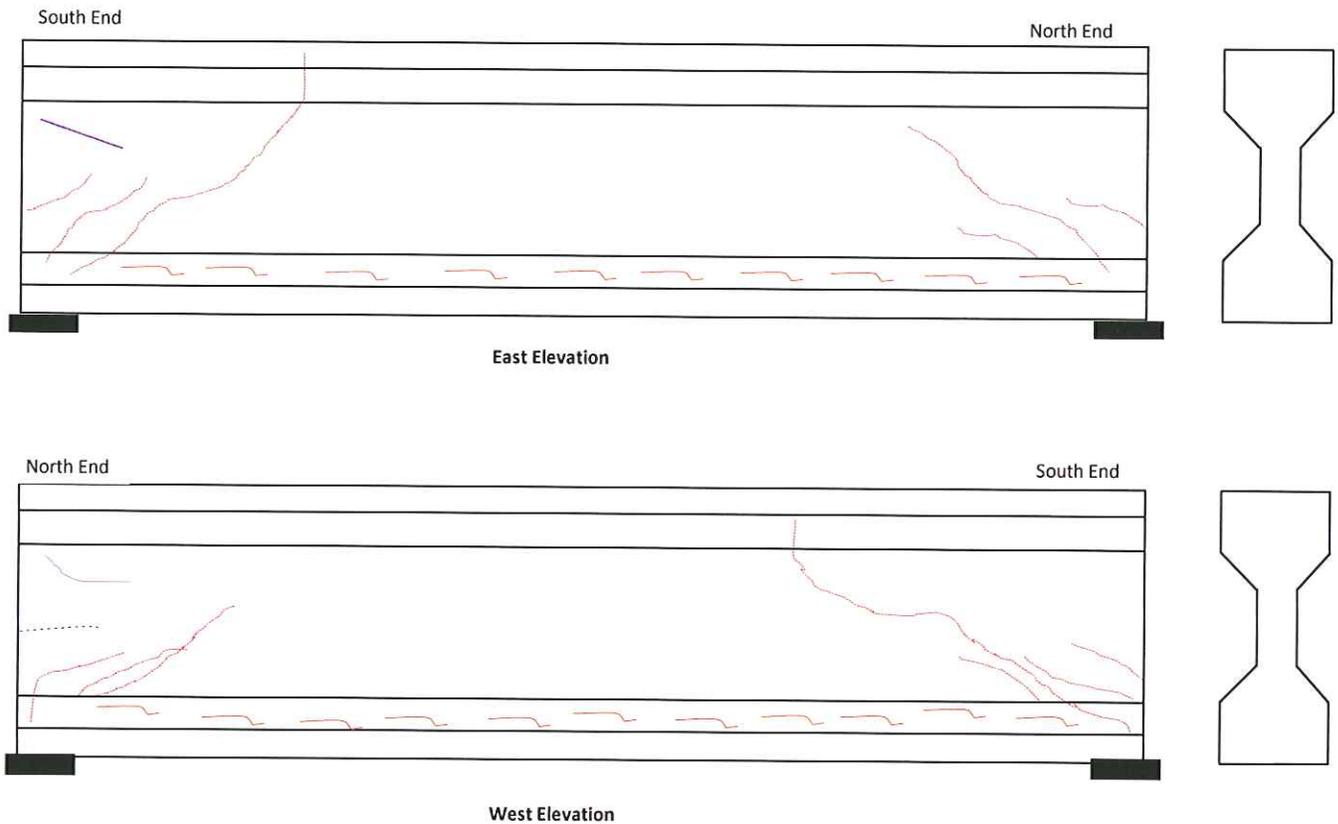
### BEAM SKETCHES

Note: The following shows the general direction and locations of the cracks in the beam webs and flanges:

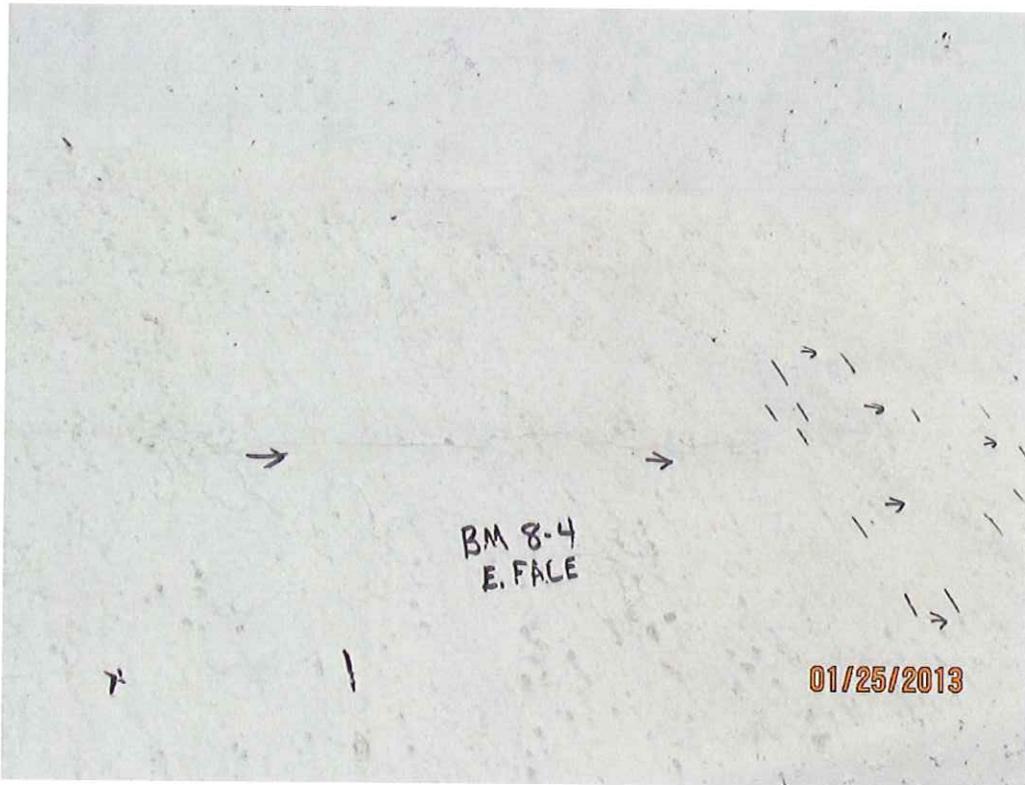
The bottom flange has intermittent length longitudinal cracks that are less than 0.01in. wide throughout. These cracks are most evident in the exterior beams possibly from exposure to adverse weather conditions. Refer to Photo 1.

Photo 1 – Typical longitudinal cracks in bottom flanges of beams

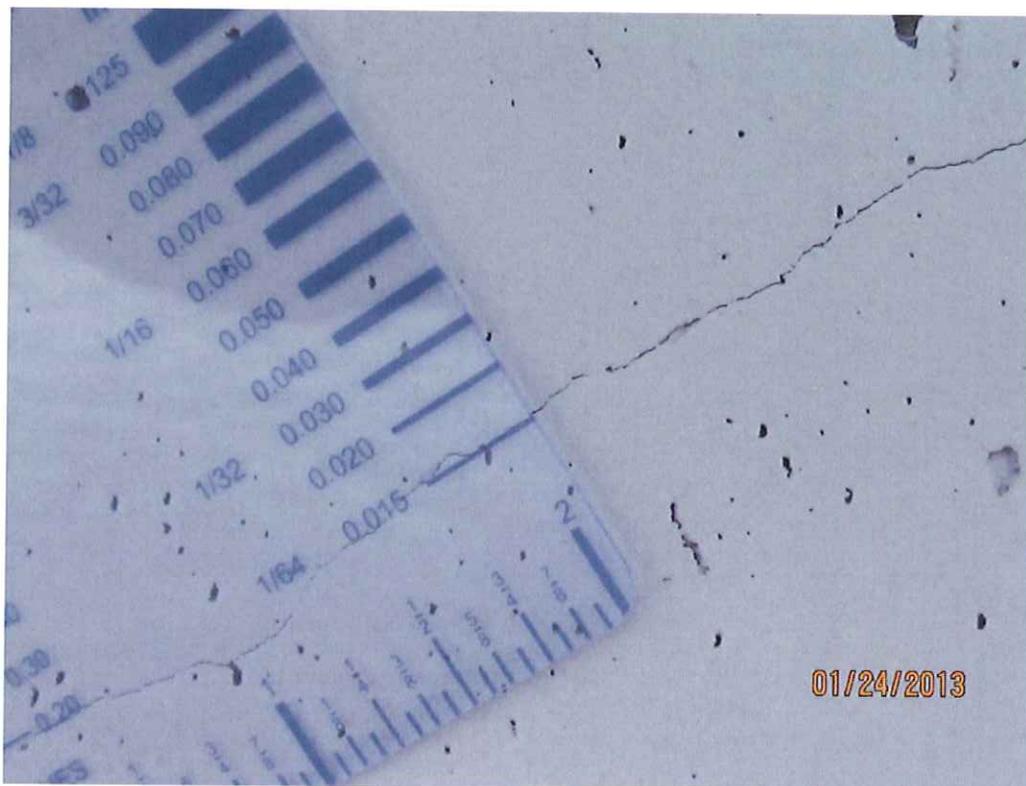
The beam webs typically have intersecting diagonal cracks which begin in or near the bearing area of the bottom flange extending up and away giving them a shear crack appearance. These cracks are less than 0.010in. wide and typically are less than 5ft. long. Adjacent to these cracks are multiple shorter length diagonal, horizontal and some pattern/map style cracks, all being less than 0.010in. wide. There are random beams having longer more evident diagonal/shear cracks from up to 8.5ft. long and are less than 0.01in. wide. Several cracks were marked with a permanent black marker and dated 01/13 for future reference. Refer to Photos 2 and 3. Also refer to the charts on Pages 5 and 6 for crack quantities and the sketch on Page 7 showing typical cracks locations.

Photo 2 – Typical width of diagonal/shear cracks in beams

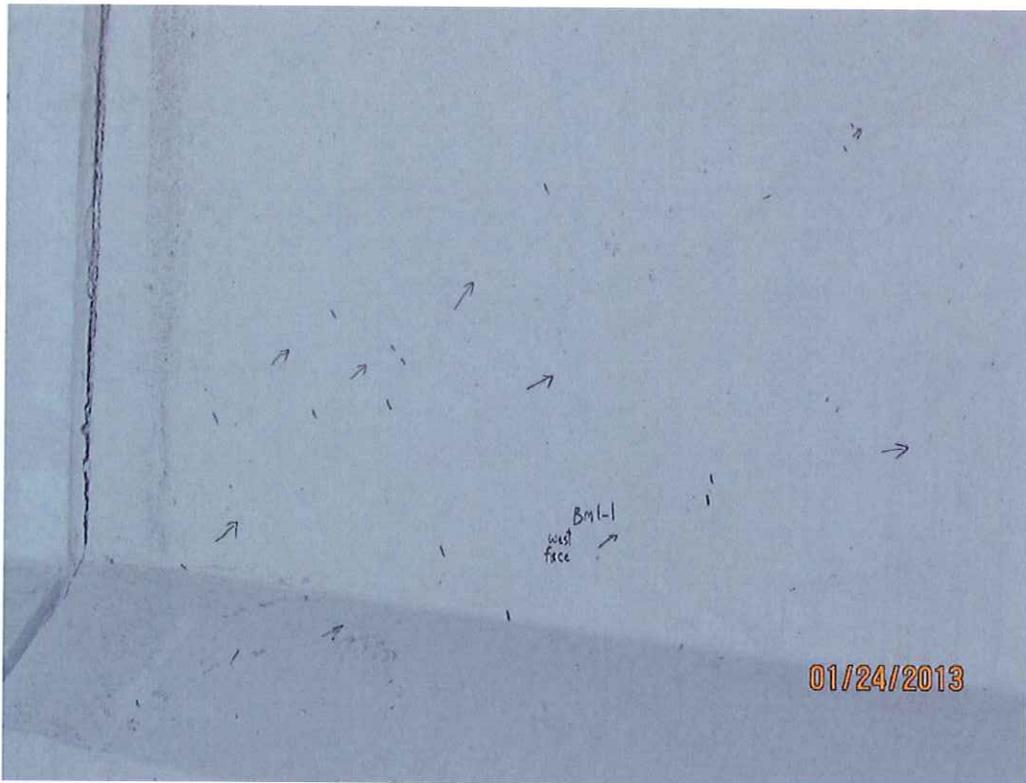
Photo 3 – Typical diagonal/shear cracks in beams

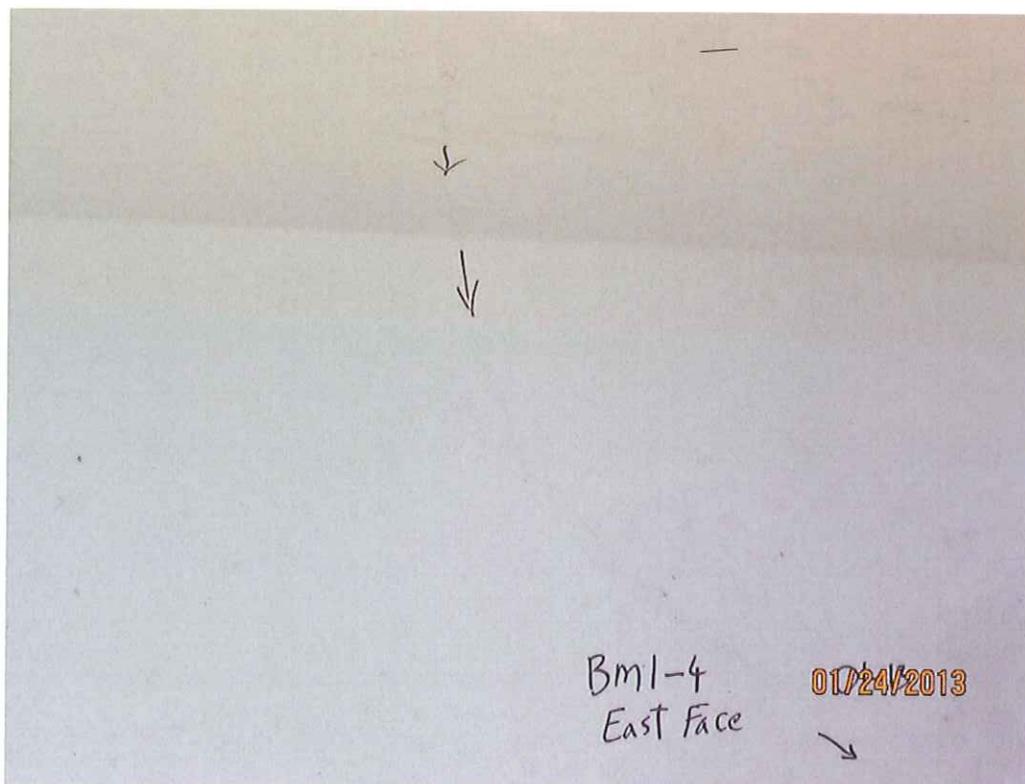
Beam 1-4 east face at north end in addition to the adjacent diagonal/shear cracks has one crack which extends 92in. from the bottom of the beam end/bearing area up and across the bottom face of the top flange. Refer to Photo 4.

Photo 4 – Diagonal/shear crack extending from bottom bearing area across top flange
