Bridge No. 124116 - Structure A Sanibel Causeway over San Carlos Bay
1st Structure South of Toll Plaza

BRIDGE INSPECTION REPORT

Bridge No. 124116
 Bridge Name: Structure A Sanibel Causeway over San Carlos Bay
 Location: 1st Bridge South of Toll Plaza

Type of Inspection: Routine Interim Special Evaluation – Beams Only

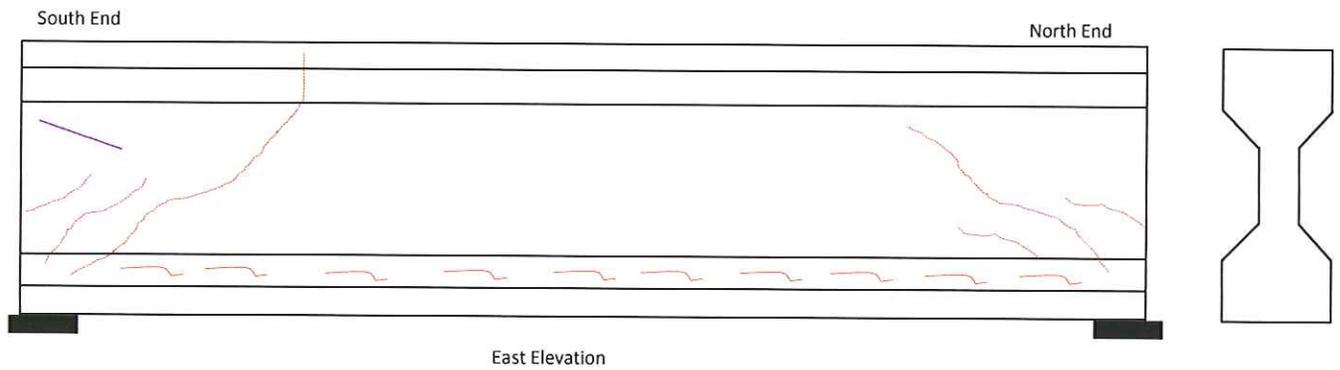
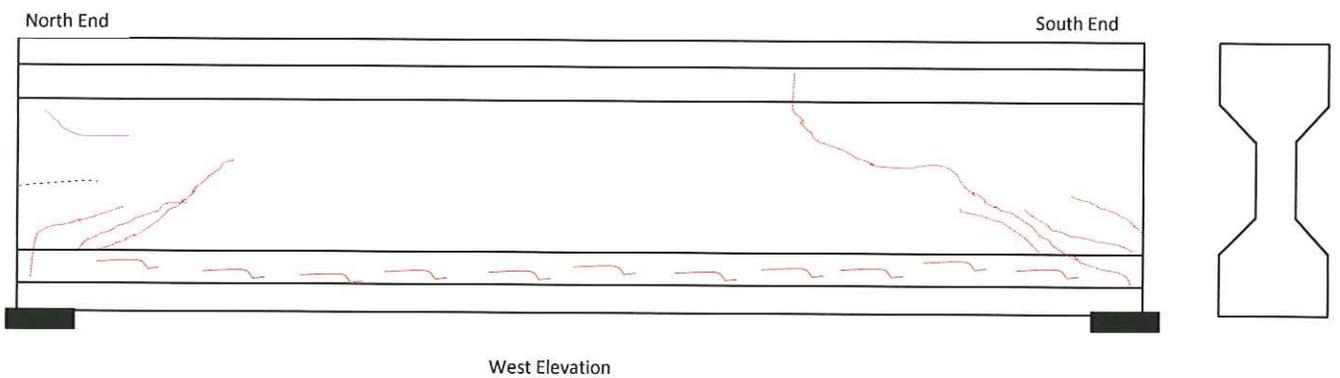
BEAM SKETCHES

Note: The following shows the general direction and locations of the cracks in the beam webs and flanges:

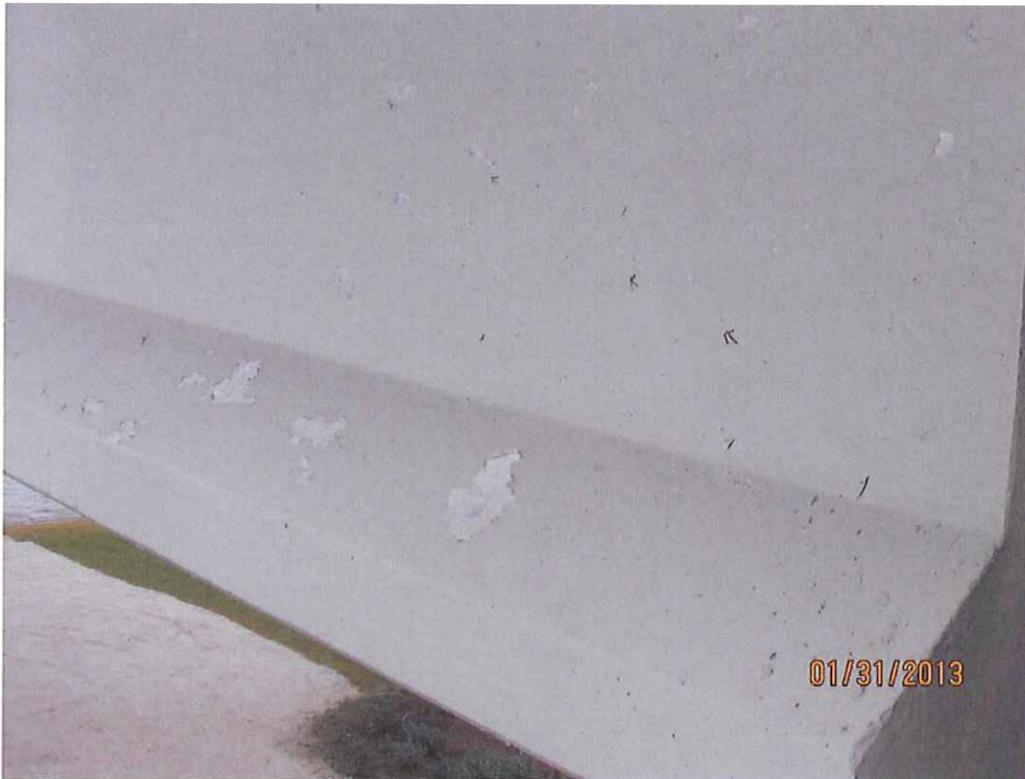
The exterior face of Beams 1 and 4 have a paint system. There are some isolated areas of peeling paint, mostly adjacent to the cracks along the bottom flanges. The worst conditions appear to be on Beam 17-4 near the south end of the west face and Beam 18-4 at the north end of the east face. Refer to Photo 1.

Photo 1 – Typical areas of peeling paint (east face of Beam 18-4 at north end shown)

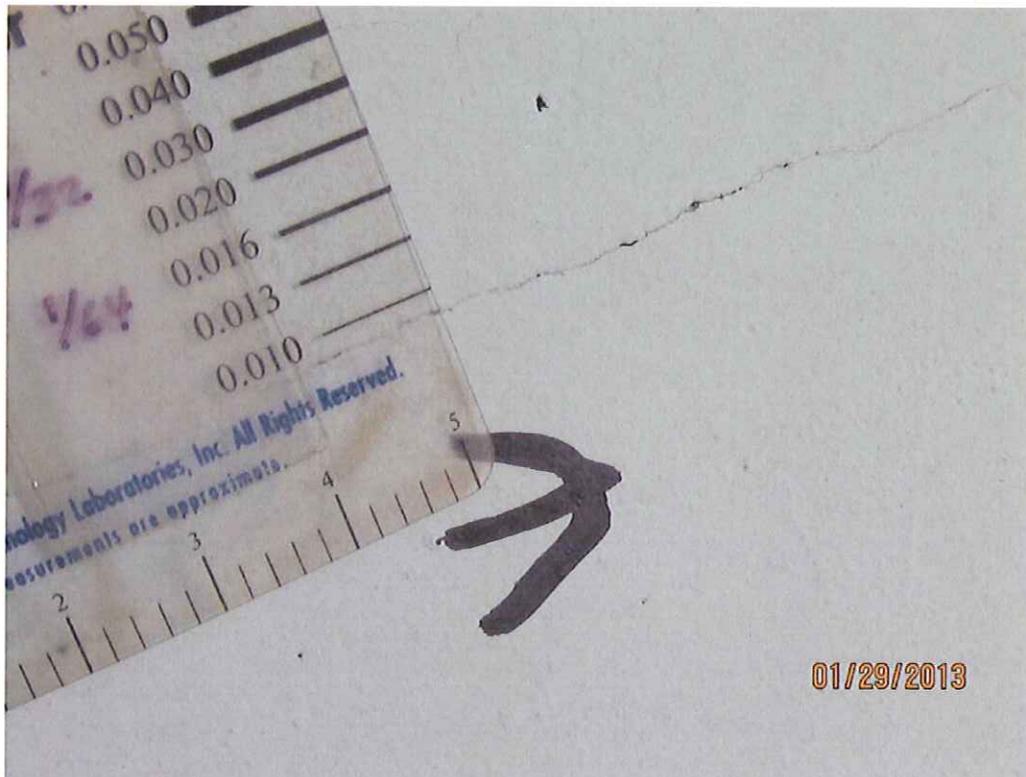
The bottom flanges of nearly all beams in all spans have intermittent longitudinal cracks that are less than 0.010in. wide throughout. These cracks are most evident in the exterior beams possibly from exposure to adverse weather conditions. Refer to Photos 2, 3 and 6.

Photo 2 – Typical crack width in the bottom flanges and beam webs

- (1) Continue to monitor cracks in the beams for any increase in severity by performing a follow up inspection in six months.
- (2) Apply a protective coating over all cracks in the beam webs extending from beam ends.
- (3) Repair 51in. longitudinal crack in west face of Beam 12-4 beginning 20ft. from south end along the top flange to web juncture.
- (4) Repair 57in. longitudinal crack in east face of Beam 13-1 beginning 20ft. from north end along the top flange to web juncture.

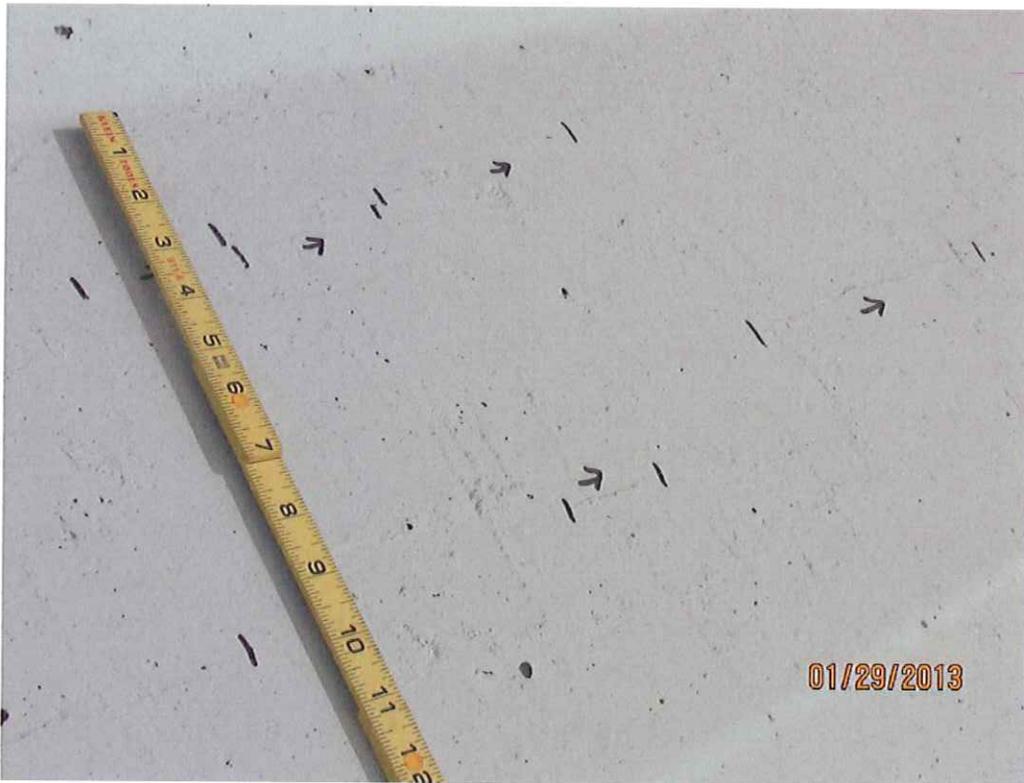
Photo 3 – Typical longitudinal cracks in the bottom flanges of the exterior faces

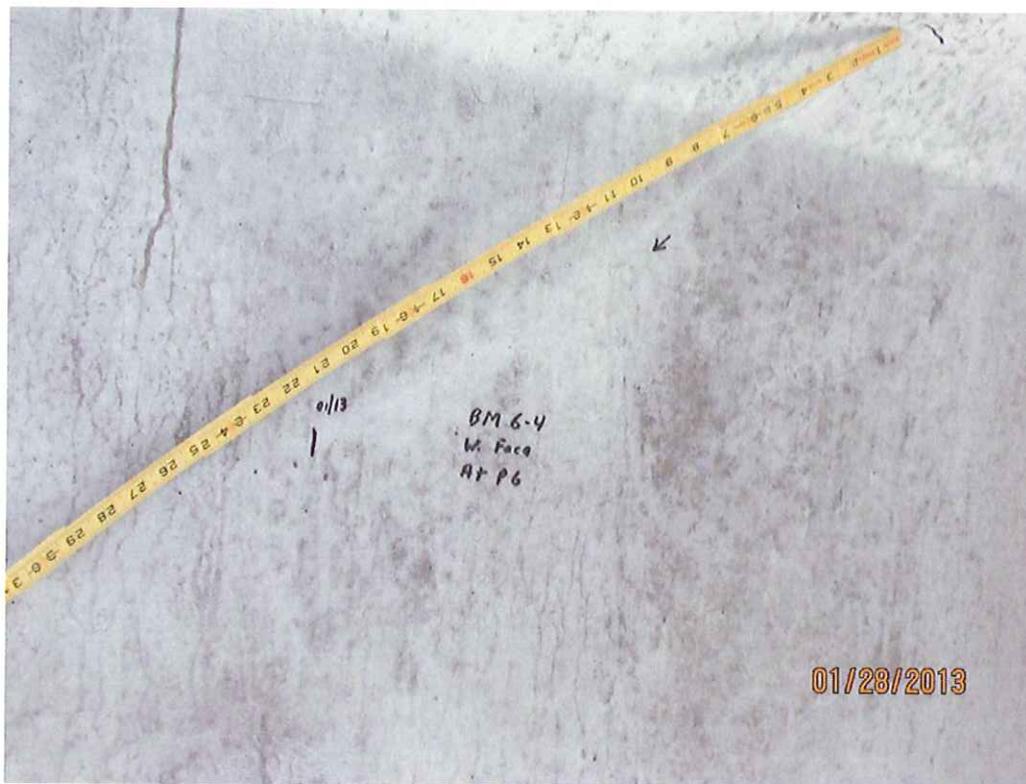
A few beams have a single diagonal crack up to 30in. long x less than 0.010in. wide in the upper web and top flange areas. These cracks begin near the beam end and extend down and away from the top flange. Refer to Photo 4. Also refer to the chart on Page 5 for list of beams with this type cracking and locations.

Photo 4 – Typical diagonal crack in beam web extending down and away from top flange

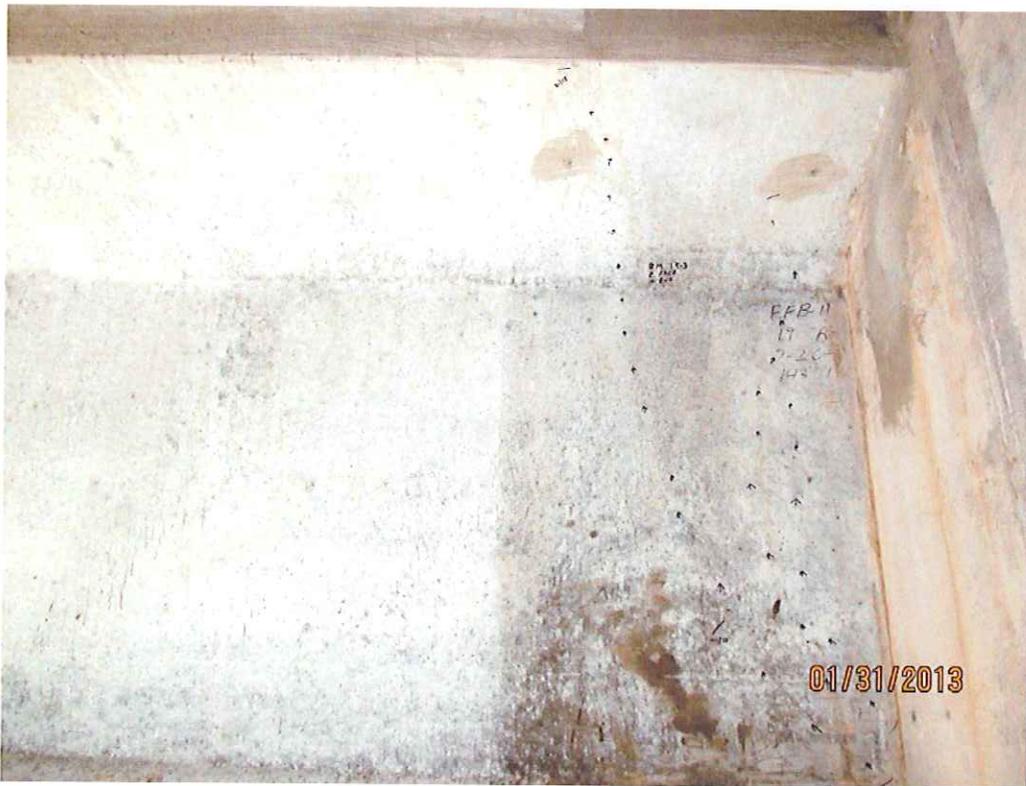
Several beam webs have vertical cracks up to 61in. long x less than 0.010in. wide with-in 24in. of the beam ends. Most of these cracks extend from the bottom flange/bearing area up to and across the underside of the top flange. Refer to Photo 5. Also refer to the chart on Page 5 for list of beams with this type cracking.

Photo 5 – Typical vertical cracks in web and across the top flange at the beam ends

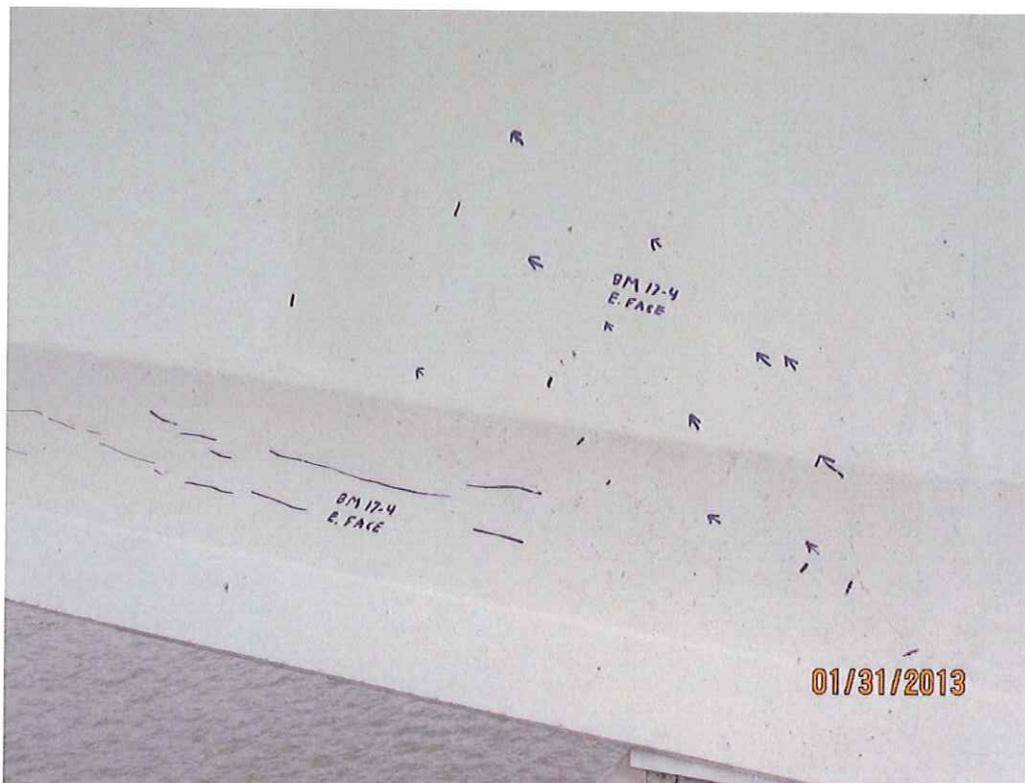
The beam webs typically have intersecting diagonal cracks which begin in or near the bearing area of the bottom flange extending up and away giving them a shear crack appearance. These cracks are less than 0.010in. wide and typically are less than 4ft. long with a few beams having longer more evident diagonal/shear cracks up to 10ft. long x less than 0.010in. wide. Adjacent to these cracks are multiple shorter length diagonal, horizontal and some pattern/map style cracks, all being less than 0.010in. wide. Several cracks throughout all spans were marked with a permanent black marker and dated 01/13 for future reference. Refer to Photo 6. Also refer to the charts on Pages 6 and 7 for crack quantities and the sketch on Page 8 for locations.

Photo 6 – Typical diagonal crack in beam web and horizontal cracks in bottom flange

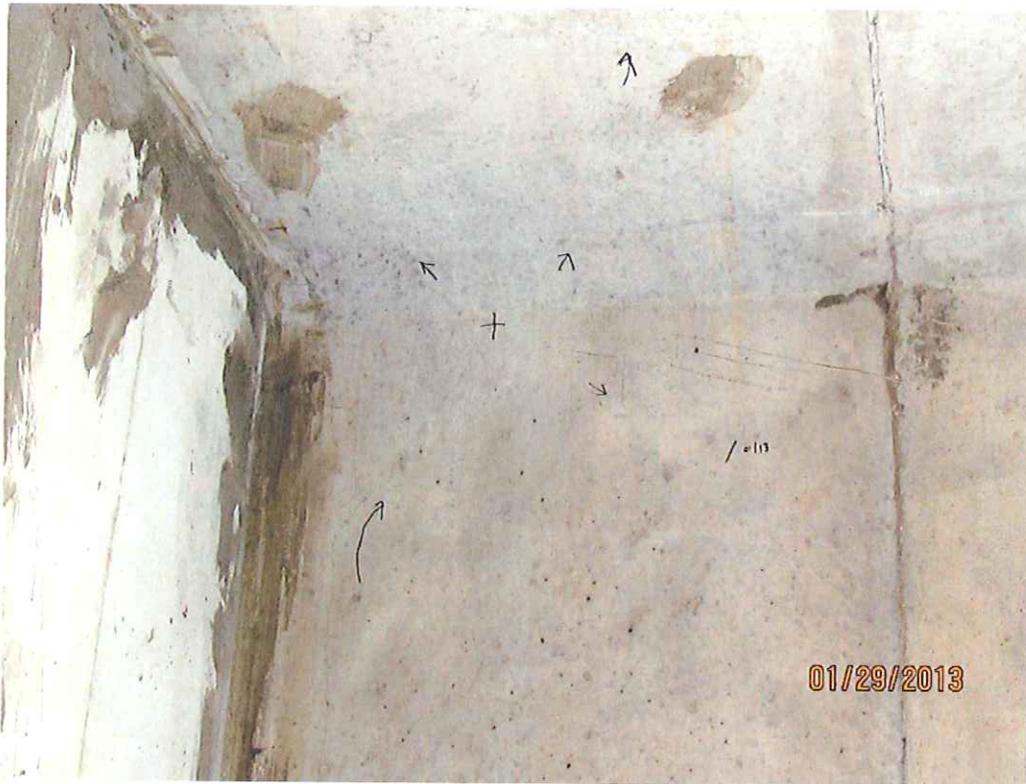
Beam 11-2 east face, at north end has intersecting diagonal cracks less than 0.010in. wide. One is 61in. long and extends from with-in the bottom flange up and across underside of the top flange. The second crack is 18in. long and extends down and away from the beam end. Refer to Photo 7.

Photo 7 – Intersecting cracks on east face at north end of Beam 11-2

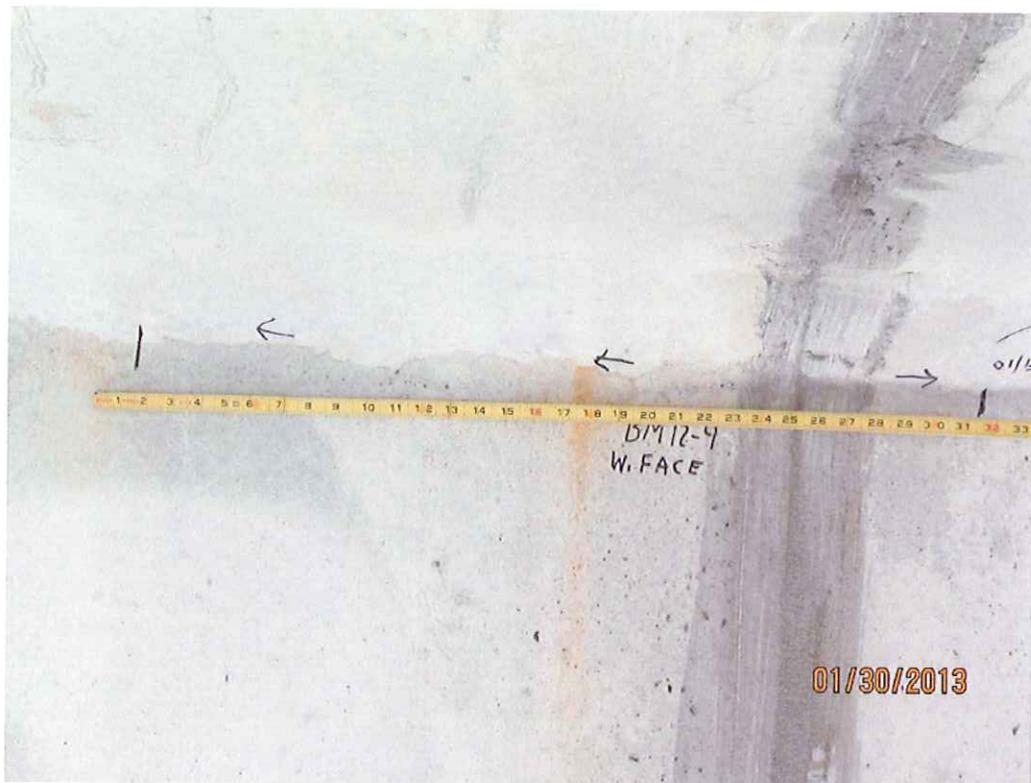
Beam 12-4 west face, 20ft. from south end along the top flange to web juncture has a longitudinal crack 51in. long x less than 0.010in. wide. Refer to Photo 8.

Photo 8 – Longitudinal crack along west face of Beam 12-4 at top flange juncture
