# BRIDGE RECORD

BRIDGE NUMBER: 124116  
BRIDGE NAME: STRUCTURE A SANIBEL CAUSEWAY

# BRIDGE INSPECTION REPORT

Inspection Report  
(INITIAL INSPECTION)

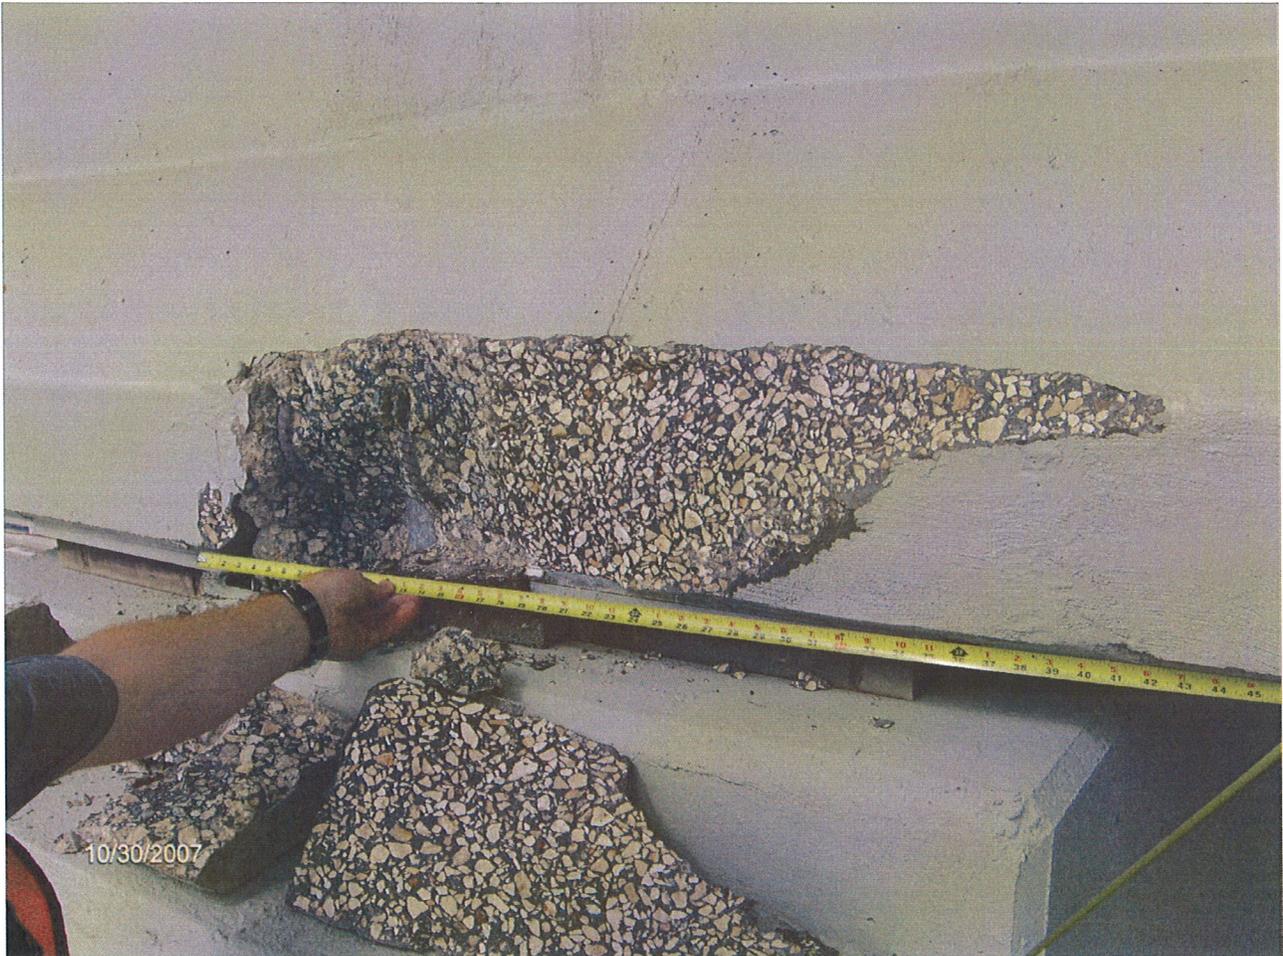
**PHOTO 1: 109/4 P/S CONC OPEN GIRDER**

CS2: There are beam end /closure pour delaminations and spalls at pier 11 as follows:

- 10/11-1, east and west faces, delamination, 10in x 5in;
- 10/11-2, west face, spall with no exposed steel, delamination, 24in x 4in x 2in;
- 10/11-3, west face, spall with no exposed steel, 10in x 10in x 1/2in;
- 10/11-4, west face, delamination, 6in x 5in;
- 10/11-4, east face, spall with exposed steel, 42in x 12in x 5in. Refer to Photo 1. REPAIR ALL

Spall with exposed closure pour /diaphragm steel, beam 10/11-4 east face at pier 11.

Repair spalls and delaminations on all beams over pier 11. Suggest in depth inspection on blast damaged beams. 0.25CY 20MH

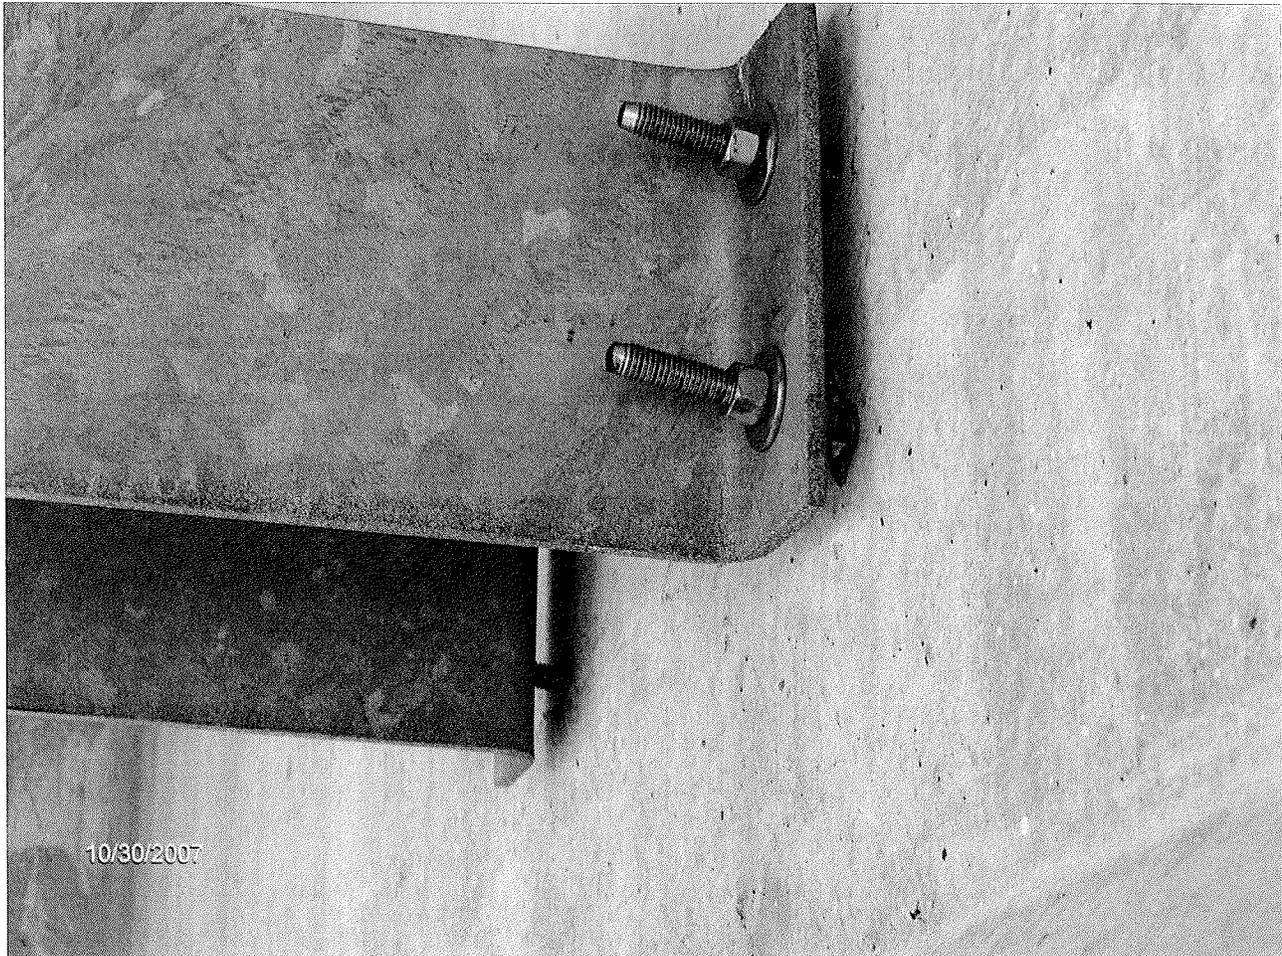
**PHOTO 2: 397/4 DRAIN SYST METAL**

CS1: Most scupper down spouts are not properly shimmed or anchored to the beams. Refer to Photo 2. REPAIR

Drain system down spout improperly anchored to beam, bay 4-1 near pier 4 - typical.

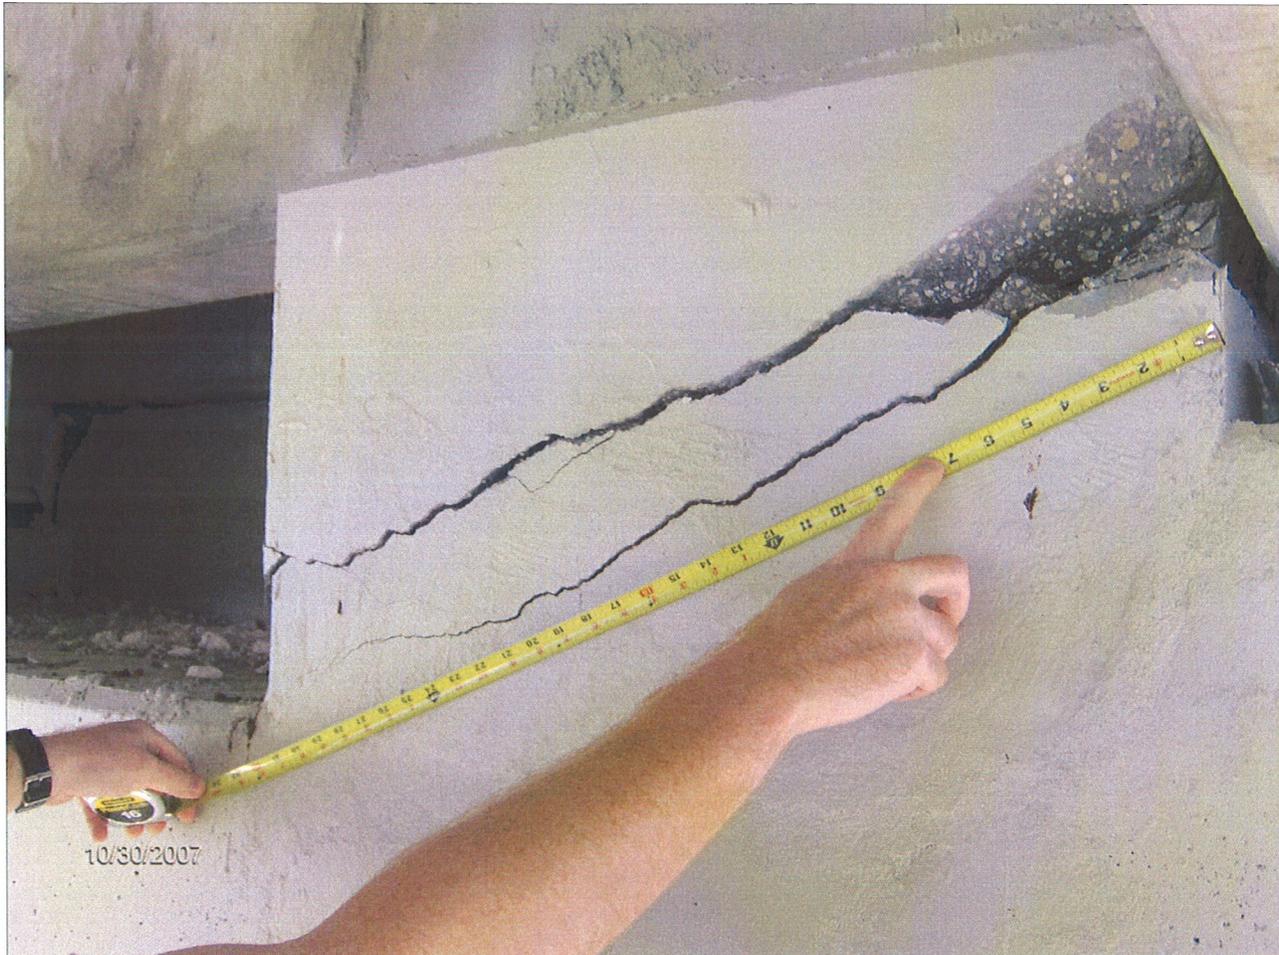
**PHOTO 3: 234/4 R/CONC CAP**

CS1: Both shear blocks in span 10 at pier 10 and the right block in span 11 at pier 12 are fractured. Refer to Photo 3. REPAIR

Fractured left shear key span 10, pier 10 - typical.

Replace both shear keys span 1- pier 10 and right block span 11 at pier 12. Consider in depth inspection of areas possibly affected by blast. 100M-

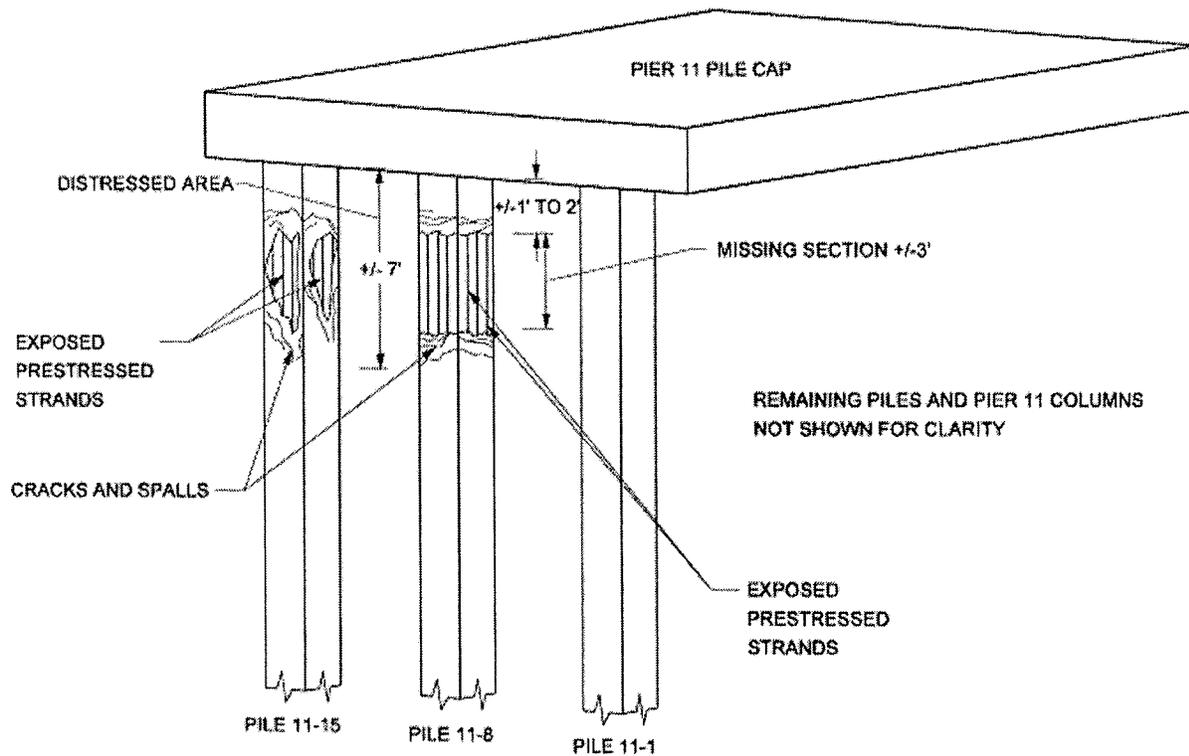
SKETCH 1: 207/4 P/S CONC HALL PILE

CS4: The upper 7ft of piles 11-8 and 11-15 are fractured and all prestress strands are exposed. Refer to Sketch 1. REPAIR

Fractured pile 11-8 with missing section and all prestressed strands exposed – typical.

Repair or replace pile 11-8 and 11-15. Consider performing in depth inspection of all substructure elements possibly affected by the demolition blast. 400MH
