BRIDGE INSPECTION REPORT

BRIDGE NO. 124114

INSPECTION DATE: 11/30/2009

CR-867 over San Carlos Bay (Sanibel Structure C)

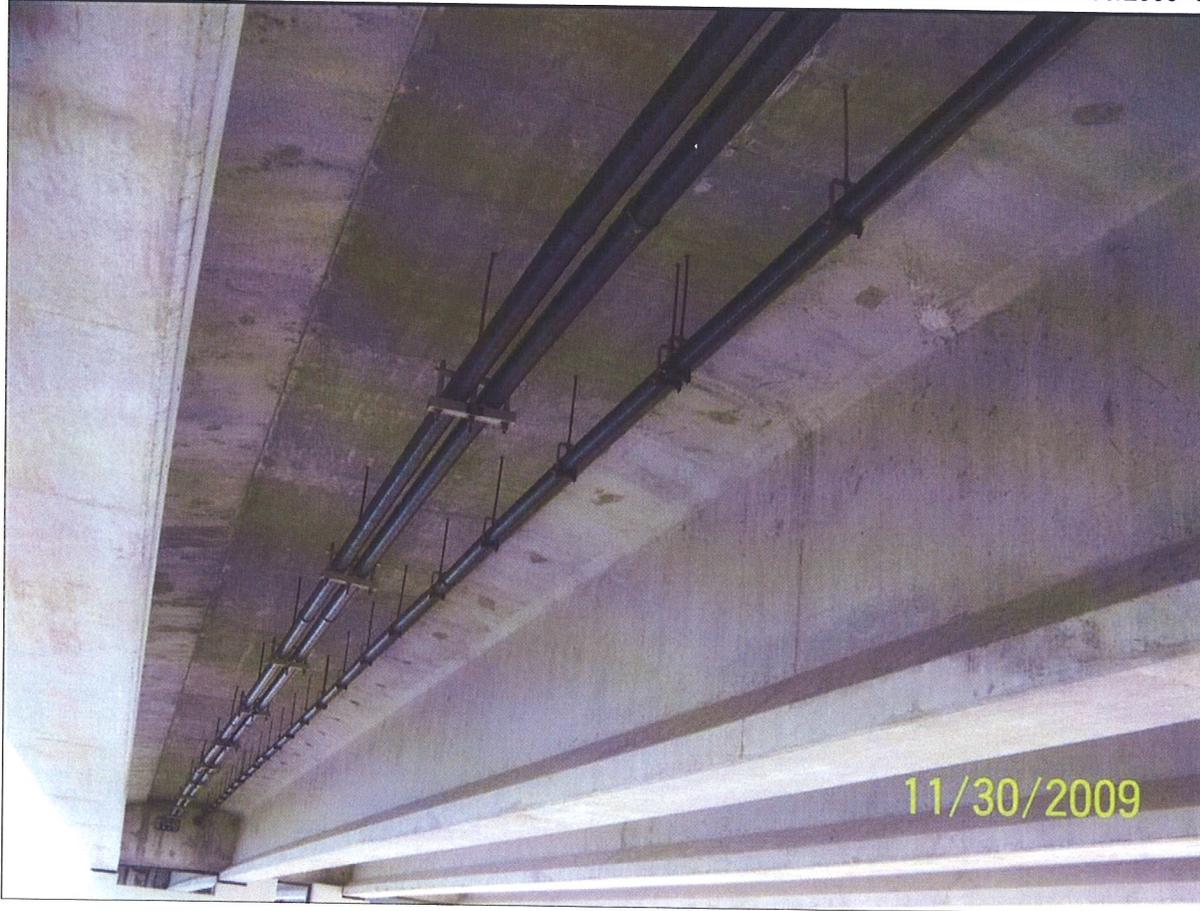
Photo 1 - Element 12 Bare Concrete Deck

Note: Two 4-1/2in. diameter fiberglass conduits and one 3-1/2in. diameter PVC conduit are suspended from hangers anchored to the underside of Bay 1 in all spans. Refer to photo 1. The type of anchorage for the hangers is unknown.

View of utilities in Bay 1 of all spans

REPAIR RECOMMENDATION:
None

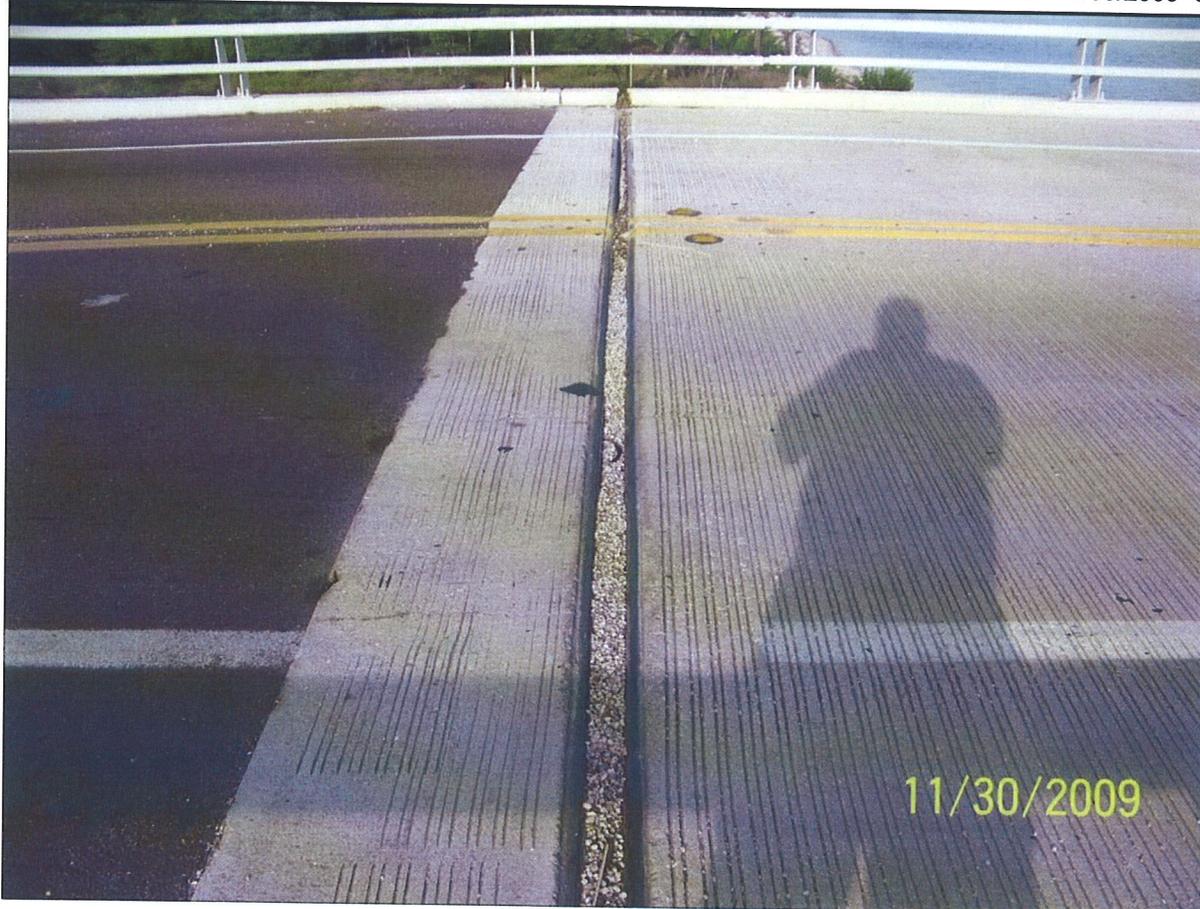
Photo 2 - Element 300 Strip Seal Exp Joint

CS1 = The joints are filling with dirt and debris, but are functioning as intended at this time - NEW. Refer to photo 2.

Typical view of dirt and debris in the joints (Abutment 1 joint shown)

REPAIR RECOMMENDATION:
None

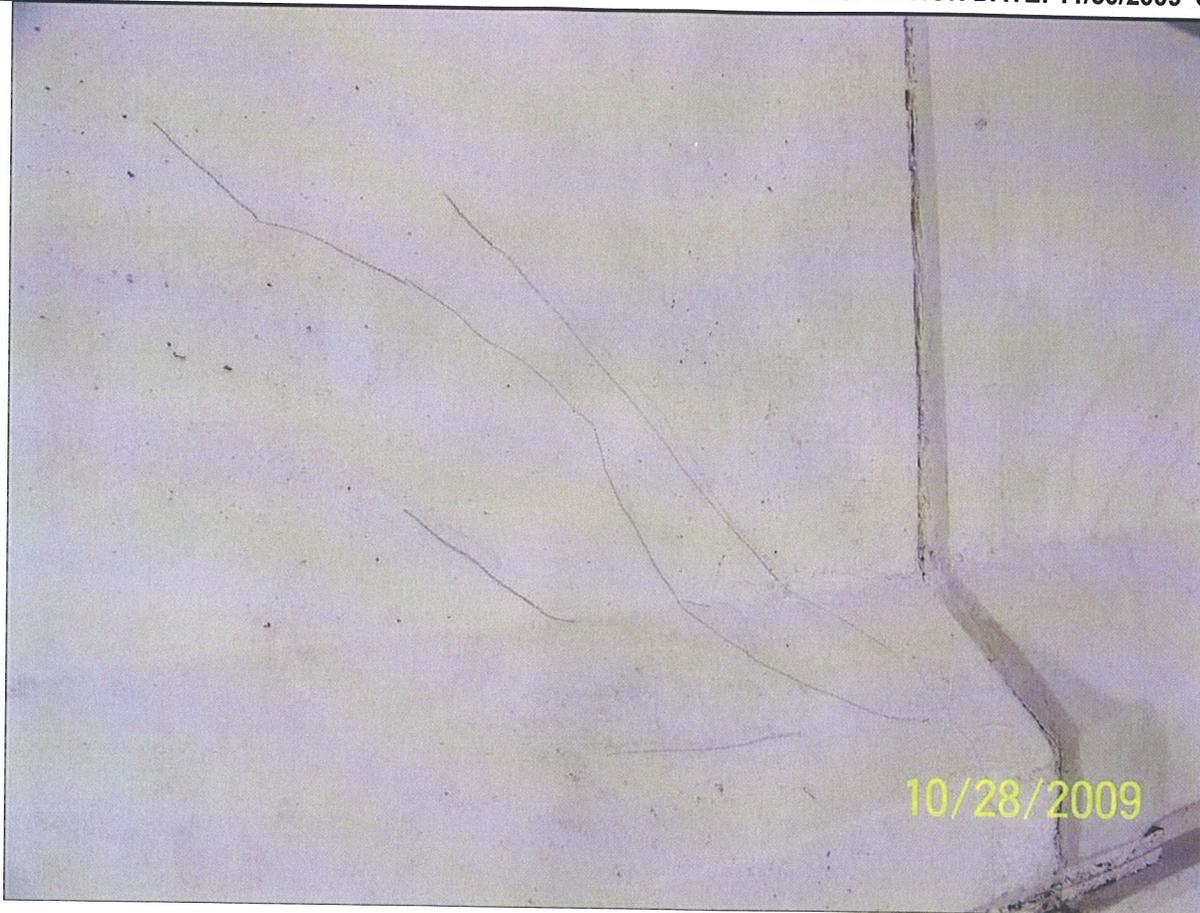
Photo 3 - Element 109 P/S Conc Open Girder

CS1 = The beams have multiple diagonal web cracks of various lengths up to 4ft. long x 1/64in. wide near the bearing areas, extending up and away from the supports. Refer to photo 3.

Typical view of diagonal web cracks in the beams

Note: NBI Item #58 Superstructure was changed from an 8 to a 7 due to the diagonal cracks in the webs of the beams. NBI Item #61 Channel was changed from an 8 to a 7 due to the changes of 2ft. or greater in the channel measurements at some locations.

REPAIR RECOMMENDATION:
None

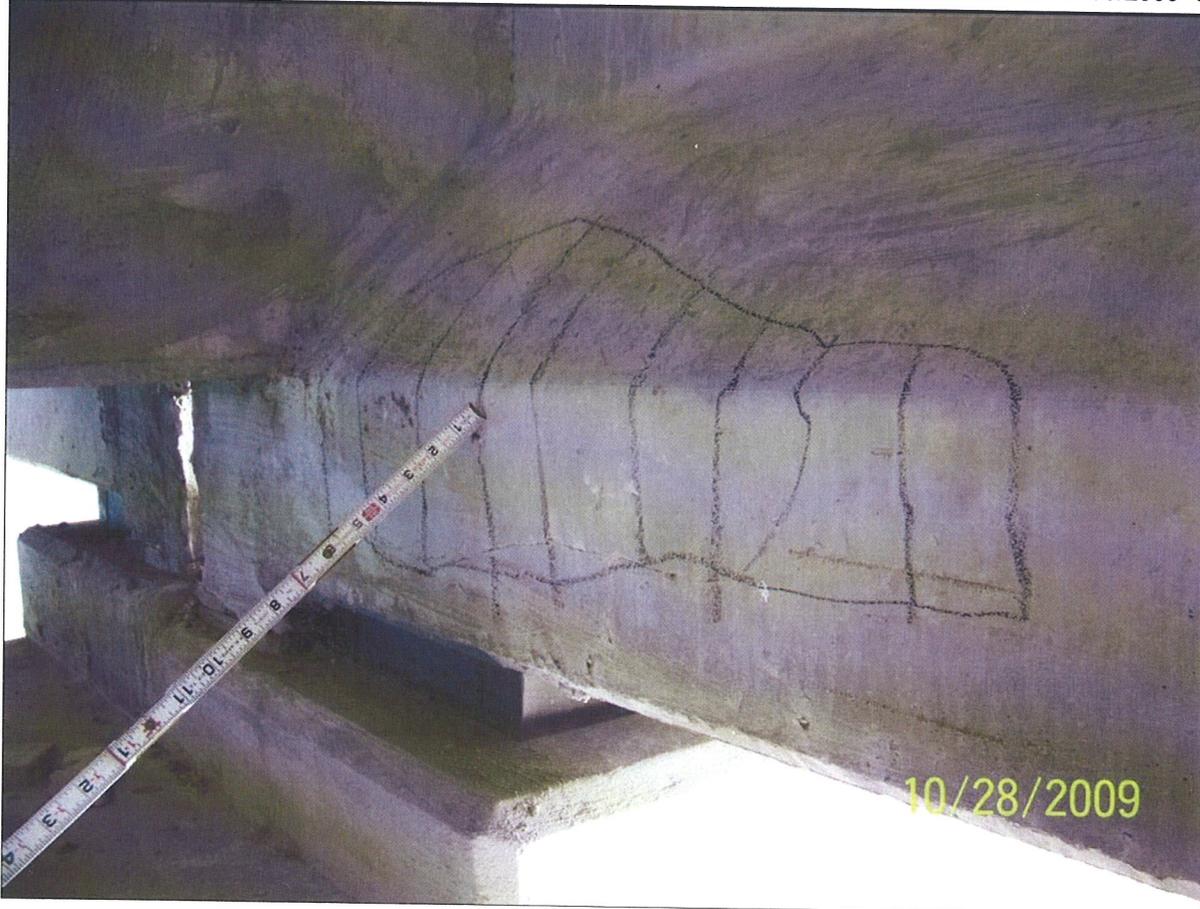
Photo 4 - Element 109 P/S Conc Open Girder

CS3 = The west face of the bottom flange of Beam 6-4 at Pier 7 has a 30in. x 12in. delamination - NEW. Refer to photo 4. REPAIR

Delamination in the west face of the bottom flange of Beam 6-4 at Pier 7

REPAIR RECOMMENDATION:

Repair the delamination in the west face of the bottom flange of Beam 6-4 at Pier 7.
