# BRIDGE INSPECTION REPORT

BRIDGE NO. 124115

INSPECTION DATE: 11/30/2009

CR-867 over San Carlos Bay (Sanibel Structure B)

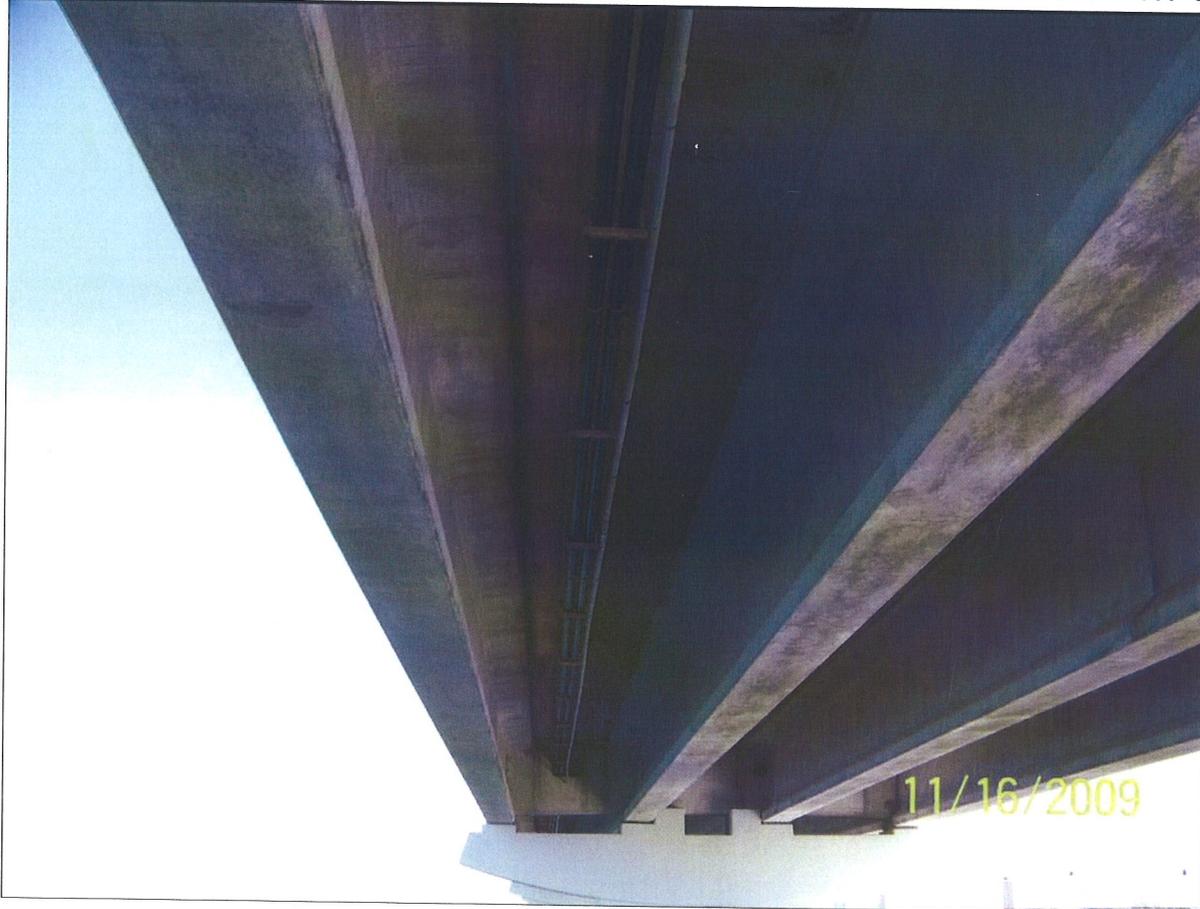
Photo 1 - Element 12 Bare Concrete Deck

Note: Two 4-1/2in. diameter fiberglass conduits and one 3-1/2in. diameter PVC conduit are suspended from hangers anchored to the underside of Bay 1 in all spans. Refer to photo 1. The type of anchorage for the utility hangers is unknown.

Utilities in Bay 1 of all spans

REPAIR RECOMMENDATION:  
None

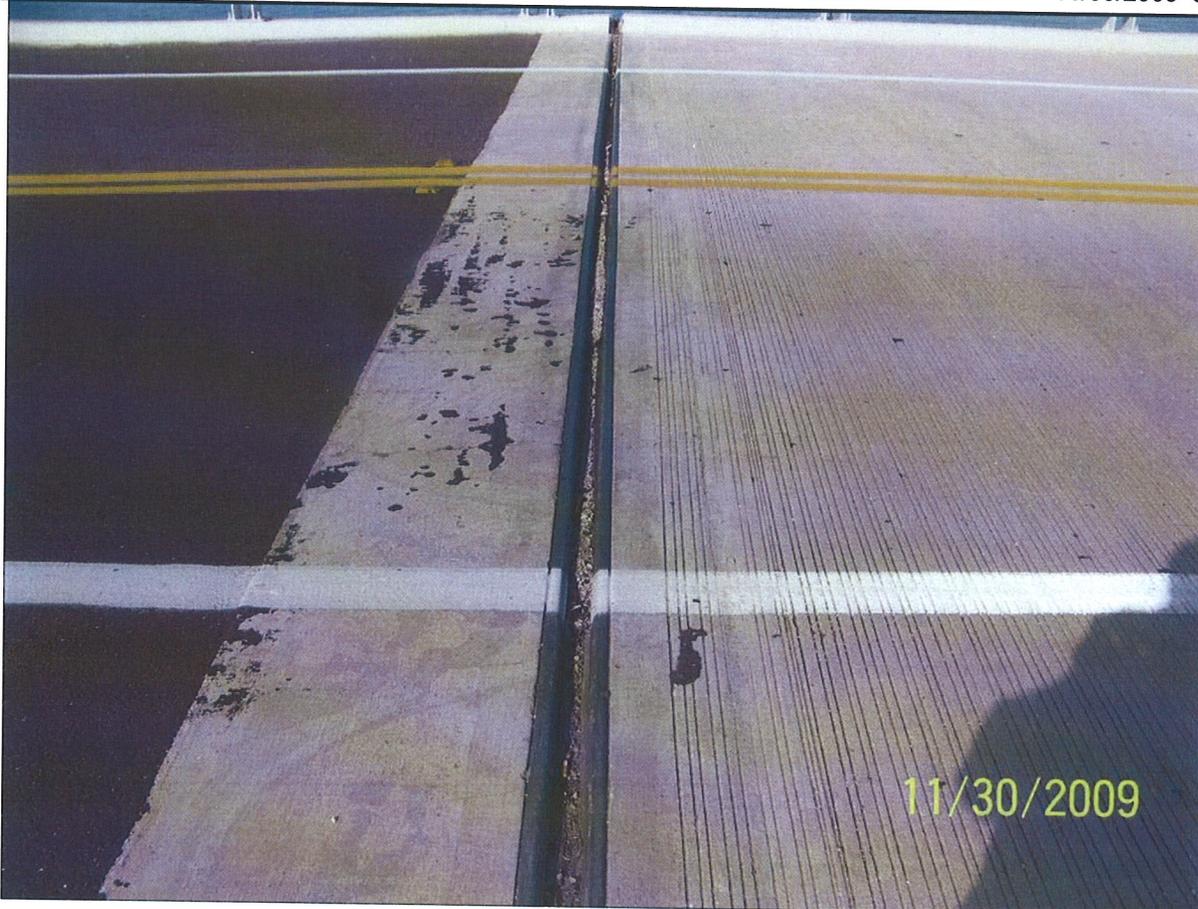
Photo 2 - Element 300 Strip Seal Exp Joint

CS1 = The joints are filling with dirt and debris, but are functioning as intended at this time - NEW. Refer to photo 2.

Typical view of dirt and debris in the joints (joint at Abutment 1 shown)

REPAIR RECOMMENDATION:  
None
