BRIDGE INSPECTION REPORT

BRIDGE NO. 124116

INSPECTION DATE: 11/30/2009

CR-867 over San Carlos Bay (Sanibel Structure A)

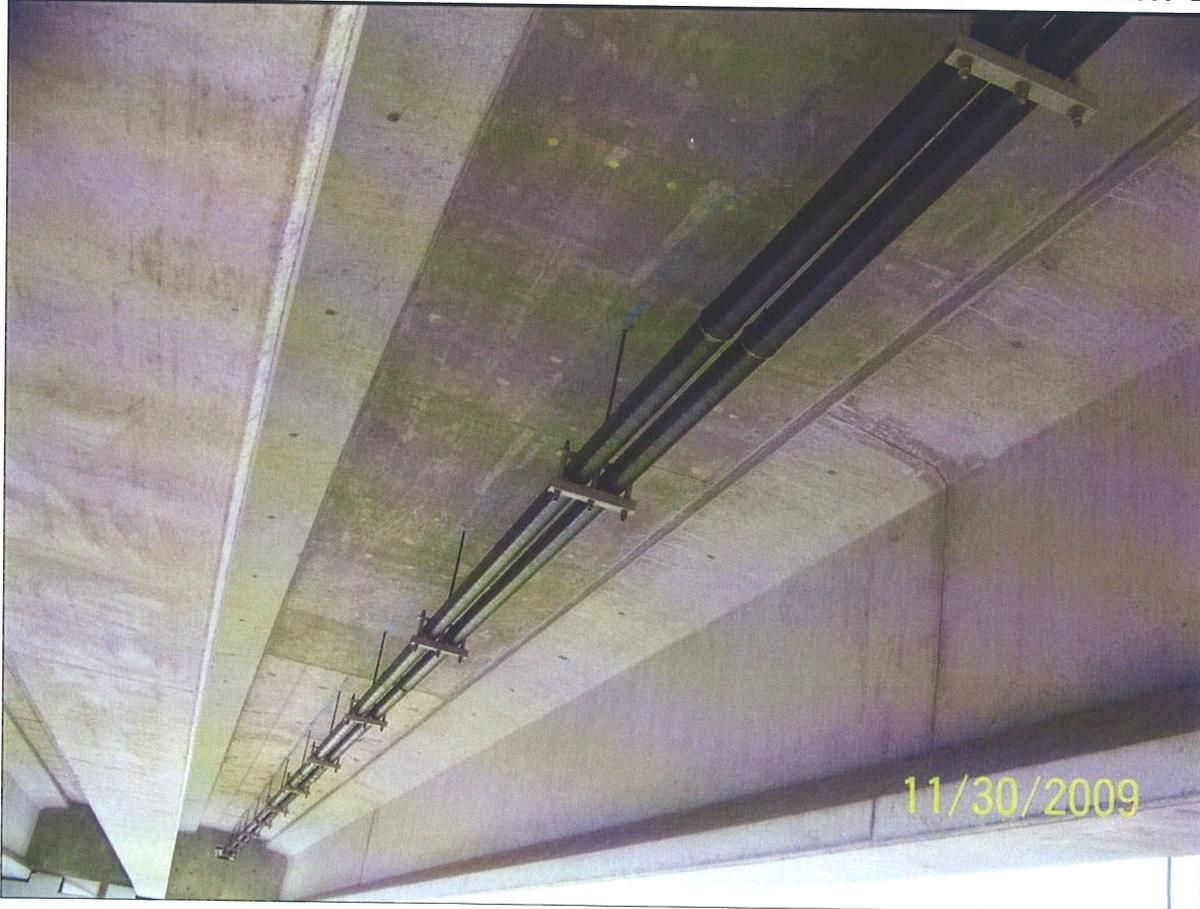
Photo 1 - Element 12 Bare Concrete Deck

Note: Two 4-1/2in. diameter fiberglass conduits are attached to hangers anchored to the underside of Bay 3 in all spans. Refer to photo 1. The type of hanger anchorage is unknown.

Utilities suspended from hangers anchored to the underside of Bay 3 in all spans

REPAIR RECOMMENDATION:
None

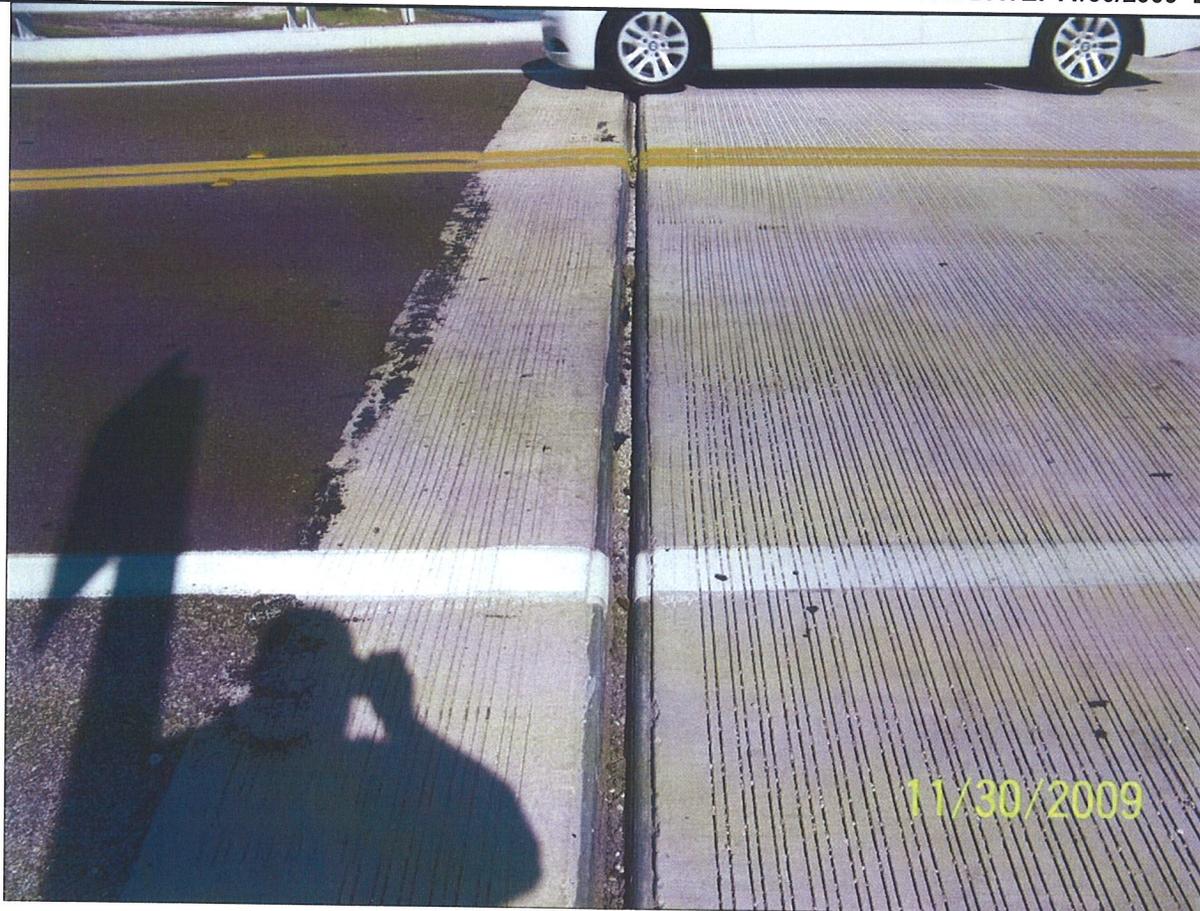
Photo 2 - Element 300 Strip Seal Exp Joint

CS1 = The joints are filling with dirt and debris, but are functioning as intended at this time - NEW. Refer to photo 2.

Typical view of dirt and debris in the joints (Abutment 1 joint shown)

REPAIR RECOMMENDATION:
None

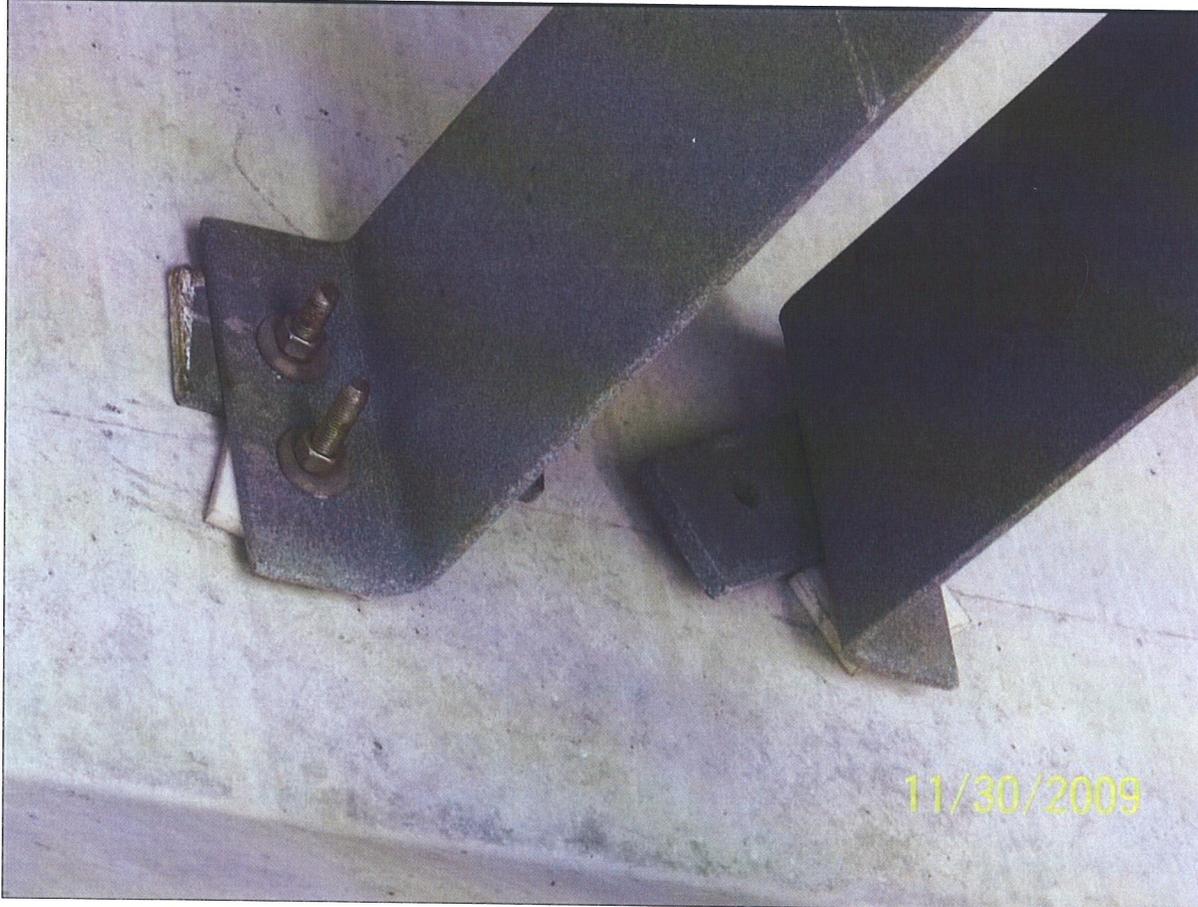
Photo 3 - Element 397 Drain Syst Metal

CS1 = Most scupper down spouts are not properly shimmed or anchored to the beams. Refer to photo 3. REPAIR

Typical view of improperly shimmed drainage down spout and down spout improperly attached to the beam

REPAIR RECOMMENDATION:

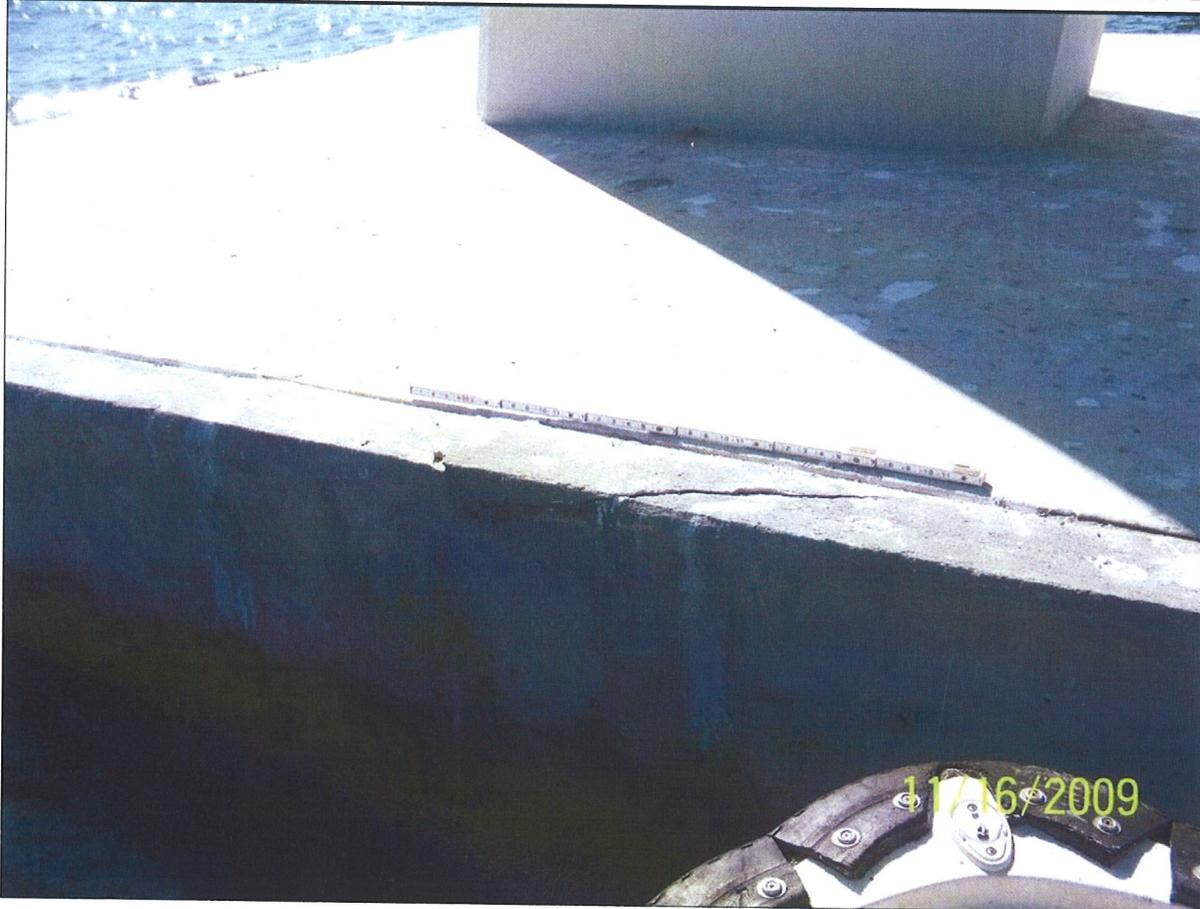
Photo 4 - Element 220 R/C Sub Pile Cap/Ftg

CS3 = The top east edge of Footer 9 has a 30in. x 9in. delamination - NEW. Refer to photo 4.
The top northwest corner of Footer 10 has a 24in. x 8in. x 1in. spalled and delaminated area with no exposed steel - NEW.
The top northwest corner of Footer 16 has a 15in. x 6in. x 1/2in. spalled and delaminated patch with no exposed steel - NEW.

Delamination along the top east edge of Footer 9

REPAIR RECOMMENDATION:

Repair the spalled and/or delaminated areas in the top east edge of Footer 9, the top northwest corner of Footer 10 and the top northwest corner of Footer 16.

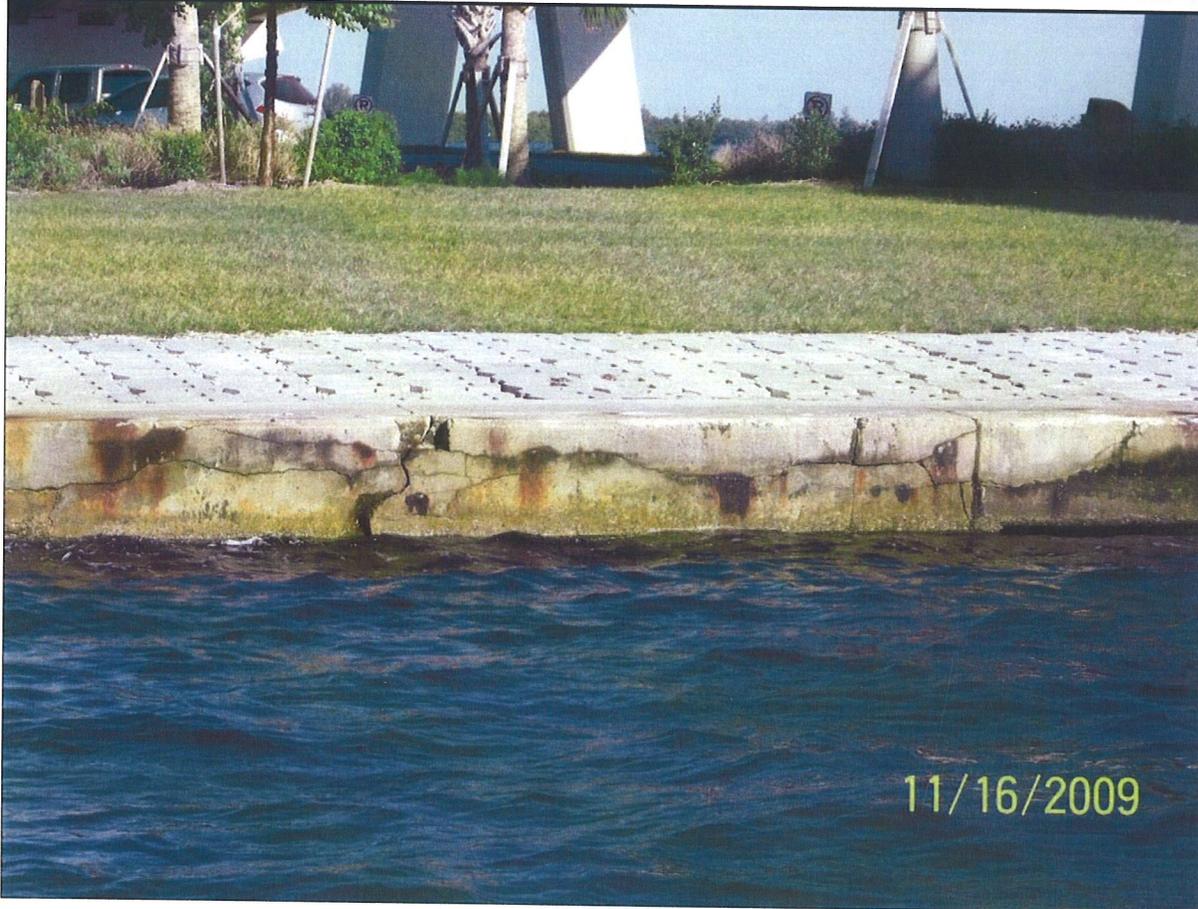
Photo 5 - Element 290 Channel

CS2 = The north bulkhead cap, at the northeast corner of the structure, is intermittently spalled and delaminated with corrosion bleedout, up to 10ft. long 18in. wide x 3in. deep - NEW. Refer to photo 5.
REPAIR

Typical spalled and delaminated areas with corrosion bleedout in the bulkhead cap at the northeast corner of the structure

REPAIR RECOMMENDATION:

Repair the spalled and delaminated areas in the bulkhead cap at the northeast corner of the structure.
