Miscellaneous Structural Engineering Services
Sanibel Bridge Beam Inspections

Bridge No. 124115 - Structure B Sanibel Causeway over San Carlos Bay
2nd Structure South of Toll Plaza

Prepared For:
Lee County

July 2013

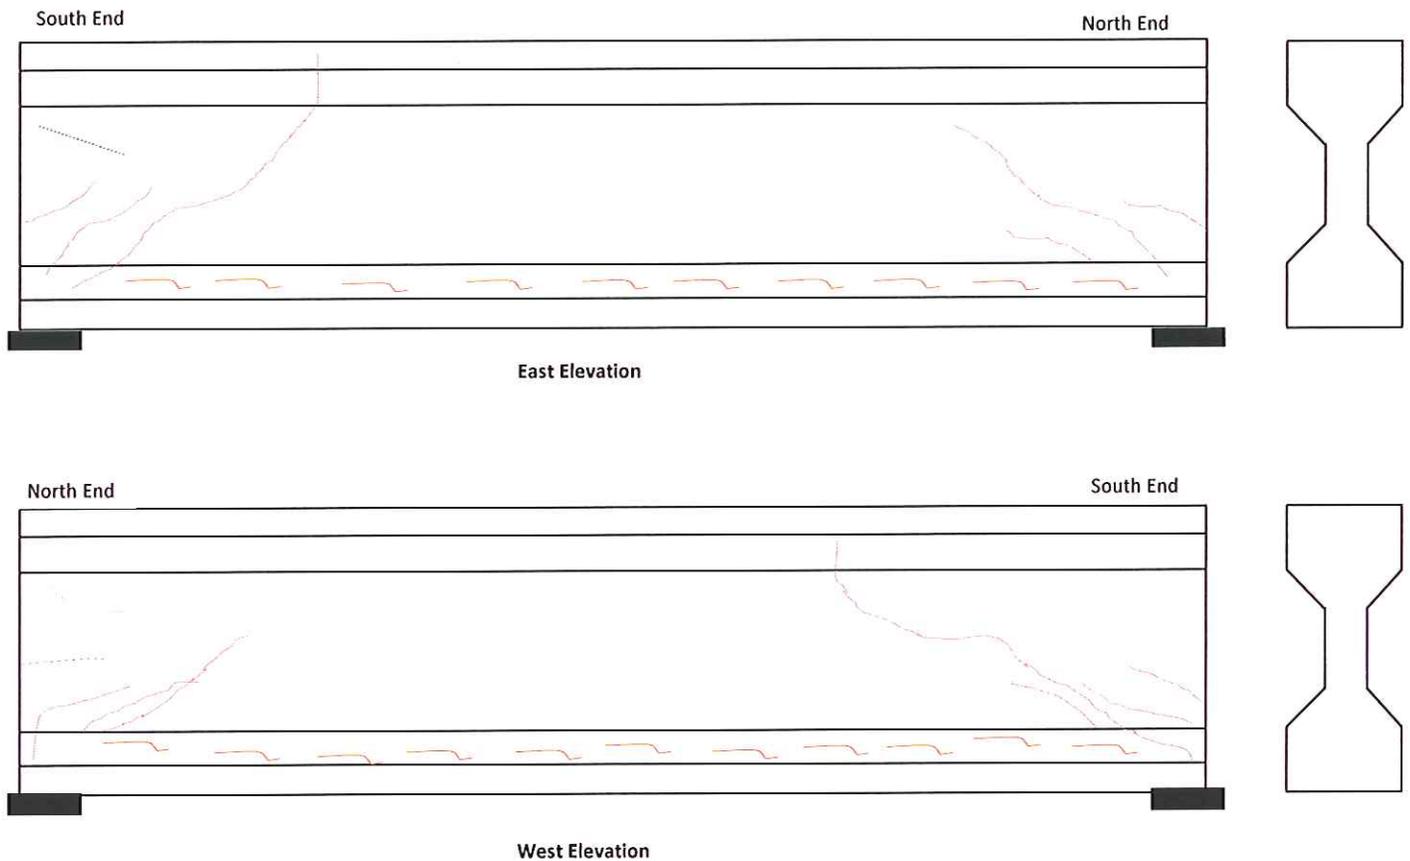
BEAM SKETCHES

Note: The following shows the general direction and locations of the cracks in the beam webs and flanges:

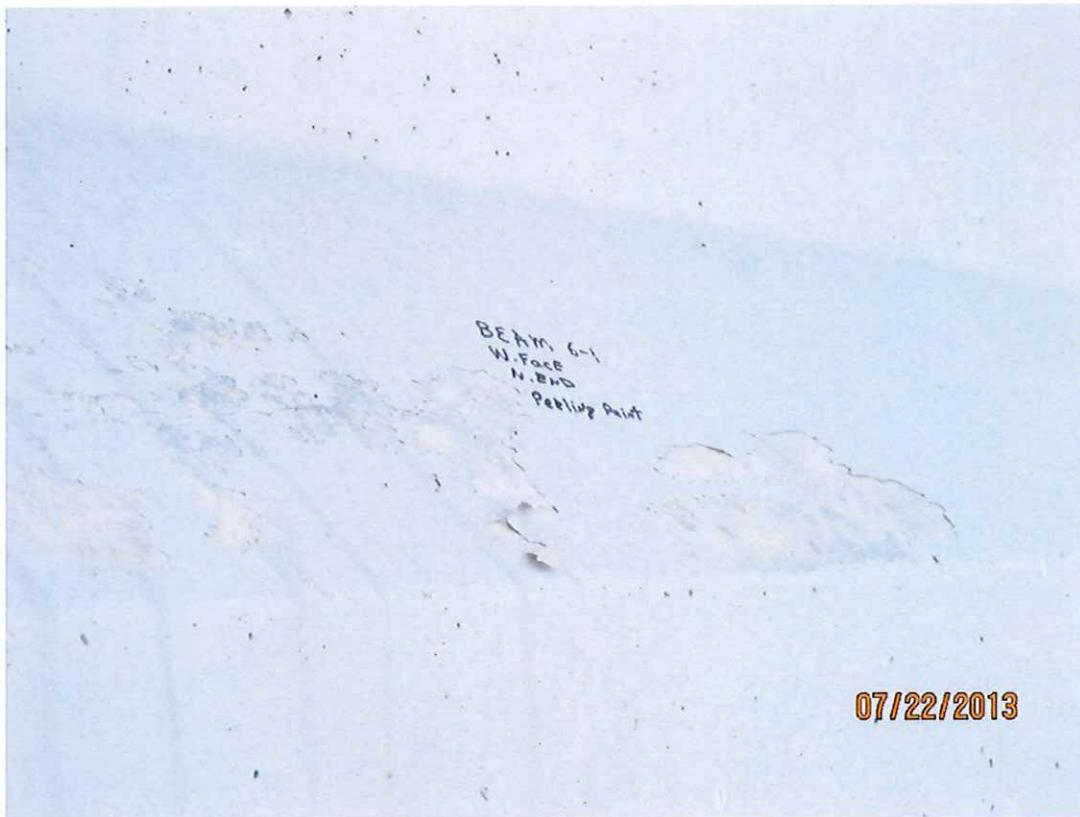
- ✓ Exterior faces of Beams 1 and 4 are painted. There are some isolated areas of peeling paint, mostly adjacent to the cracks along the bottom flanges. The worst condition is on west face of Beam 6-1 at north end. Refer to Photo 1.

Photo 1 – Typical of minor areas of peeling paint (Beam 6-1 west face shown)

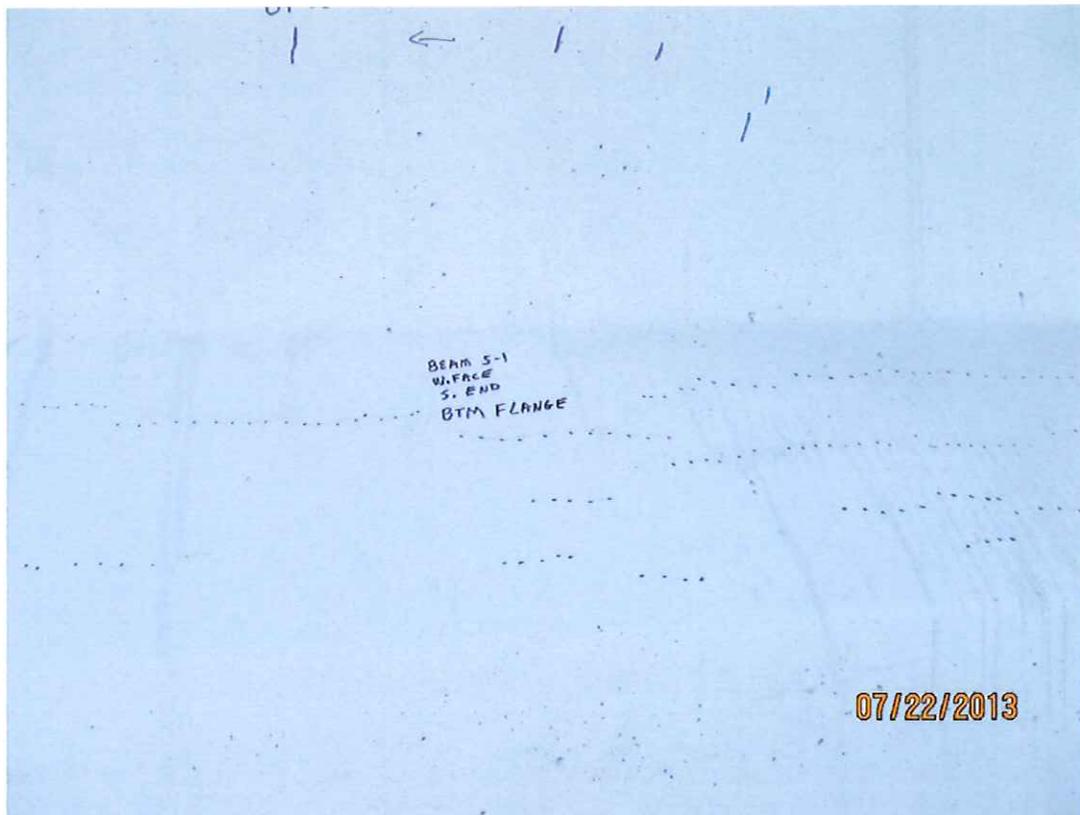
- ✓ Intermittent length longitudinal cracks in bottom flange less than 0.01in. wide throughout. These cracks are most evident in the exterior beams possibly from exposure to adverse weather conditions. Refer to Photo 2.

Photo 2 – Typical longitudinal cracks in bottom flanges of beams

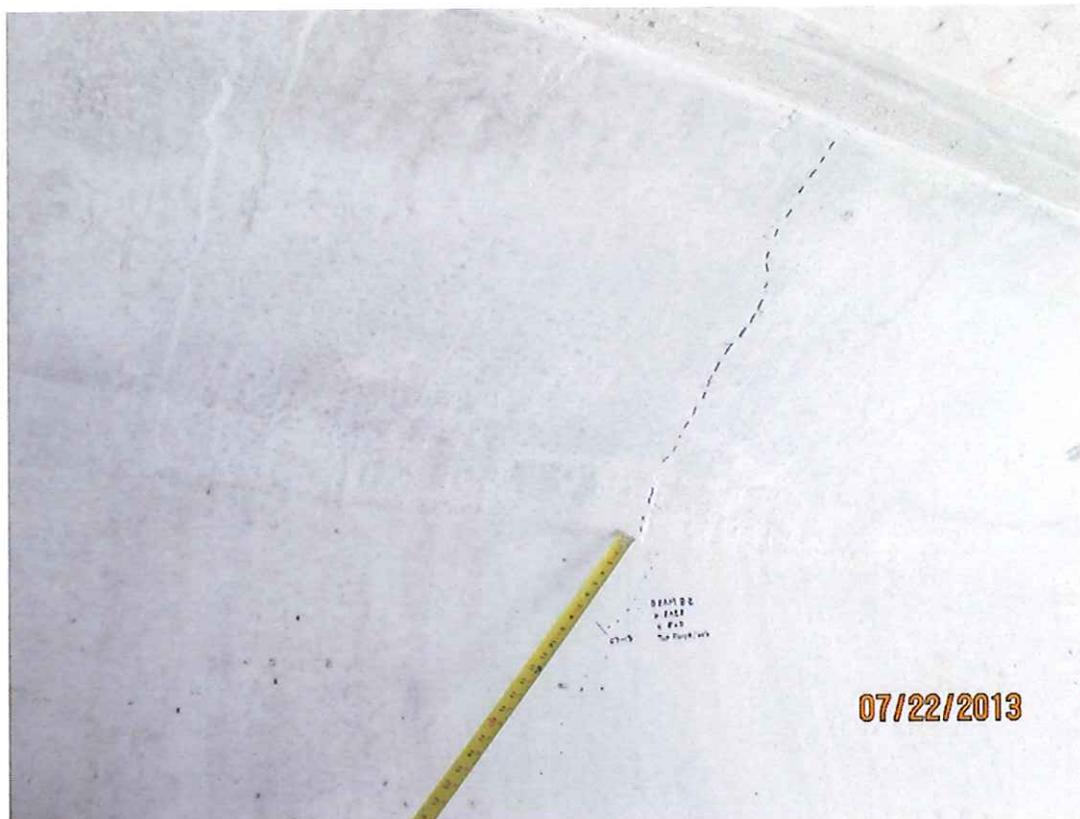
- ✓ Transverse and longitudinal cracks in underside face of top flange up to full flange width (24in. long) x 0.010in. wide with some having light efflorescence. Refer to Photo 3.

Photo 3 – Typical crack in bottom face of top flange

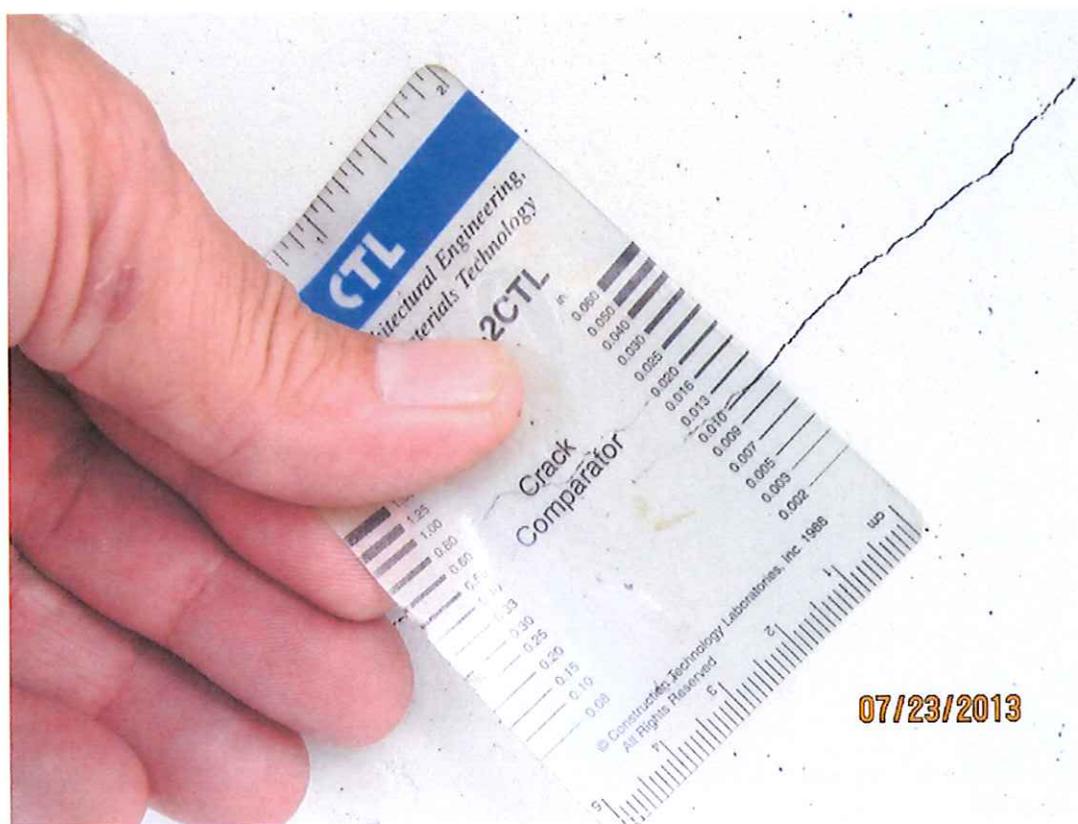
- ✓ Horizontal cracks in beam webs up to 16in. long x less than 0.010in. wide extending from beam ends typically located near mid-height.
- ✓ Intersecting diagonal cracks in beam webs typically in or near the bearing area of the bottom flange extending up and away giving them a shear crack appearance. These cracks are typically up to 5ft. long x less than 0.010in. wide. Adjacent to these cracks are multiple shorter length diagonal, horizontal and some pattern/map style cracks, all being less than 0.010in. wide. Random beams have longer more evident diagonal/shear cracks up to 10ft. long and less than 0.010in. wide. Refer to Photos 4 and 5. Also refer to the charts on Pages 5 and 6 for crack quantities and the sketch on Page 7 showing typical cracks locations.

Photo 4 – Typical width of diagonal/shear cracks extending from beam ends (Beam 13-4 shown)

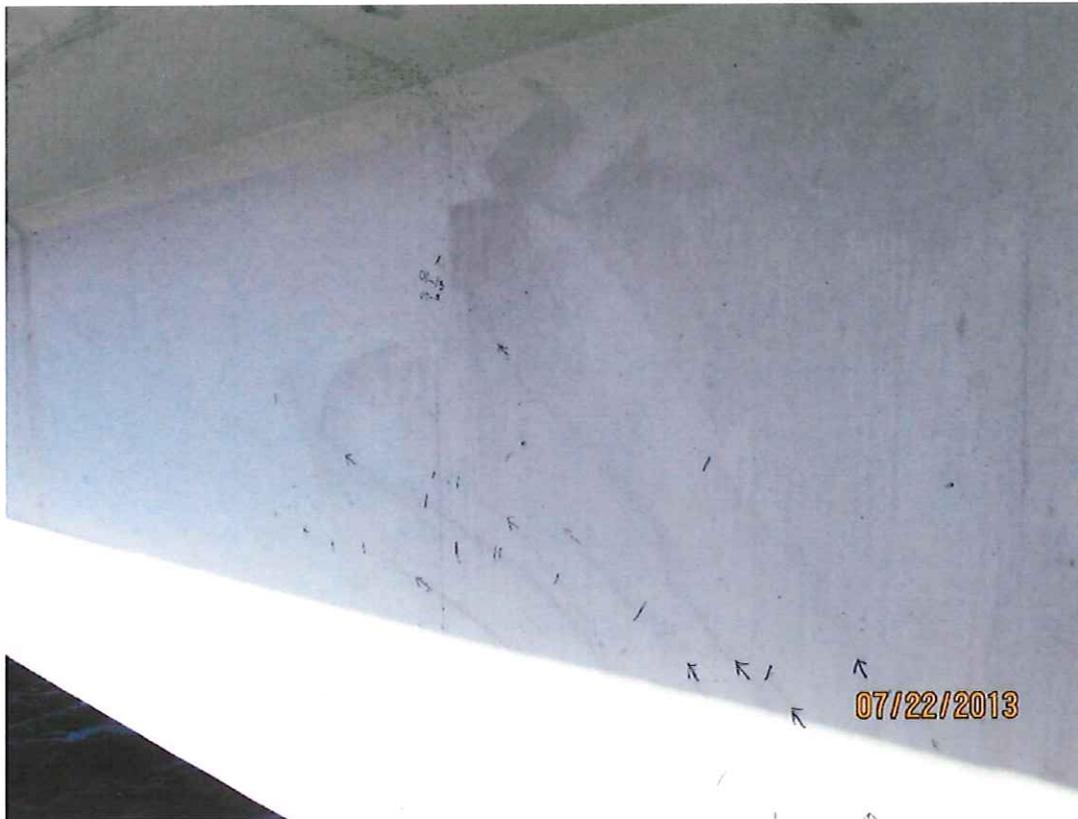
Photo 5 – Typical diagonal/shear cracks extending from beam ends (Beam 5-4 shown)

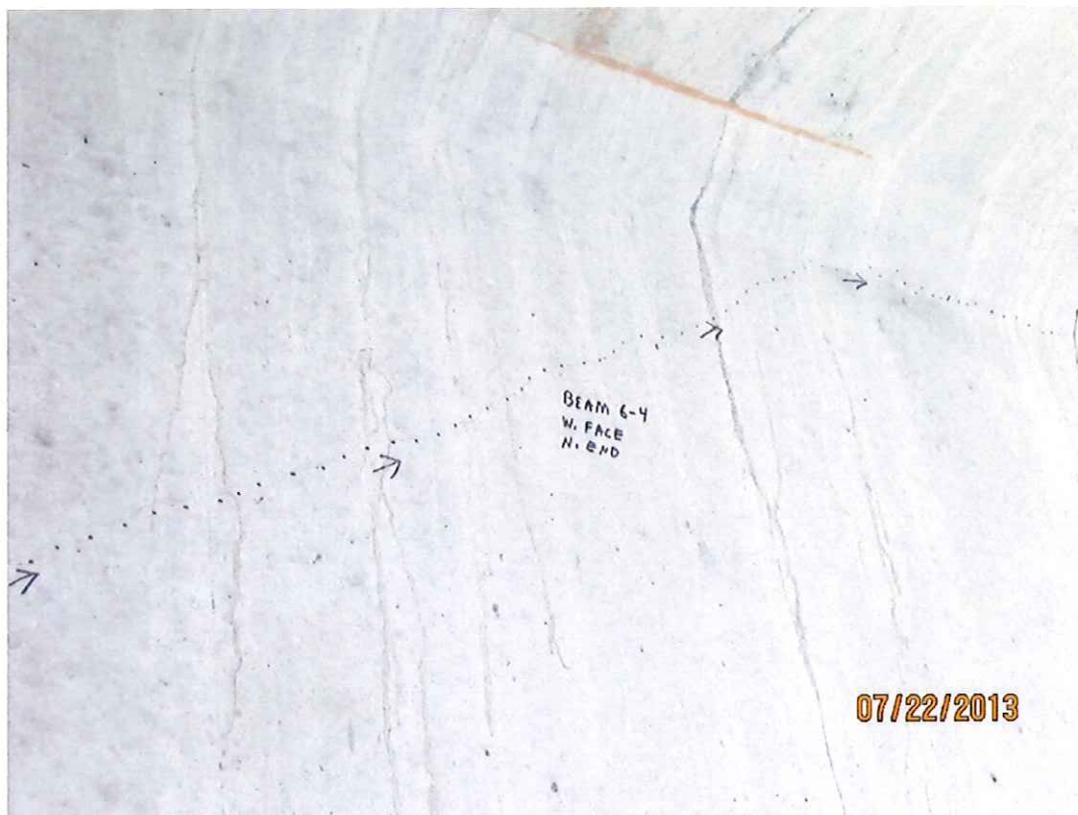
- Beam 1-4 east face of web at north end in addition to the typical diagonal/shear cracks has one crack which extends 92in. from the bottom of the beam end/bearing area up and across the bottom face of the top flange.
- Beam 6-4 west face of at north end has a 81in. long x 0.010in. wide diagonal crack in the web which turns longitudinal along the top flange juncture. Refer to Photo 6. (NEW)
- Beam 8-2 west face of web 6ft. from north end at the top flange has a 34in.long x 0.010in. wide horizontal crack with light efflorescence. This crack extends 6in. into the web where it turns diagonally. The east flange has a similar horizontal crack also 6ft. from the north end 24in. long x 0.010in. wide with light efflorescence. Refer to Photo 7. (NEW)

Photo 6 – Diagonal crack turning longitudinal on west face of Beam 6-4 at north end

- Beam 11-4 – South End – East Face.
- (5) Epoxy inject diagonal /shear crack in east web of Beam 1-4 at north end.
- (6) Epoxy inject diagonal /shear crack in west web of Beam 6-4 at north end.

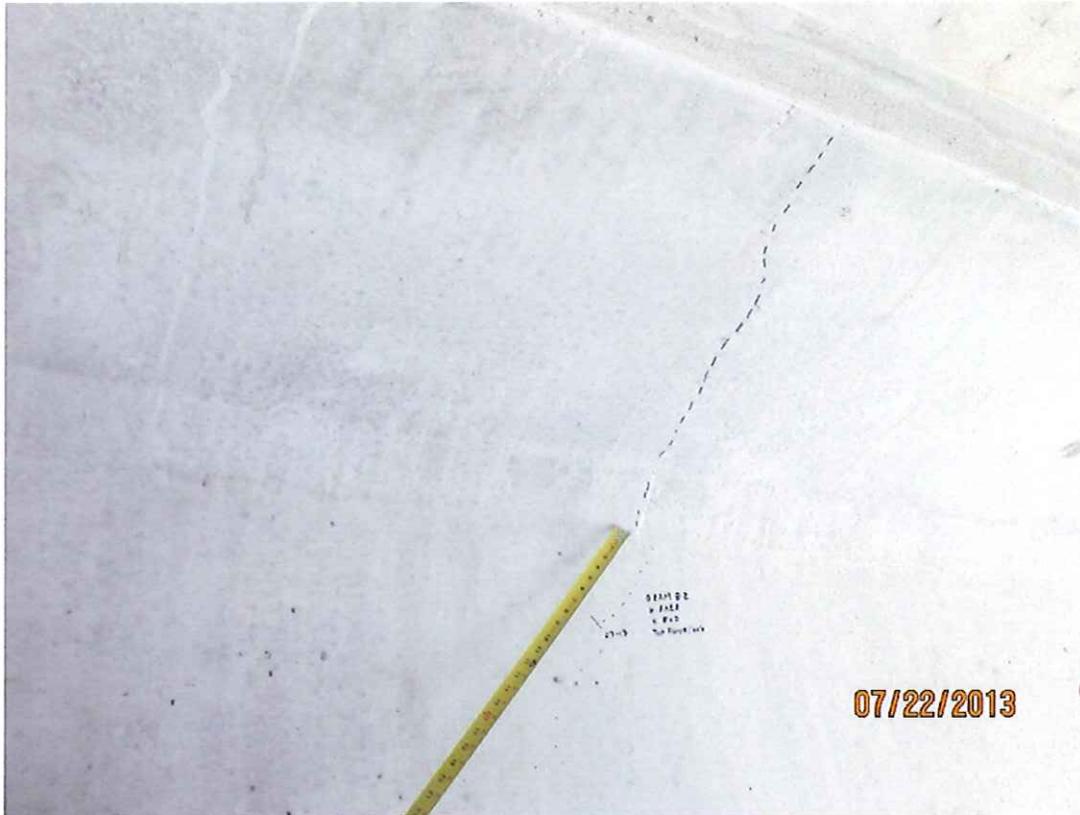
Photo 7 – Horizontal crack at top west face of web 6ft. from north end turning diagonally

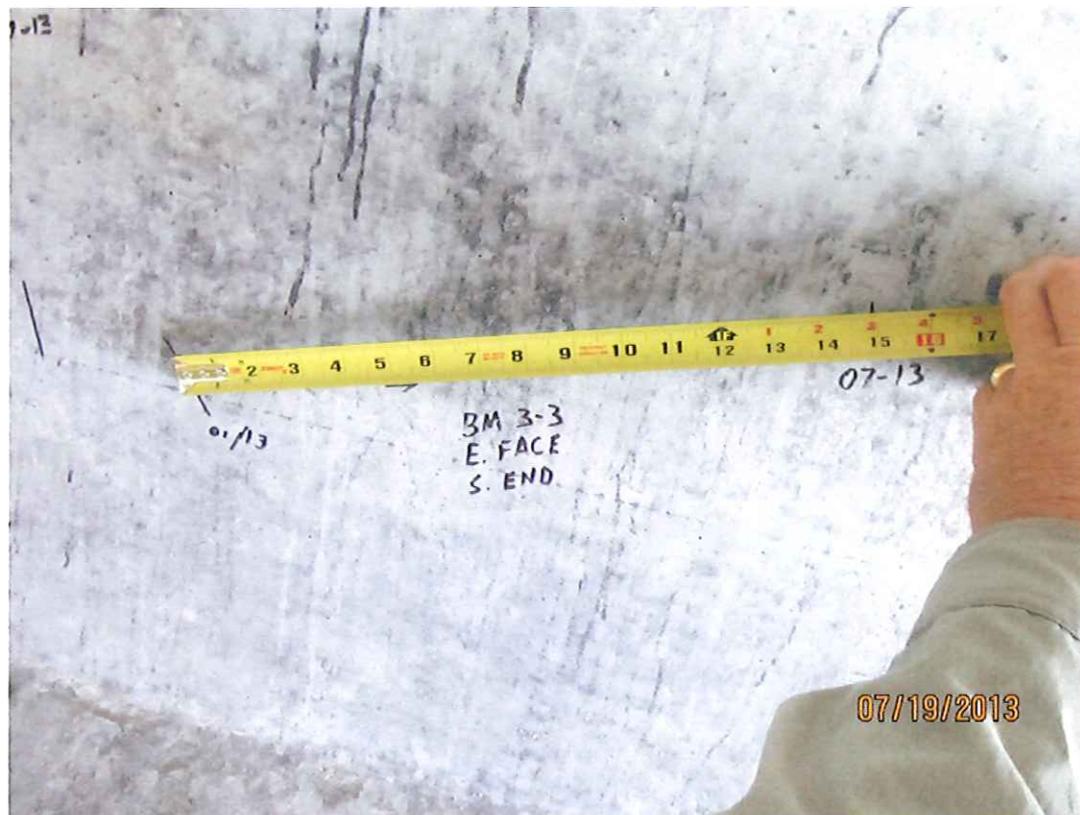
() = Amount of length crack has grown since the 01/13 inspection. Refer to Photo 8.

Photo 8 – View showing crack growth (Beam 3-3 shown)

- Beam 2-4 – North End – East Face.
 - Beam 3-2 – North End – East Face.
 - Beam 3-3 – South End – East Face.
 - Beam 3-4 – North End – West Face.
 - Beam 5-2 – South End – East Face.
