Miscellaneous Structural Engineering Services  
Sanibel Bridge Beam Inspections

Bridge No. 124114 - Structure C Sanibel Causeway over San Carlos Bay  
3rd Structure South of Toll Plaza

Prepared For:  
Lee County

Prepared By:  
T.Y. Lin International

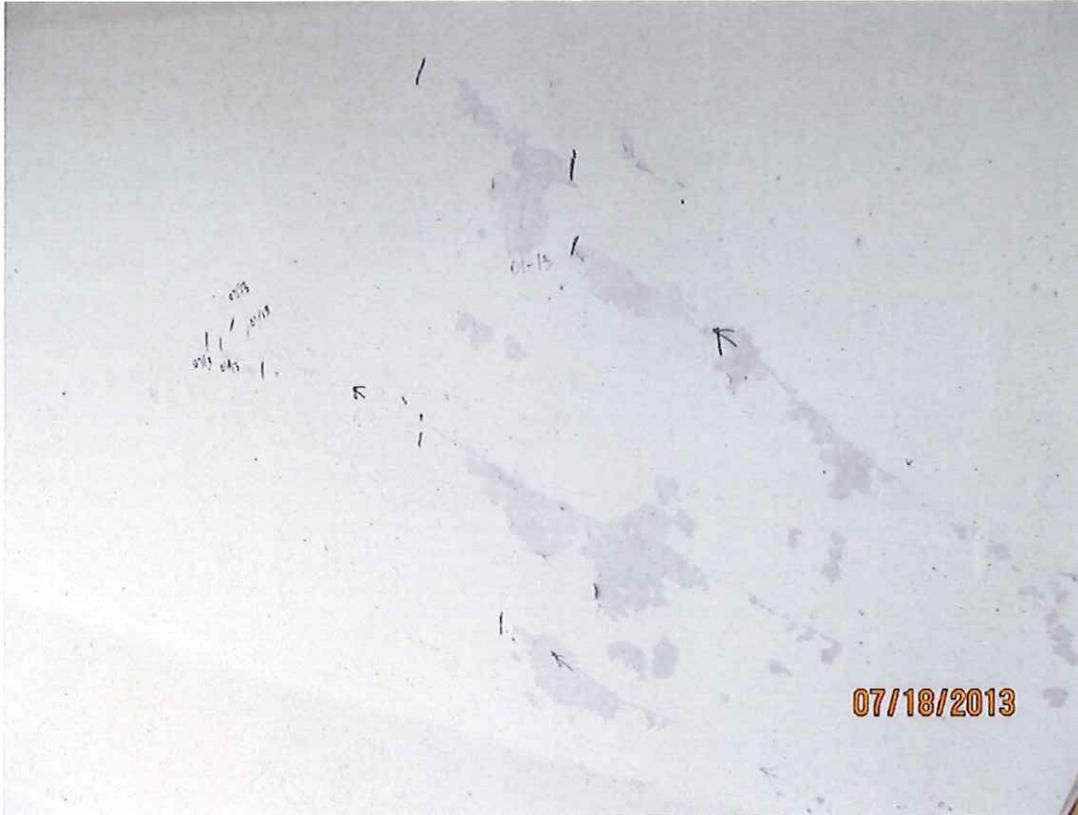
- ✓ Beams 1 and 4 exterior faces are painted. There are some isolated areas of peeling paint, mostly adjacent to the cracks along the bottom flanges. Refer to Photo 1.

Photo 1 – Typical minor areas of peeling paint on exterior beams

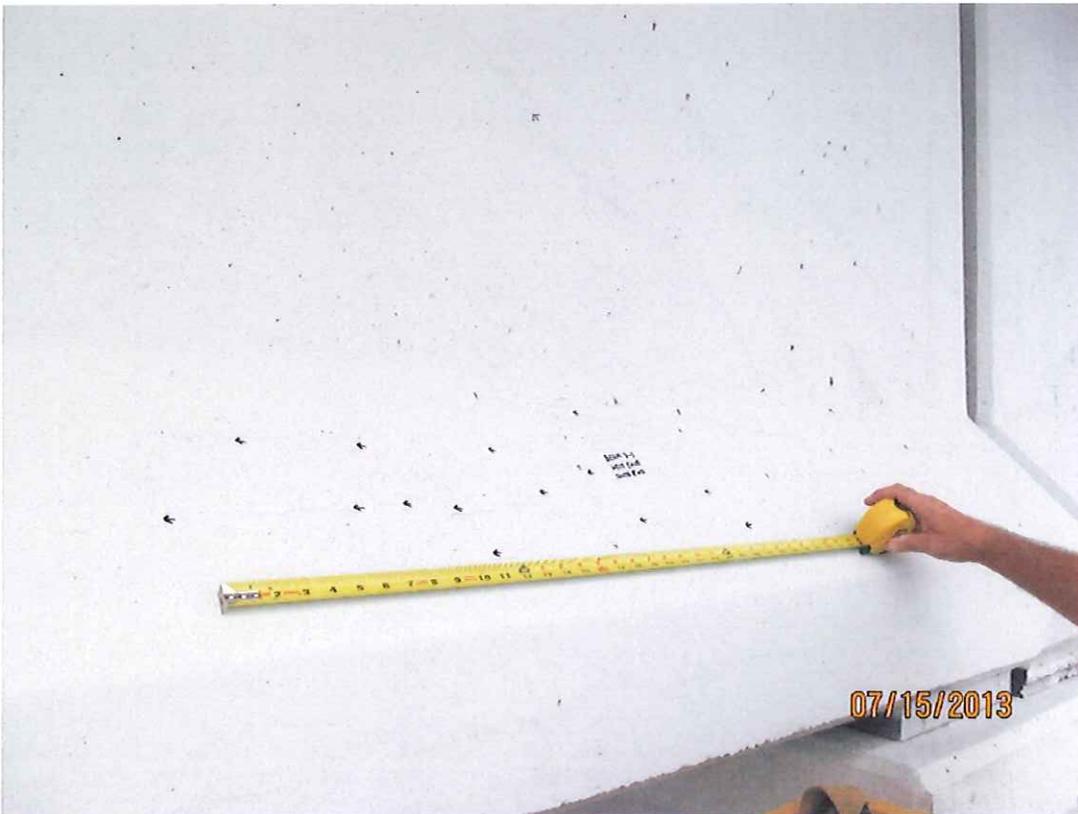
- ✓ Intermittent length longitudinal cracks in bottom flanges less than 0.010in. wide throughout. These cracks are most evident in the exterior beams possibly from exposure to adverse weather conditions. Refer to Photo 2.

Photo 2 – Typical longitudinal cracks along bottom flange (Beam 7-1 shown)

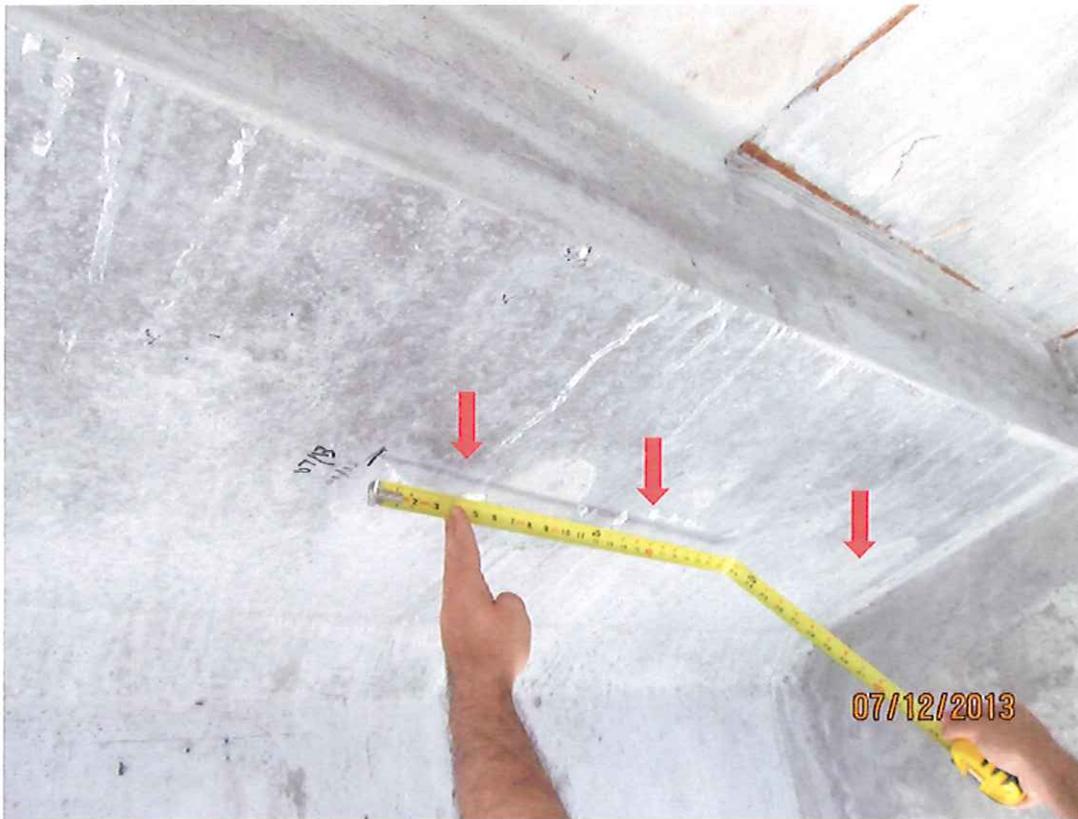
- ✓ Transverse and longitudinal cracks in underside of the top flanges up to full flange width (24in. long) x less than 0.010in. wide with some having light efflorescence. Refer to Photo 3.

Photo 3 – Typical location of longitudinal cracks in bottom face of top flange

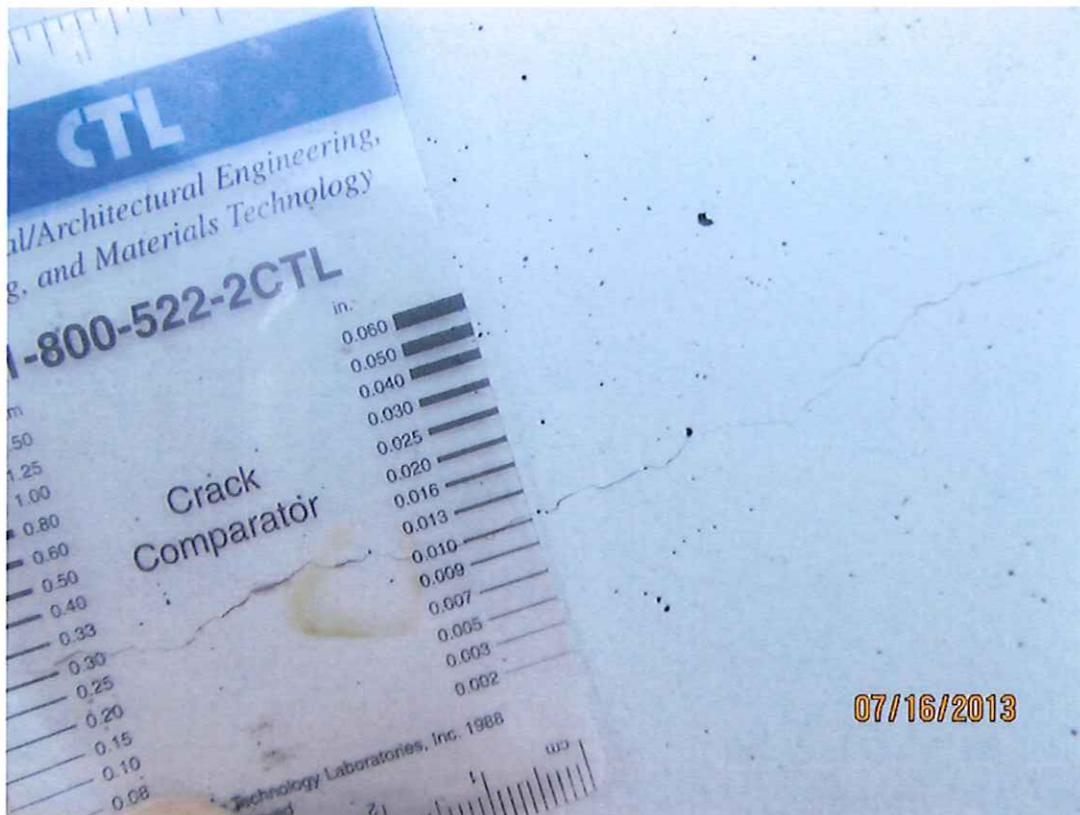
Photo 4 – Typical width of cracks in the beam webs, top and bottom flanges

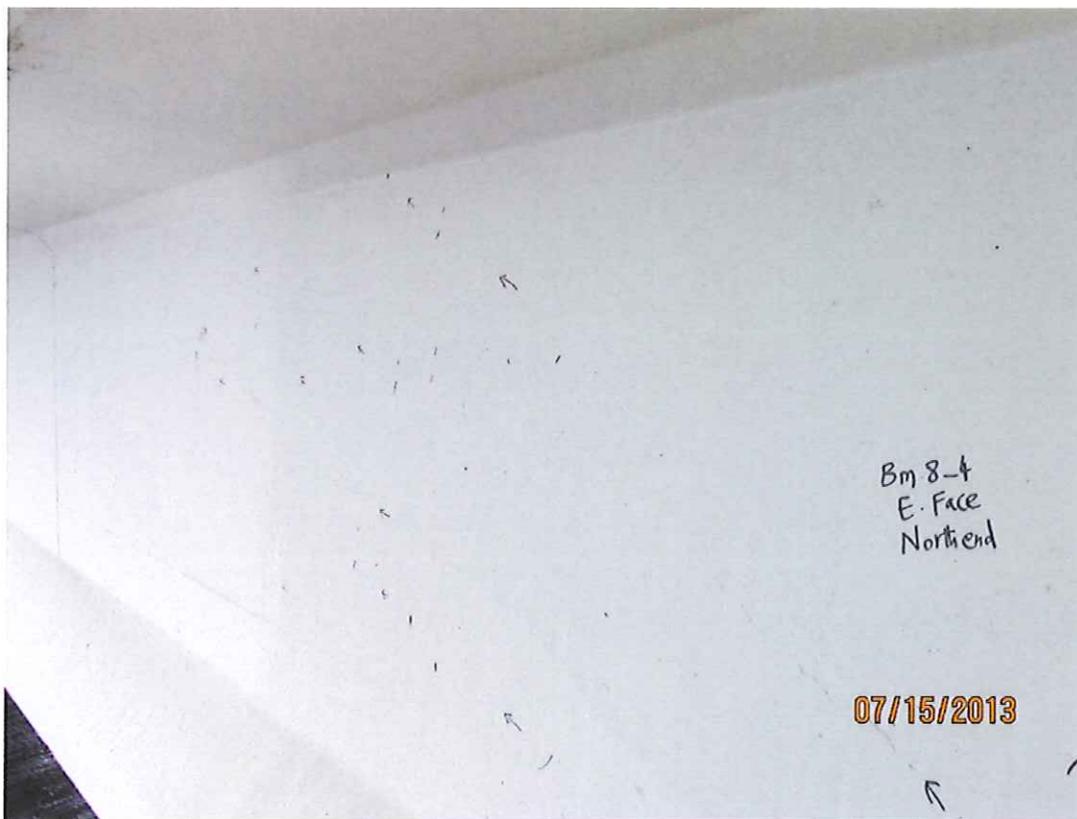
- ✓ Intersecting diagonal cracks in beam webs in or near the bearing area of the bottom flange extending up and away giving them a shear crack appearance. These cracks are typically up to 4ft. long x 0.010in. wide. Adjacent to these cracks are multiple shorter length diagonal, horizontal and some pattern/map style cracks, all being less than 0.010in. wide. Random beams have longer and more evident diagonal/shear cracks up to 10ft. long x less than 0.010in. wide. Refer to Photos 4 and 5. Also refer to the charts on Pages 7 through 10 for crack quantities and the sketch on Page 12 showing typical crack locations.

Photo 5 – Typical diagonal/shear cracks in beam webs near the beam ends

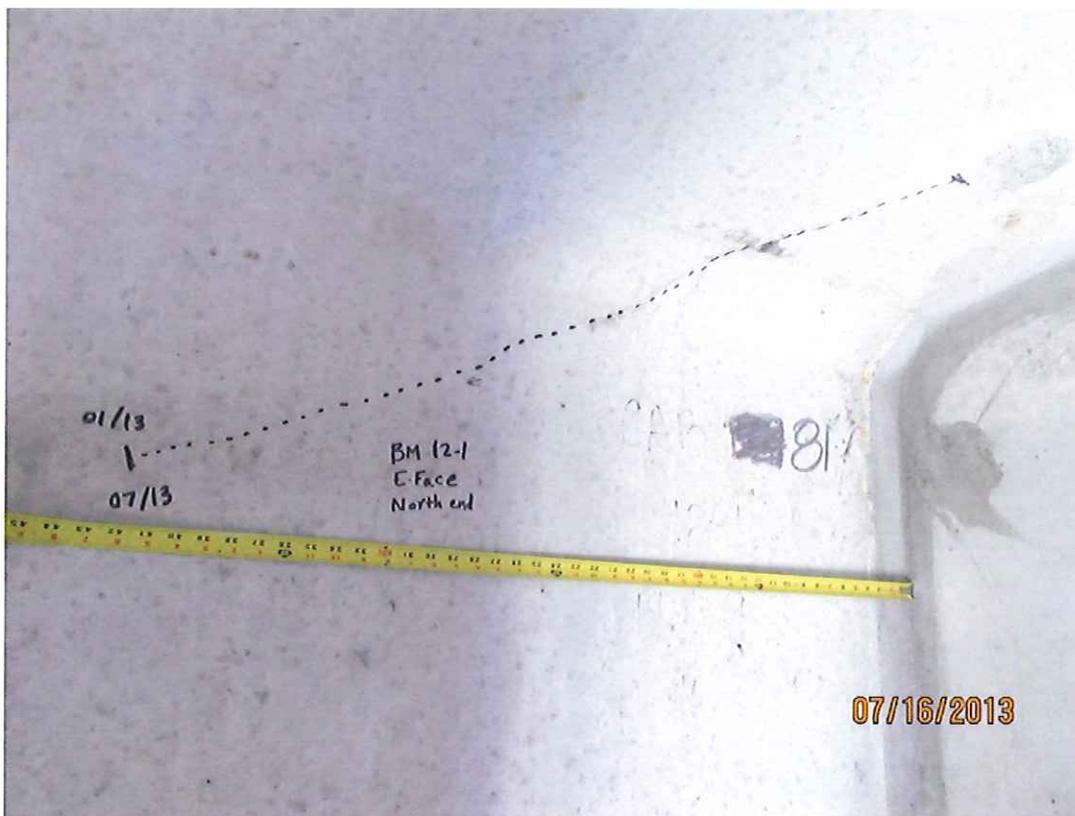
- ✓ Single diagonal crack less than 0.010in. wide in upper web areas. These cracks begin near the upper portion of the beam end and extend down and away from the top flange varying in length from 6 1/2in. to 41in. Refer to Photo 6. Also refer to the chart on Page 11 for crack lengths and the sketch on Page 12 showing typical crack locations.

Photo 6 – Typical diagonal crack in web and top flange extending down and away from beam end

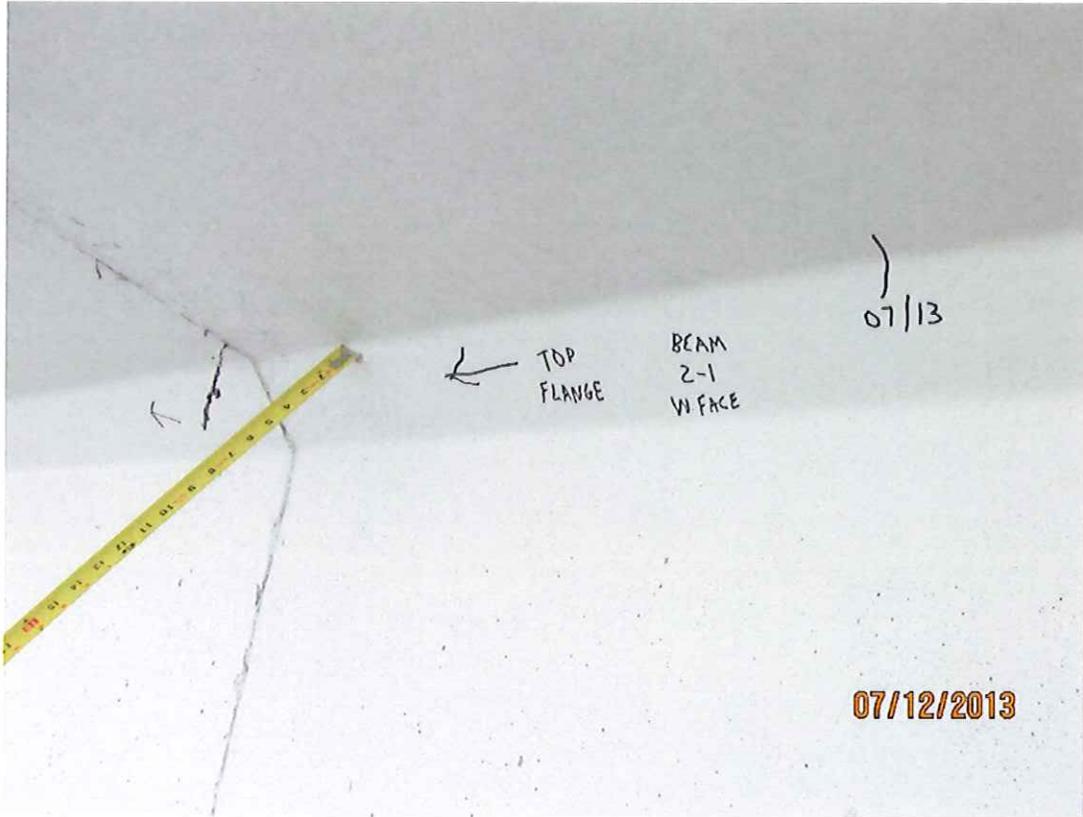
- Beam 2-1 west face of web along the top flange to deck juncture has a longitudinal crack 45ft. long x 0.025in. wide beginning 68ft. from south beam end and extends to 30ft. from north end. Refer to Photo 7.

Photo 7 – Longitudinal crack in web along top flange juncture

- (9) Beam 22-4 – North End – East Face – 7 Cracks.
- (10) Repair 45ft. longitudinal crack along west face of Beam 2-1 at top flange to deck juncture beginning 68ft. from south end.

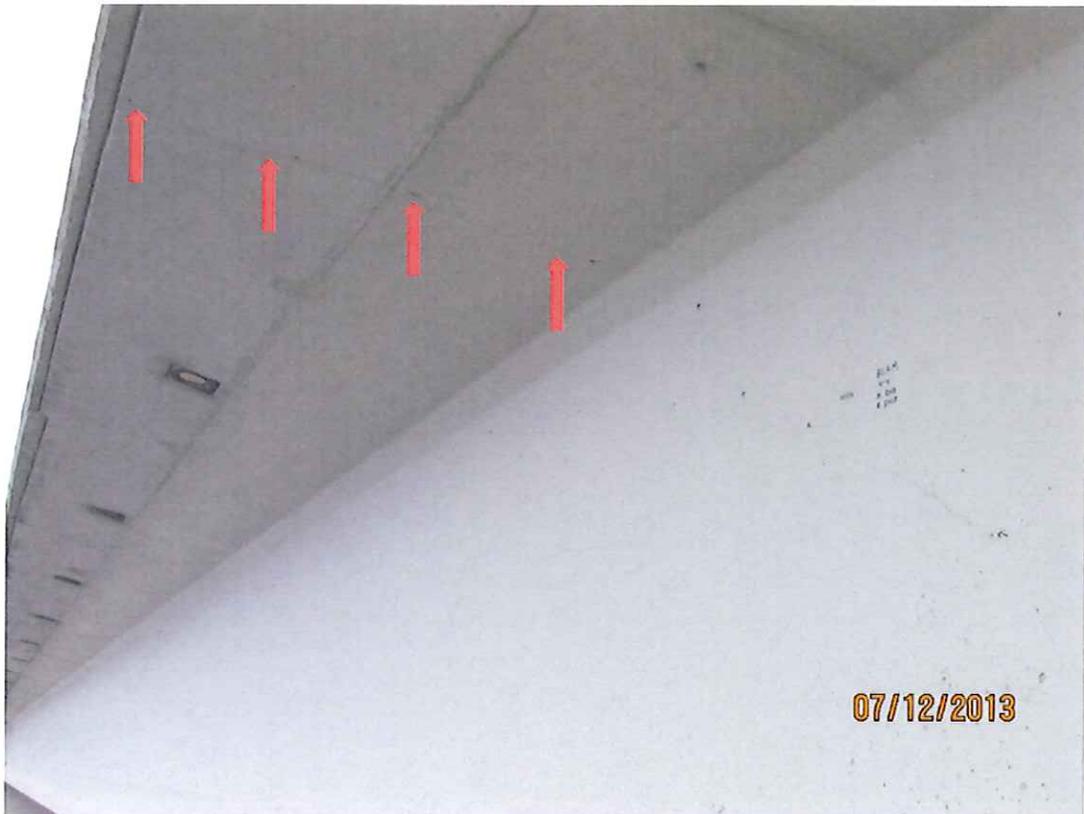
- Beam 4-4 east face of web at north end, in addition to the adjacent diagonal/shear cracks web has one crack which extends 8ft. from the beam end across the bottom face of the top flange and across the deck overhang. Refer to Photo 8.

- Beam 5-4 east face of web at north end, in addition to the adjacent diagonal/shear cracks web has one crack which extends 8ft. from the beam end across the bottom face of the top flange and across the deck overhang. Refer to Photo 8. (NEW)

Photo 8 – Beam 4-4 showing typical crack extending from web across bottom flange and deck

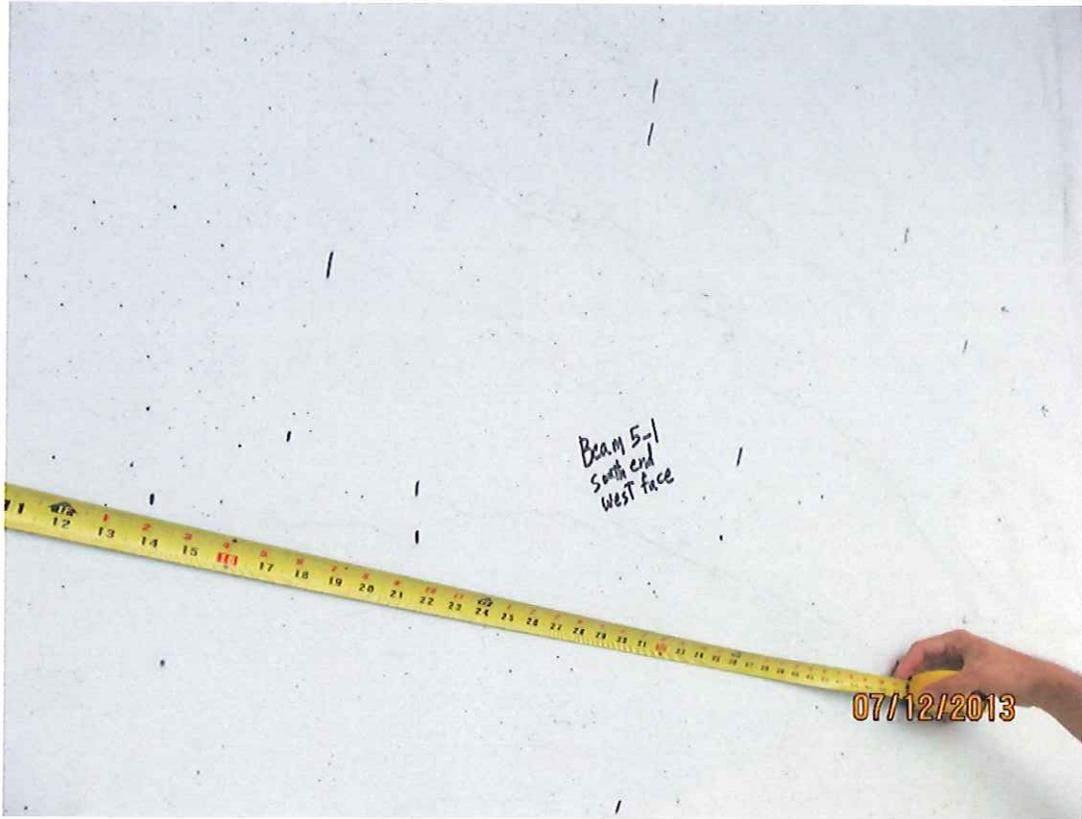
- Beam 5-1 west face of web at north end has a diagonal/shear crack beginning at the beam end and extending 15ft. to the south.
- Beam 5-1 west face of web at south end has multiple small length diagonal cracks up to 18in. long x 0.005in. wide. It was previously noted as having 4 cracks; however, 8 cracks were counted this inspection. Refer to Photo 9. (INCREASE)

Photo 9 –Multiple cracks in west face of Beam 5-1 at south end

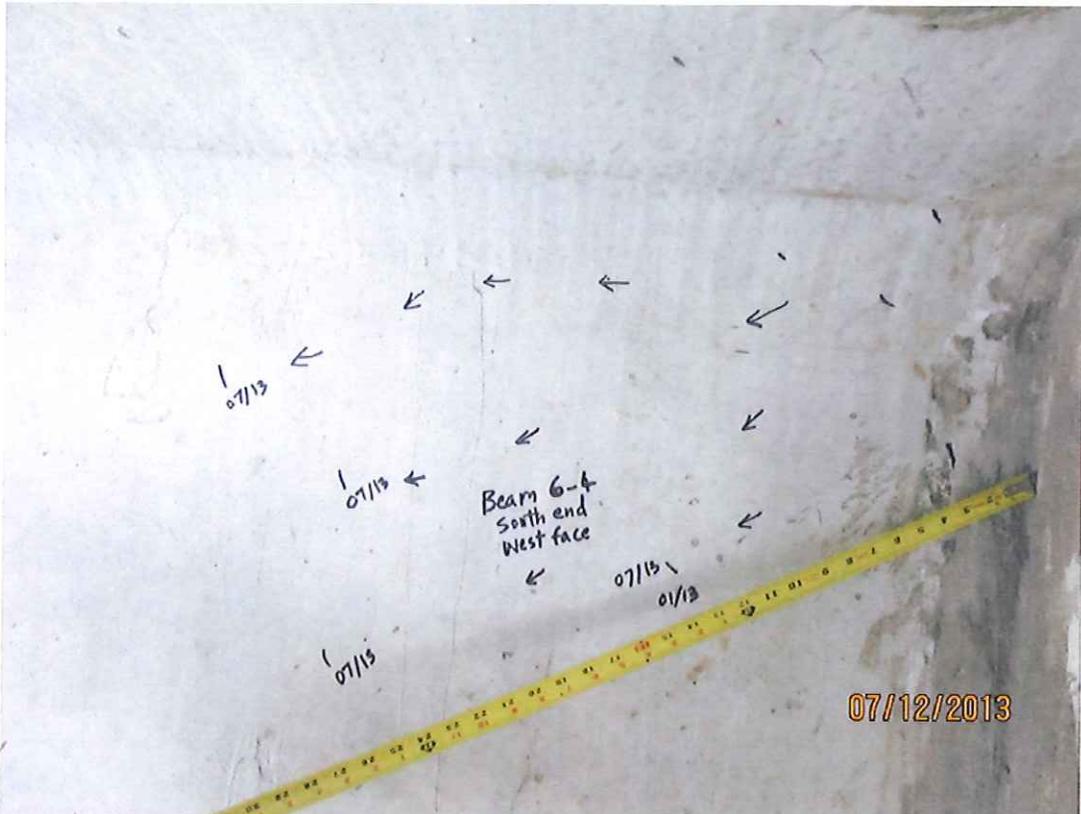
- Beam 6-4 west face at top of web at south end has 4 diagonal cracks extending down and away from beam end. Refer to Photo 10. (NEW)
- Beam 6-4 west face of web at north end has a delamination on the bottom flange 30in. long x 12in. high. Refer to Photo 11.

Photo 10 –Cracks in west face of web at south end extending down and away from beam end

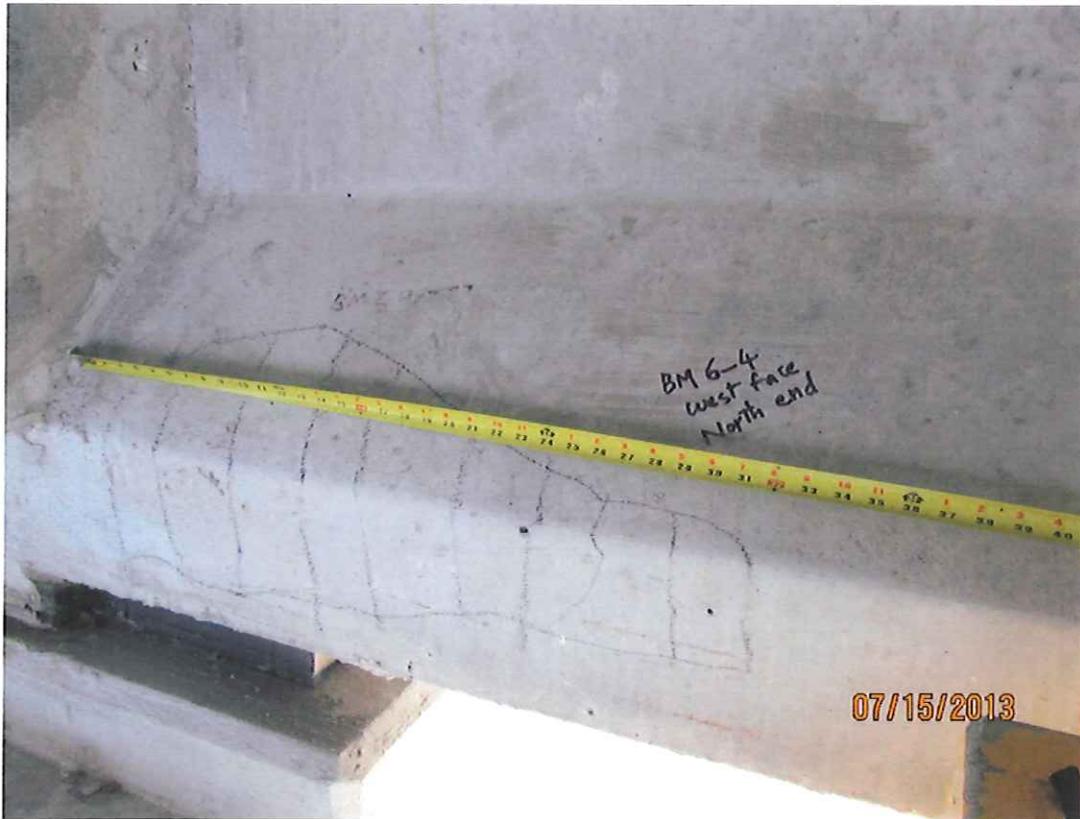
Photo 11—Delamination on west face of bottom flange at north end of Beam 6-4

- (11) Repair 46.5ft. longitudinal crack along east face of Beam 4-4 at top flange to deck juncture beginning 10ft. from south end.
- (12) Repair 30in. x 12in. delamination in west face of Beam 6-4 bottom flange at the north end.

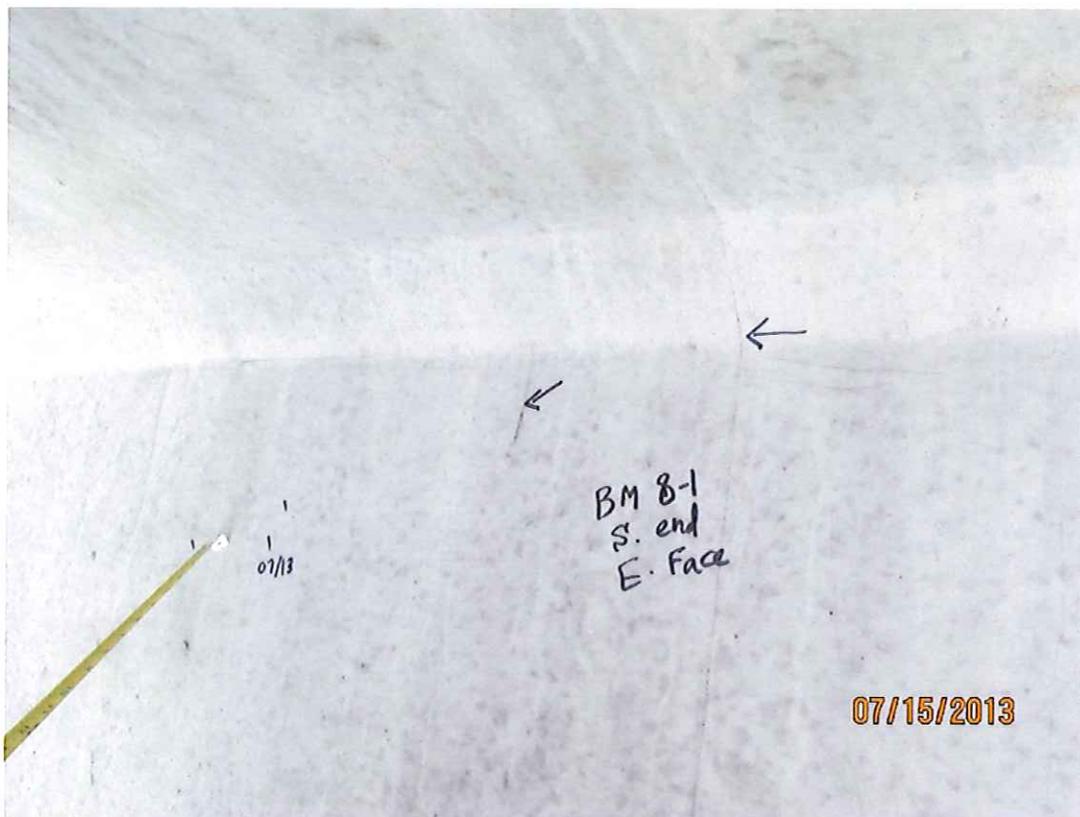
- Beam 8-1 east face of web 62in. from south end has a longitudinal crack which turns diagonal 84in. long x 0.010in. wide along the juncture to the top flange. (NEW) Refer to Photo 12.

Photo 12— Diagonal crack/ longitudinal crack in Beam 8-1 east face 62in. from south end

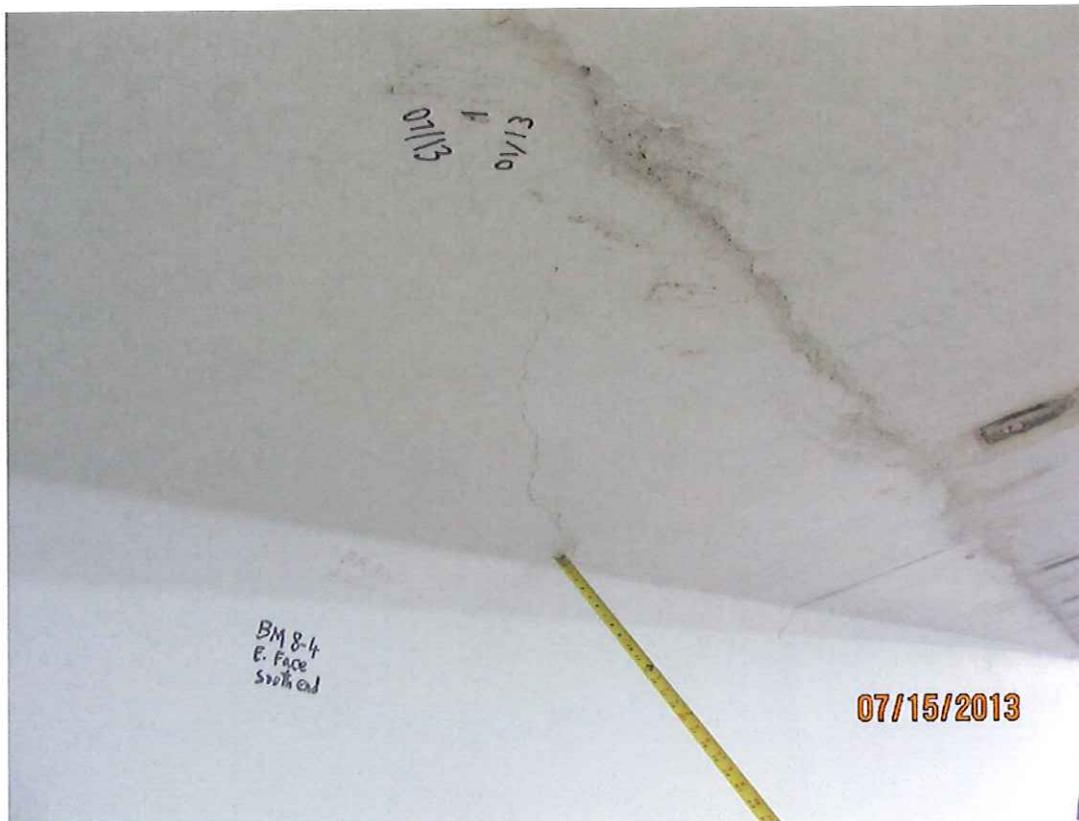
- Beam 8-4 east face of web beginning 10ft. from the south end along the top flange to web juncture has a longitudinal crack 0.030in. wide extending 46 1/2ft. to the north. Along this crack is minor edge spalls less than 1/4in. deep. This crack turns diagonally and has extended 42in. longer across the underside of the top flange since the 01/13 inspection. Refer to Photo 13.

Photo 13- Longitudinal crack at web to top flange juncture 10ft. from south end of Beam 8-4

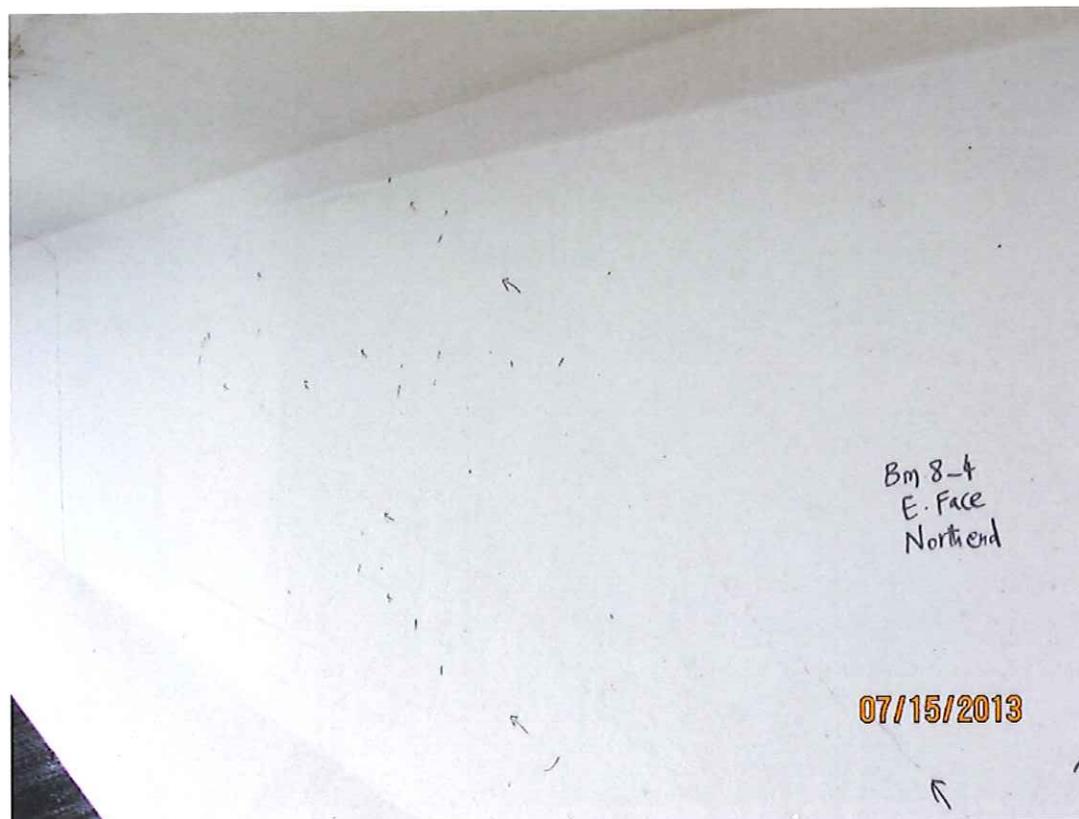
- Beam 8-4 east face of web at north end has similar diagonal/shear cracks which were previously marked during the 2011 inspection. These cracks have not grown in length since the 01/13 inspection (previously noted as grown 7in.) and the quantity has not increased (previously noted as grown from four to six cracks in the 01/13 inspection). Refer to Photo 14.

Photo 14- Cracks in east face at north end of Beam 8-4

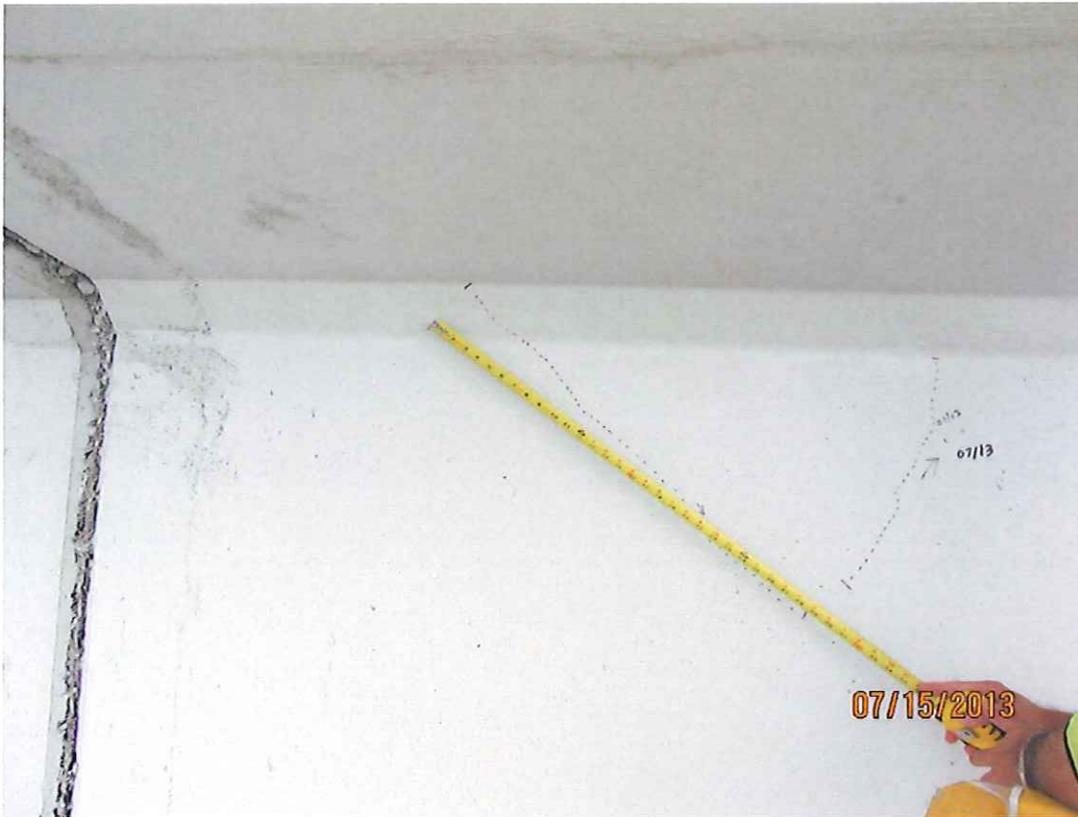
- Beam 11-4 east face of web at south end has a diagonal crack 2 ft. from beam end extending down and away from the top flange 25in. long x 0.005in. wide and a diagonal crack 4 ft. from beam end 20in. long x 0.005in. wide. Refer to Photo 15. (NEW)

Photo 15- Diagonal cracks in east face of Beam 11-4 at south end

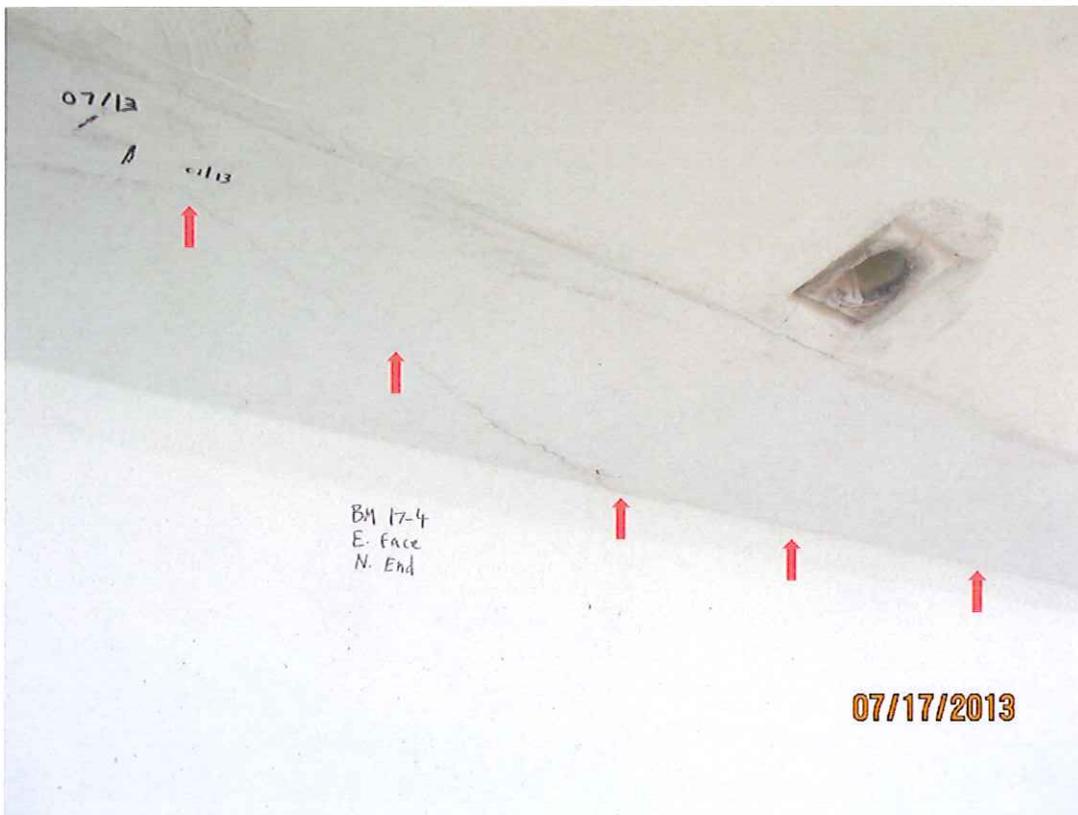
- Beam 17-4 east face of web beginning 18ft. from north end at top flange juncture has a longitudinal crack 20ft. long x 0.020in. wide which turns diagonally 4ft. at the south end of the crack up to and across the top flange and into the deck underside. Refer to Photo 16. (NEW)

Photo 16- Longitudinal and diagonal crack in east face of Beam 17-4 along top flange

- (13) Repair diagonal/ longitudinal crack in east face of Beam 17-4 beginning 18ft. from north end at top flange juncture.

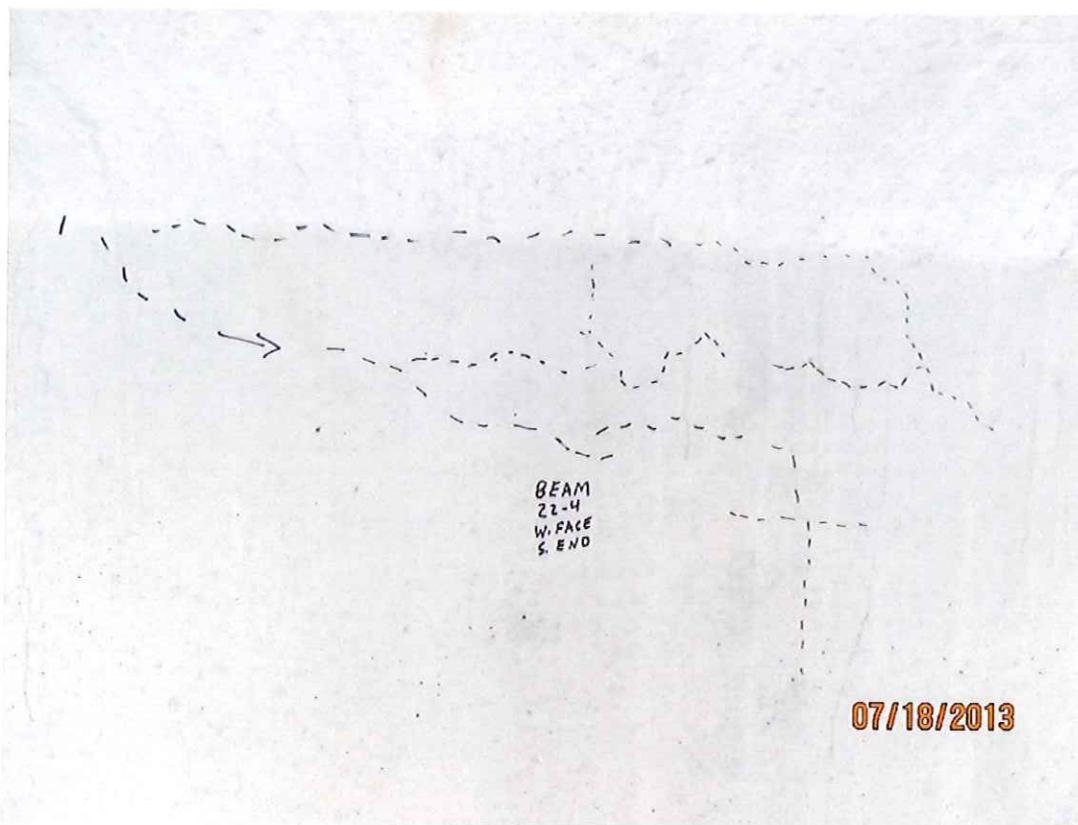
- Beam 22-4 east face of web at south end has multiple pattern/map cracks less than 0.010in. wide within 2ft. of the beam end. These cracks connect to the adjacent diagonal/shear cracks. Refer to Photo 17.

Photo 17- Cracks in east face of Beam 22-4 web at south end

- (6) Beam 17-4 – South End – East Face – 6 Cracks.
- (7) Beam 17-4 – North End – East Face – 6 Cracks.
- (8) Beam 22-4 – South End – East Face – 7 Cracks.
