CITY OF SANIBEL

SANIBEL ISLAND WIDE BEACH MANAGEMENT PLAN

APRIL 1995

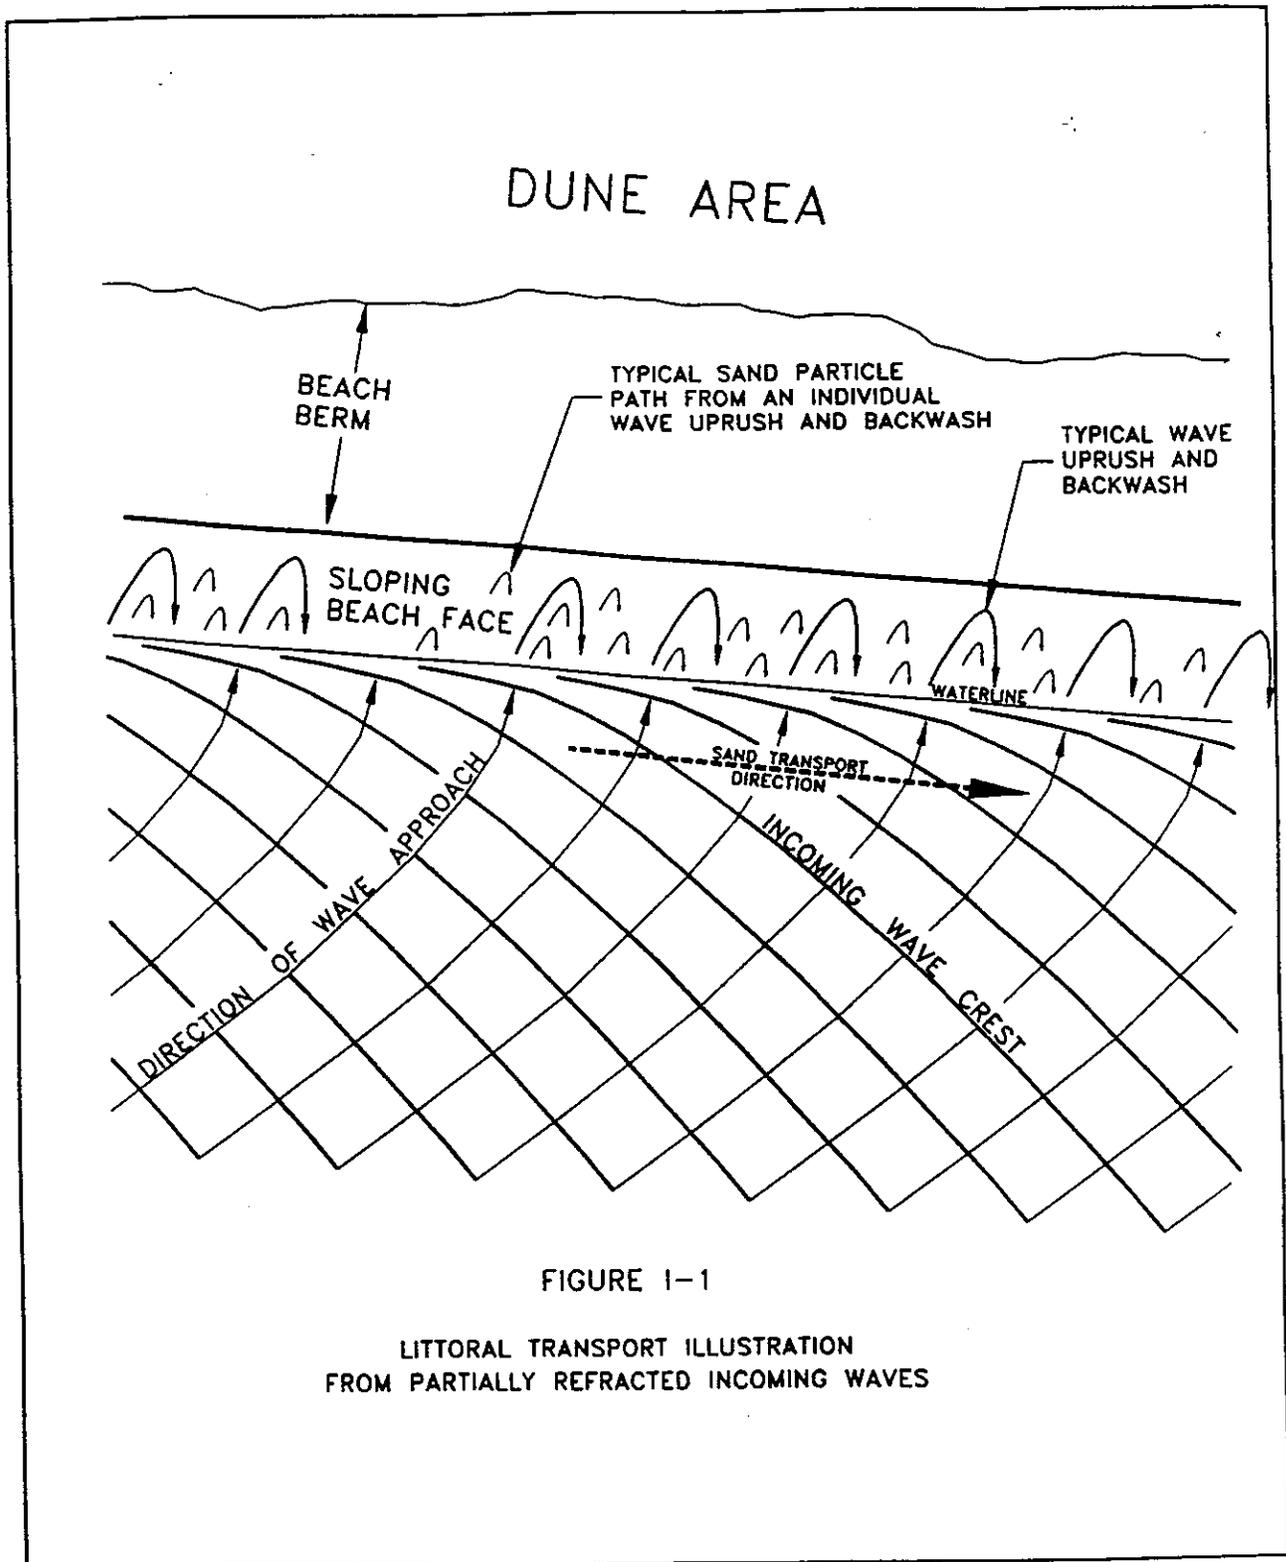
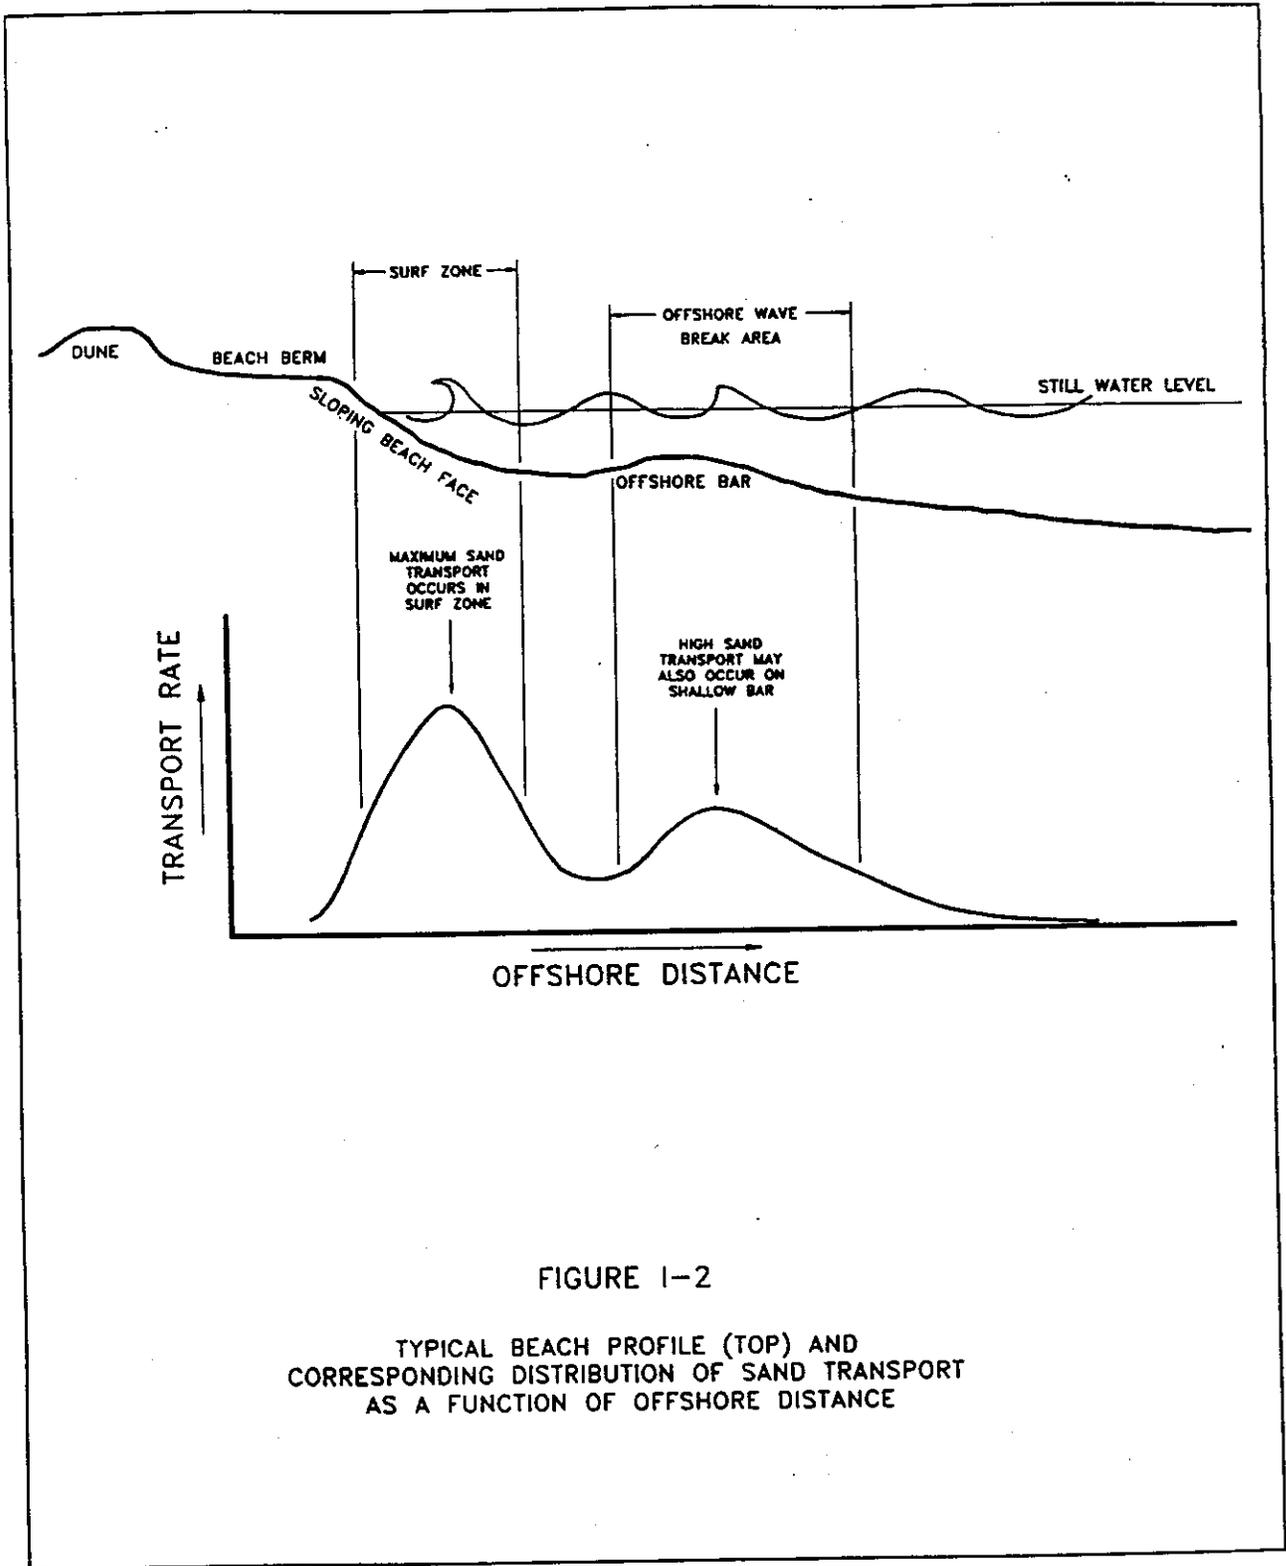
FIGURE 1-2

Figure I-2 illustrates the shape of a typical beach profile, and the distribution of sand transport across the littoral zone. The distribution of transport shown in Figure I-2 is general for descriptive purposes. Experiments by Kraus (1987) have shown the actual shape of the distribution curve to be dependent upon wave characteristics and profile shape. The distribution curve may exhibit two peaks as shown in Figure I-2, it may have only one peak, or it may be nearly flat during times when the distribution of transport is relatively uniform across the surf zone.

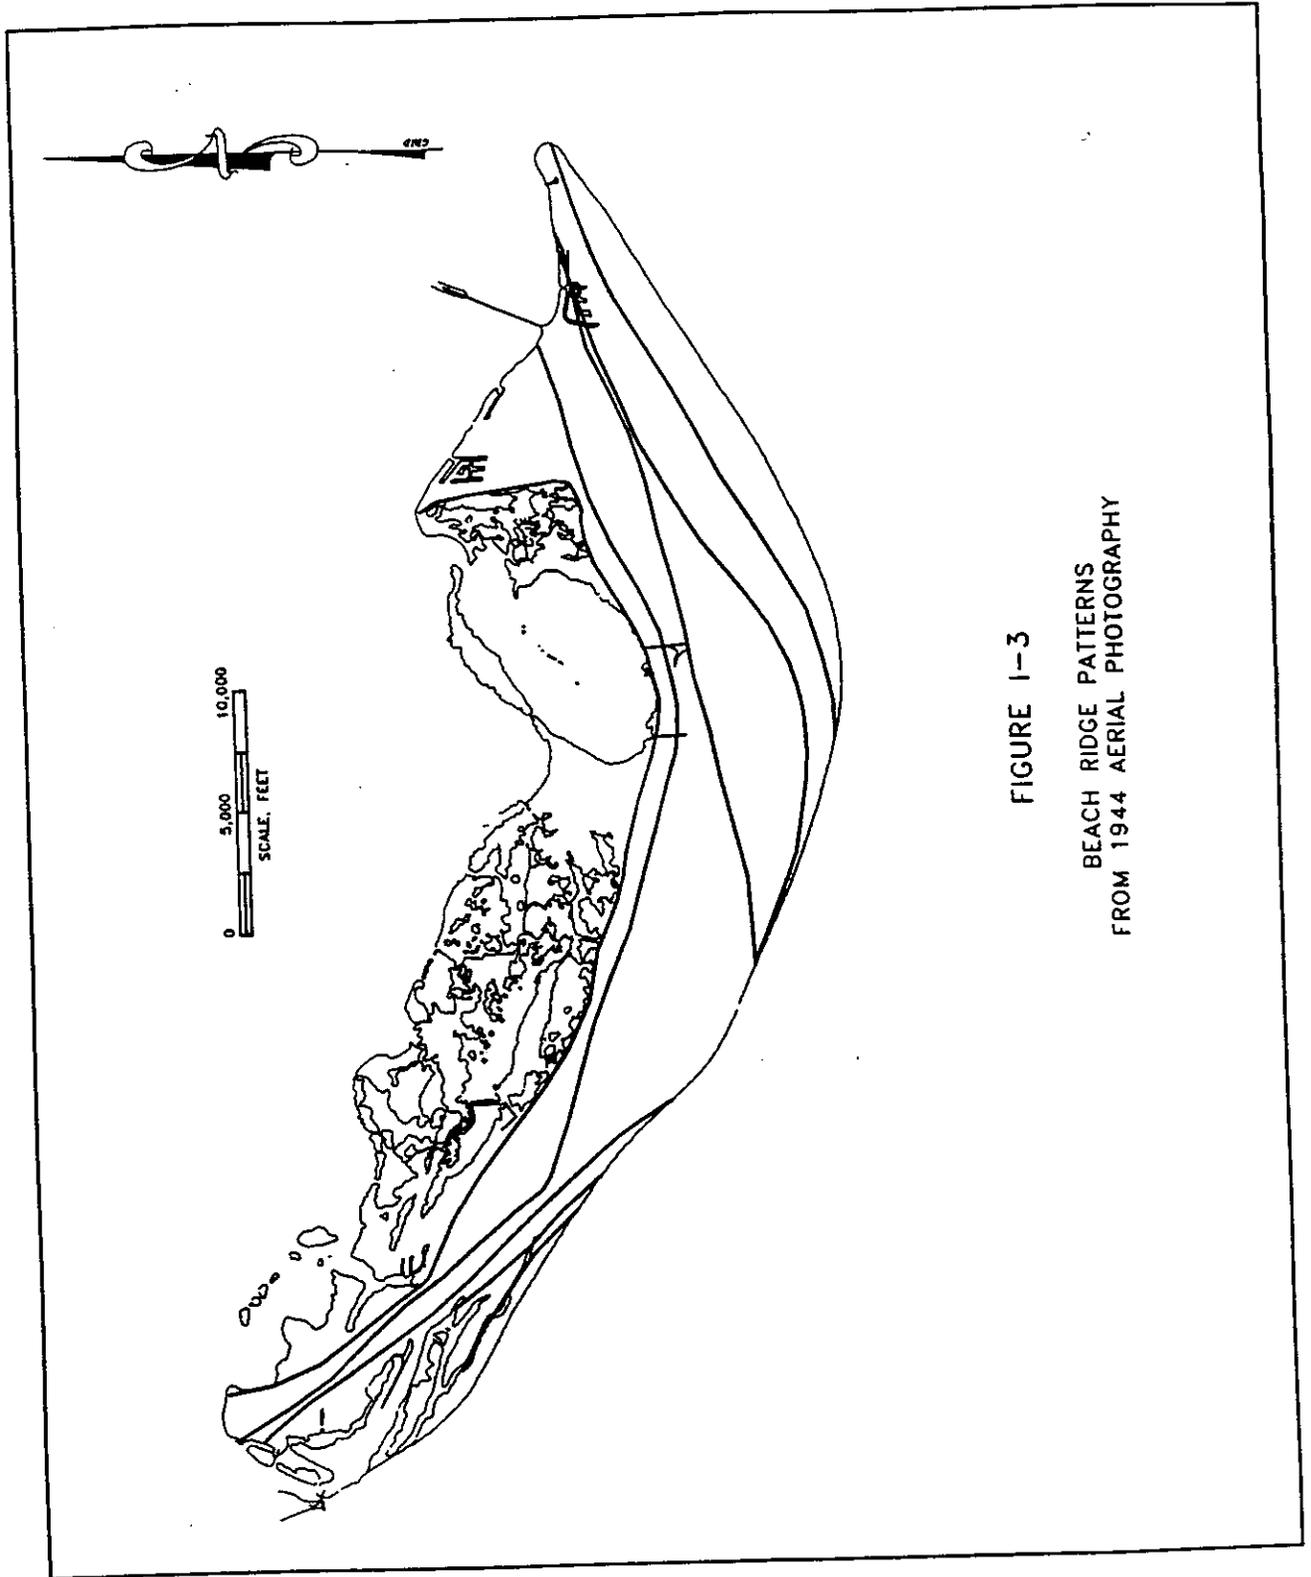
FIGURE I-3
BEACH RIDGE PATTERNS
FROM 1944 AERIAL PHOTOGRAPHY

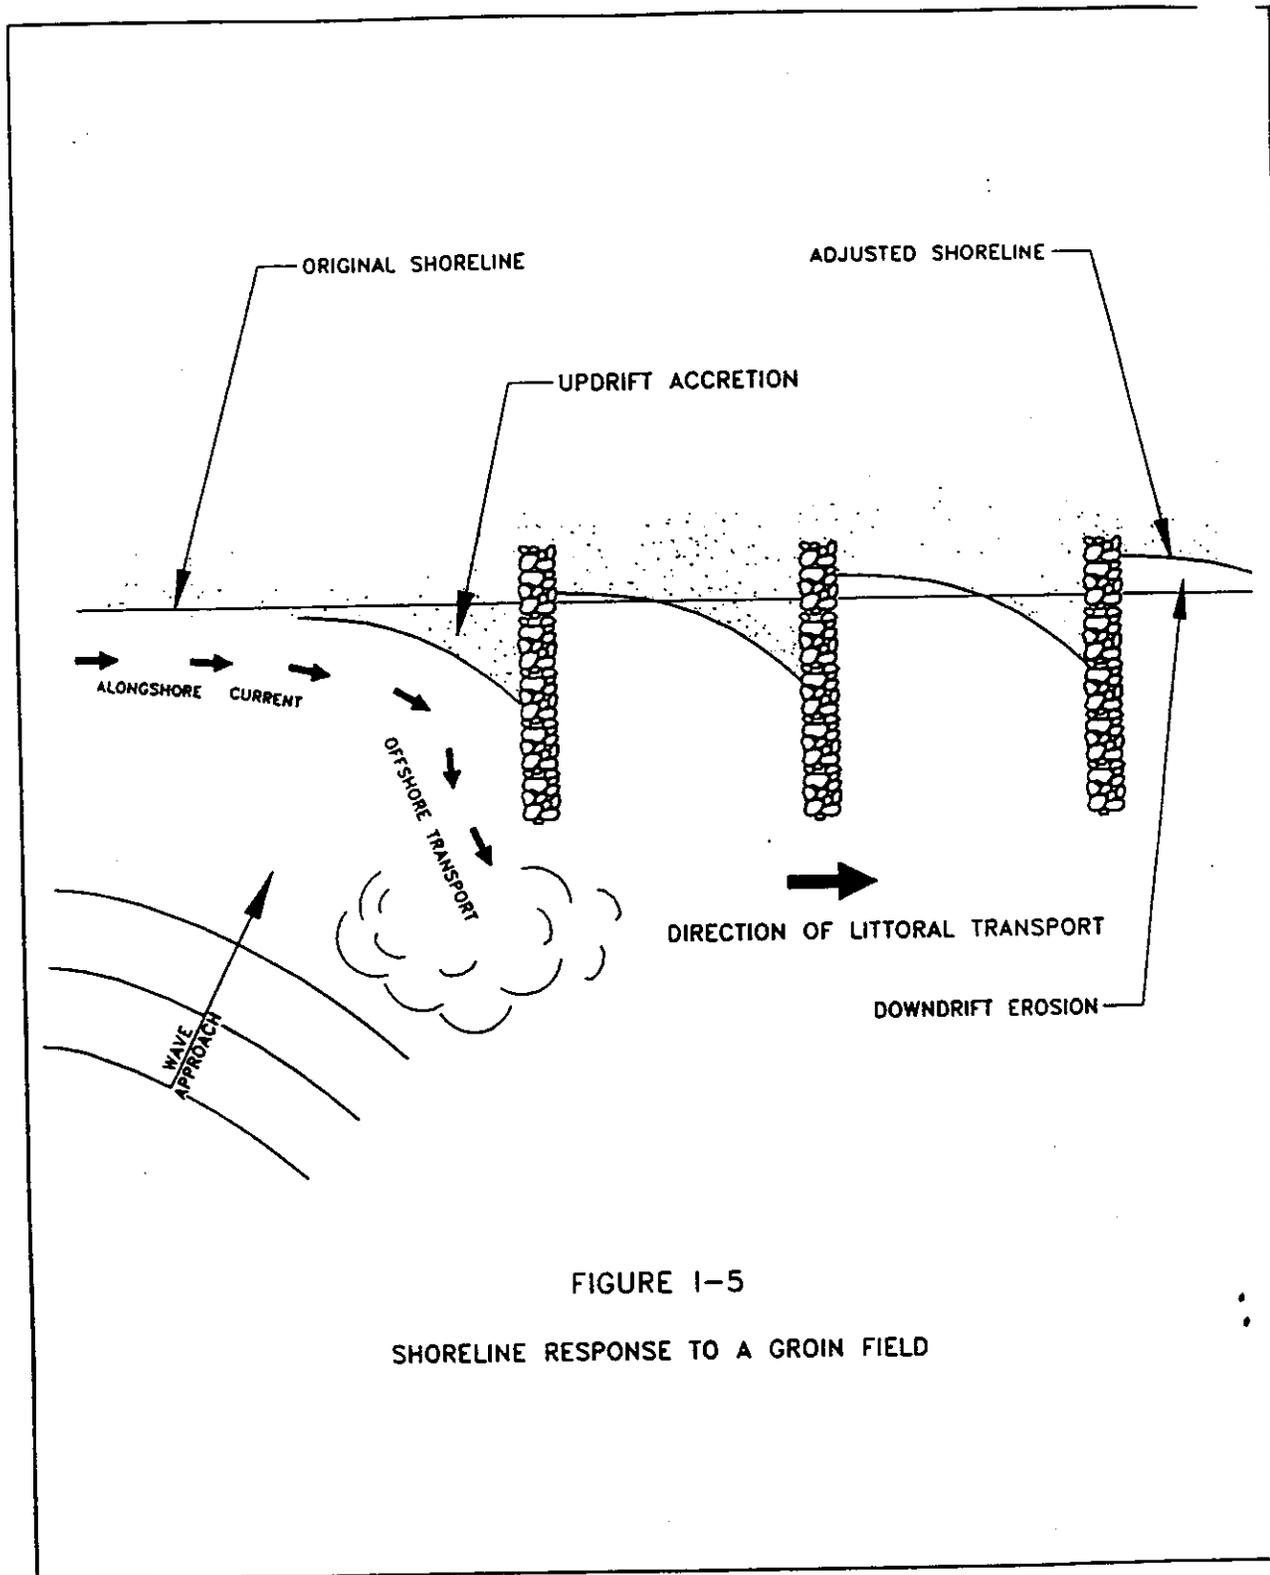
FIGURE I-5

SHORELINE RESPONSE TO A GROIN FIELD

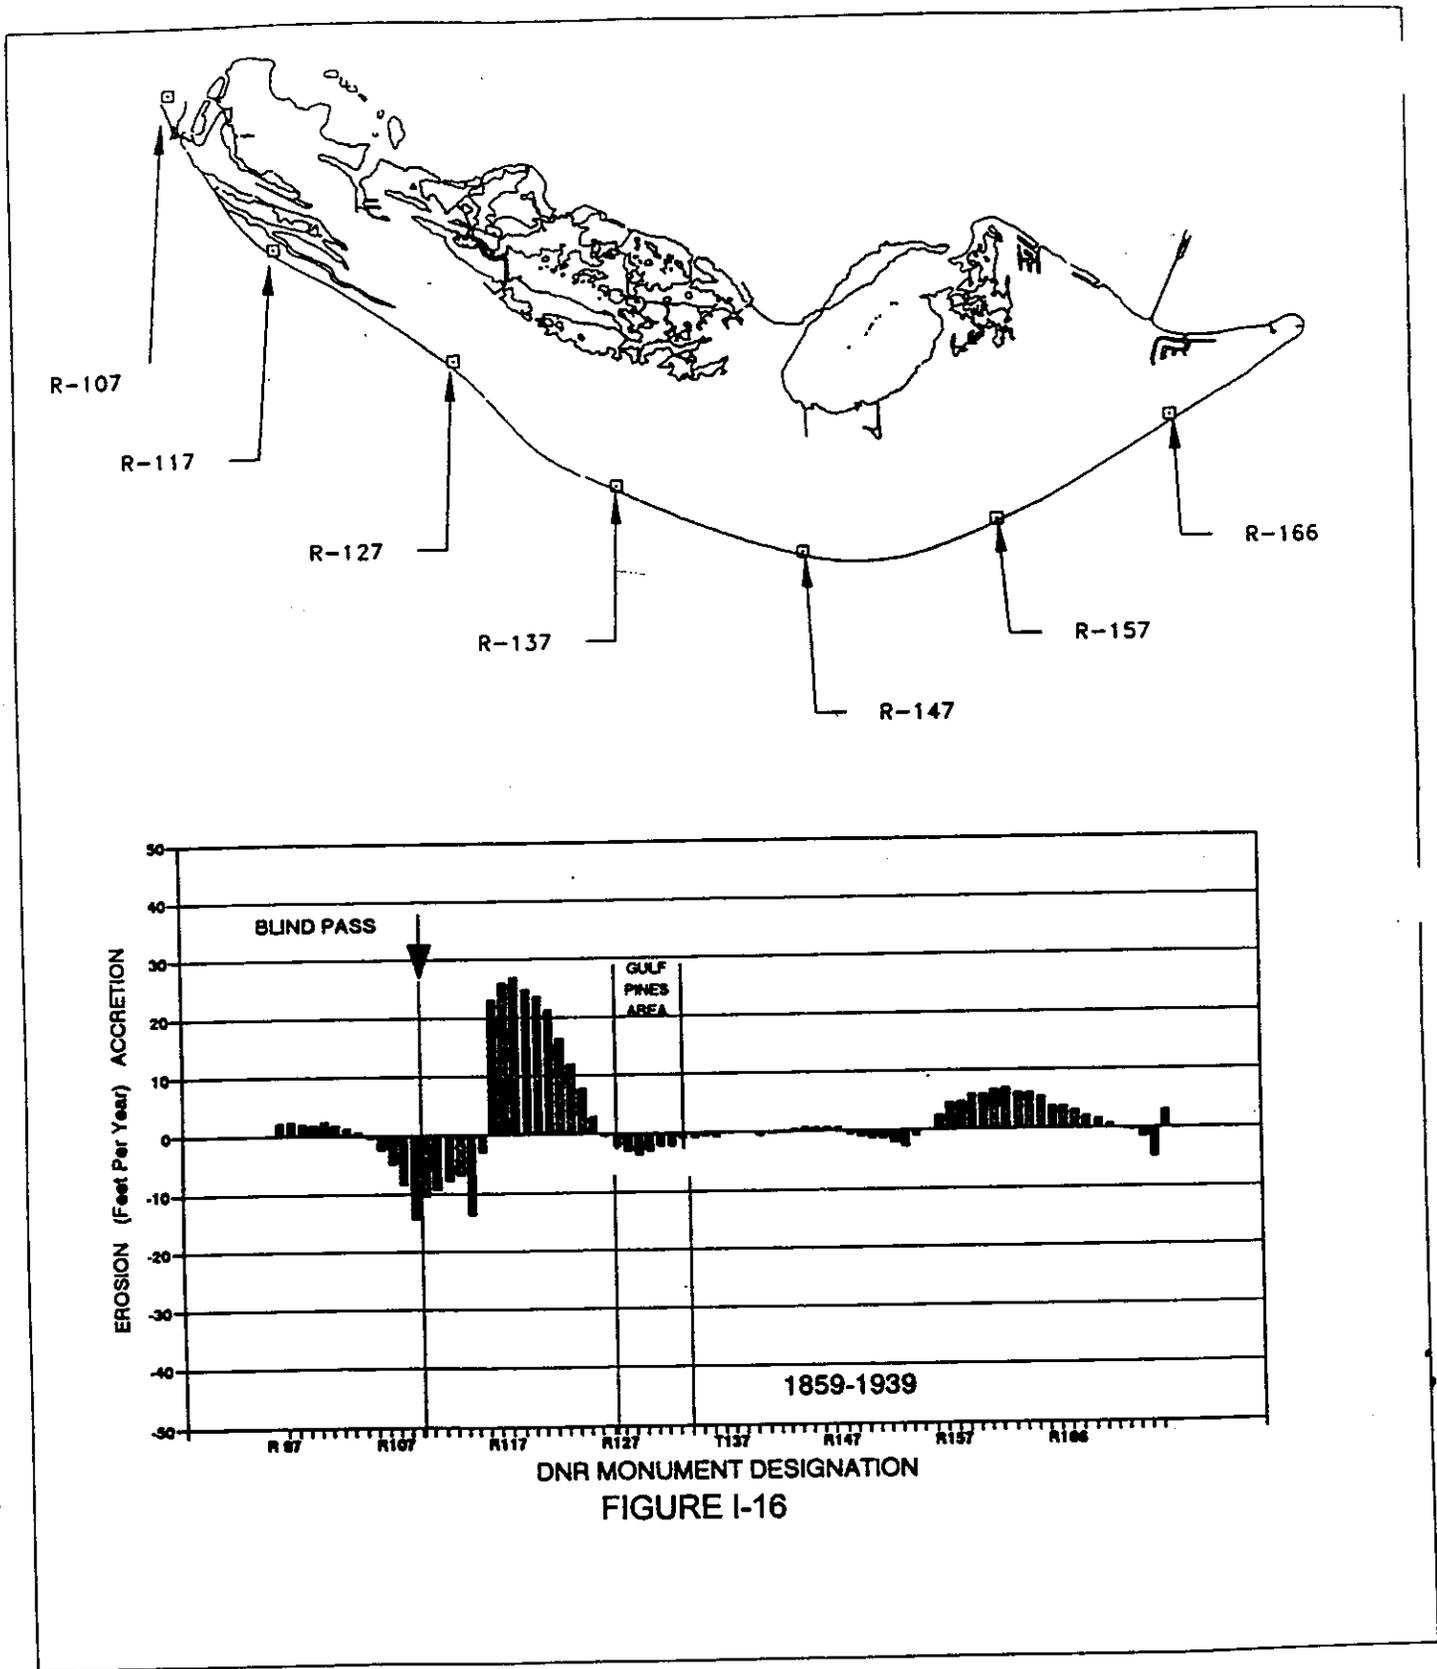
DNR MONUMENT DESIGNATION
 FIGURE I-16

The shoreline changes represented as change rates in Figures I-16 through I-22 are also represented in Figures I-23 through I-34 which are shoreline position change maps. These maps illustrate

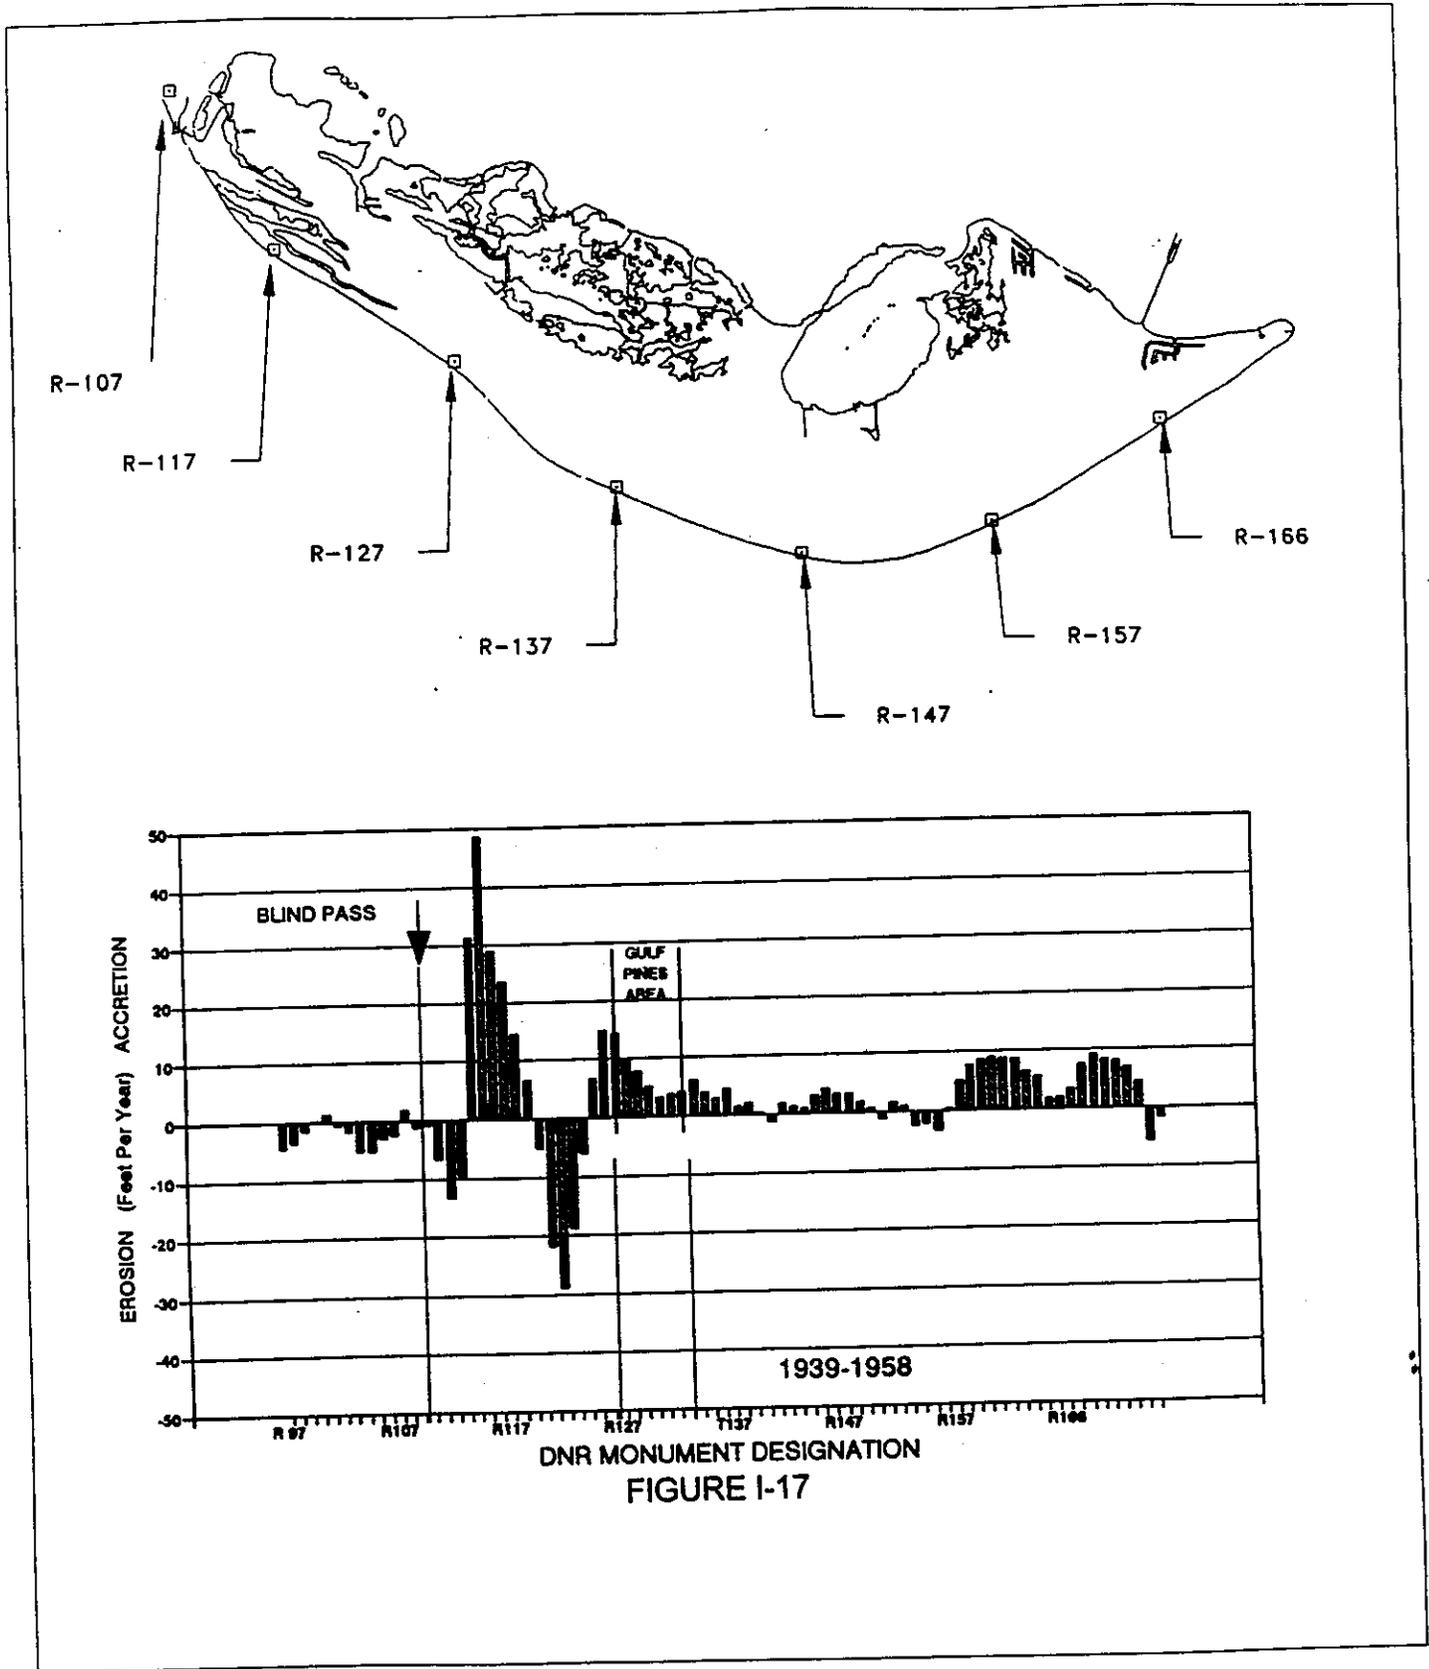
1939-1958
 DNR MONUMENT DESIGNATION
 FIGURE I-17

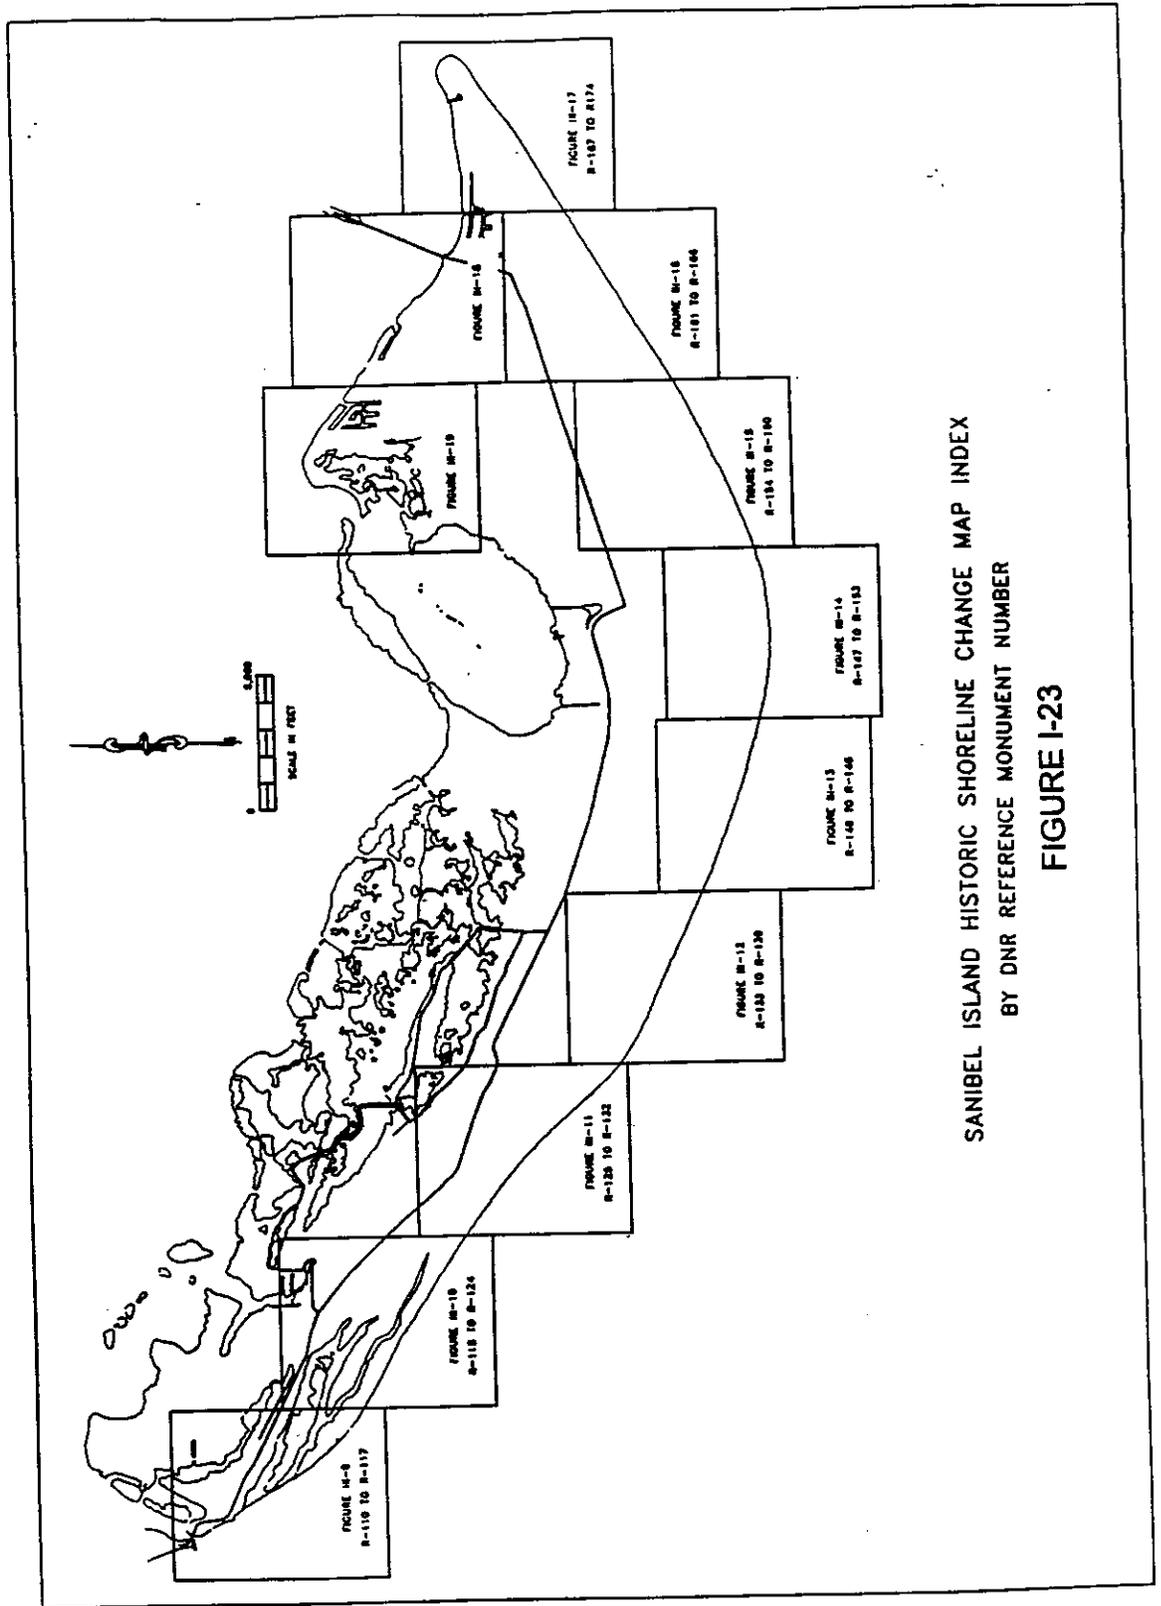
SANIBEL ISLAND HISTORIC SHORELINE CHANGE MAP INDEX
 BY DNR REFERENCE MONUMENT NUMBER
 FIGURE I-23

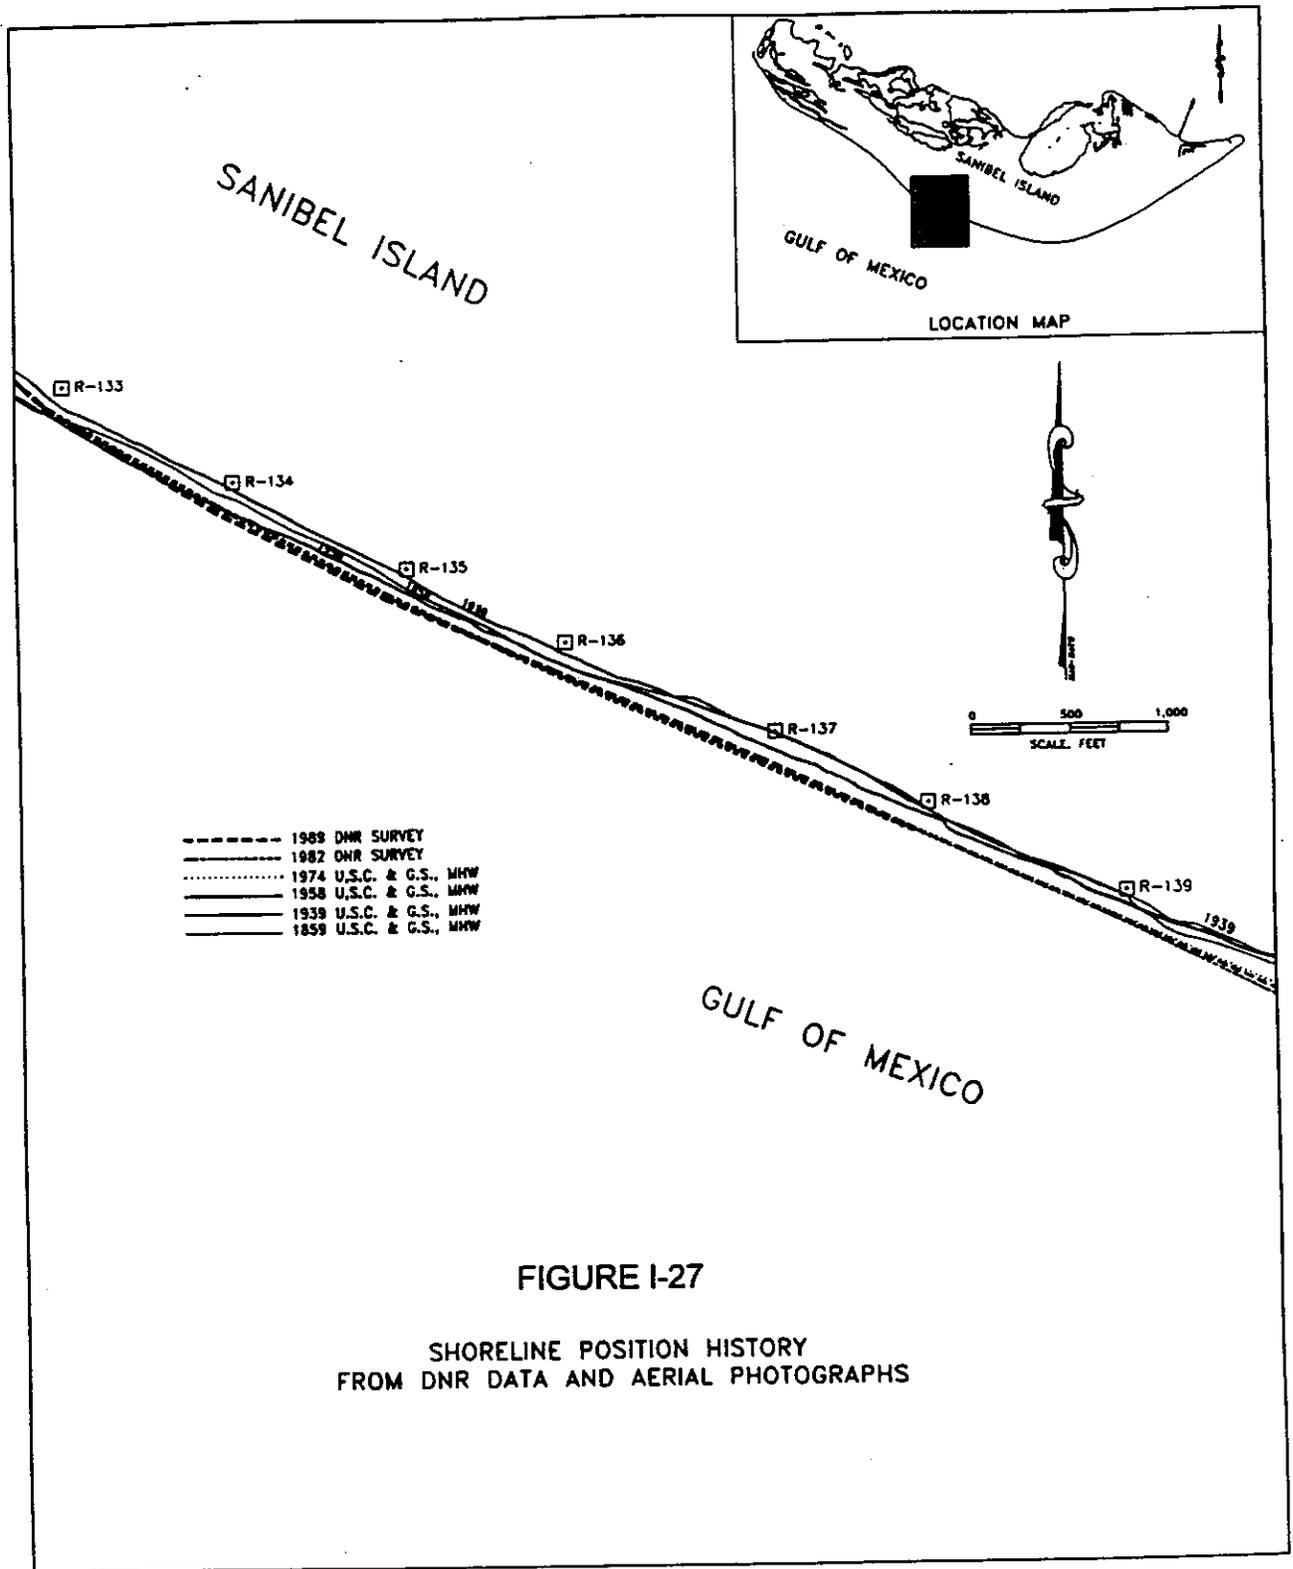
FIGURE I-27

SHORELINE POSITION HISTORY
FROM DNR DATA AND AERIAL PHOTOGRAPHS

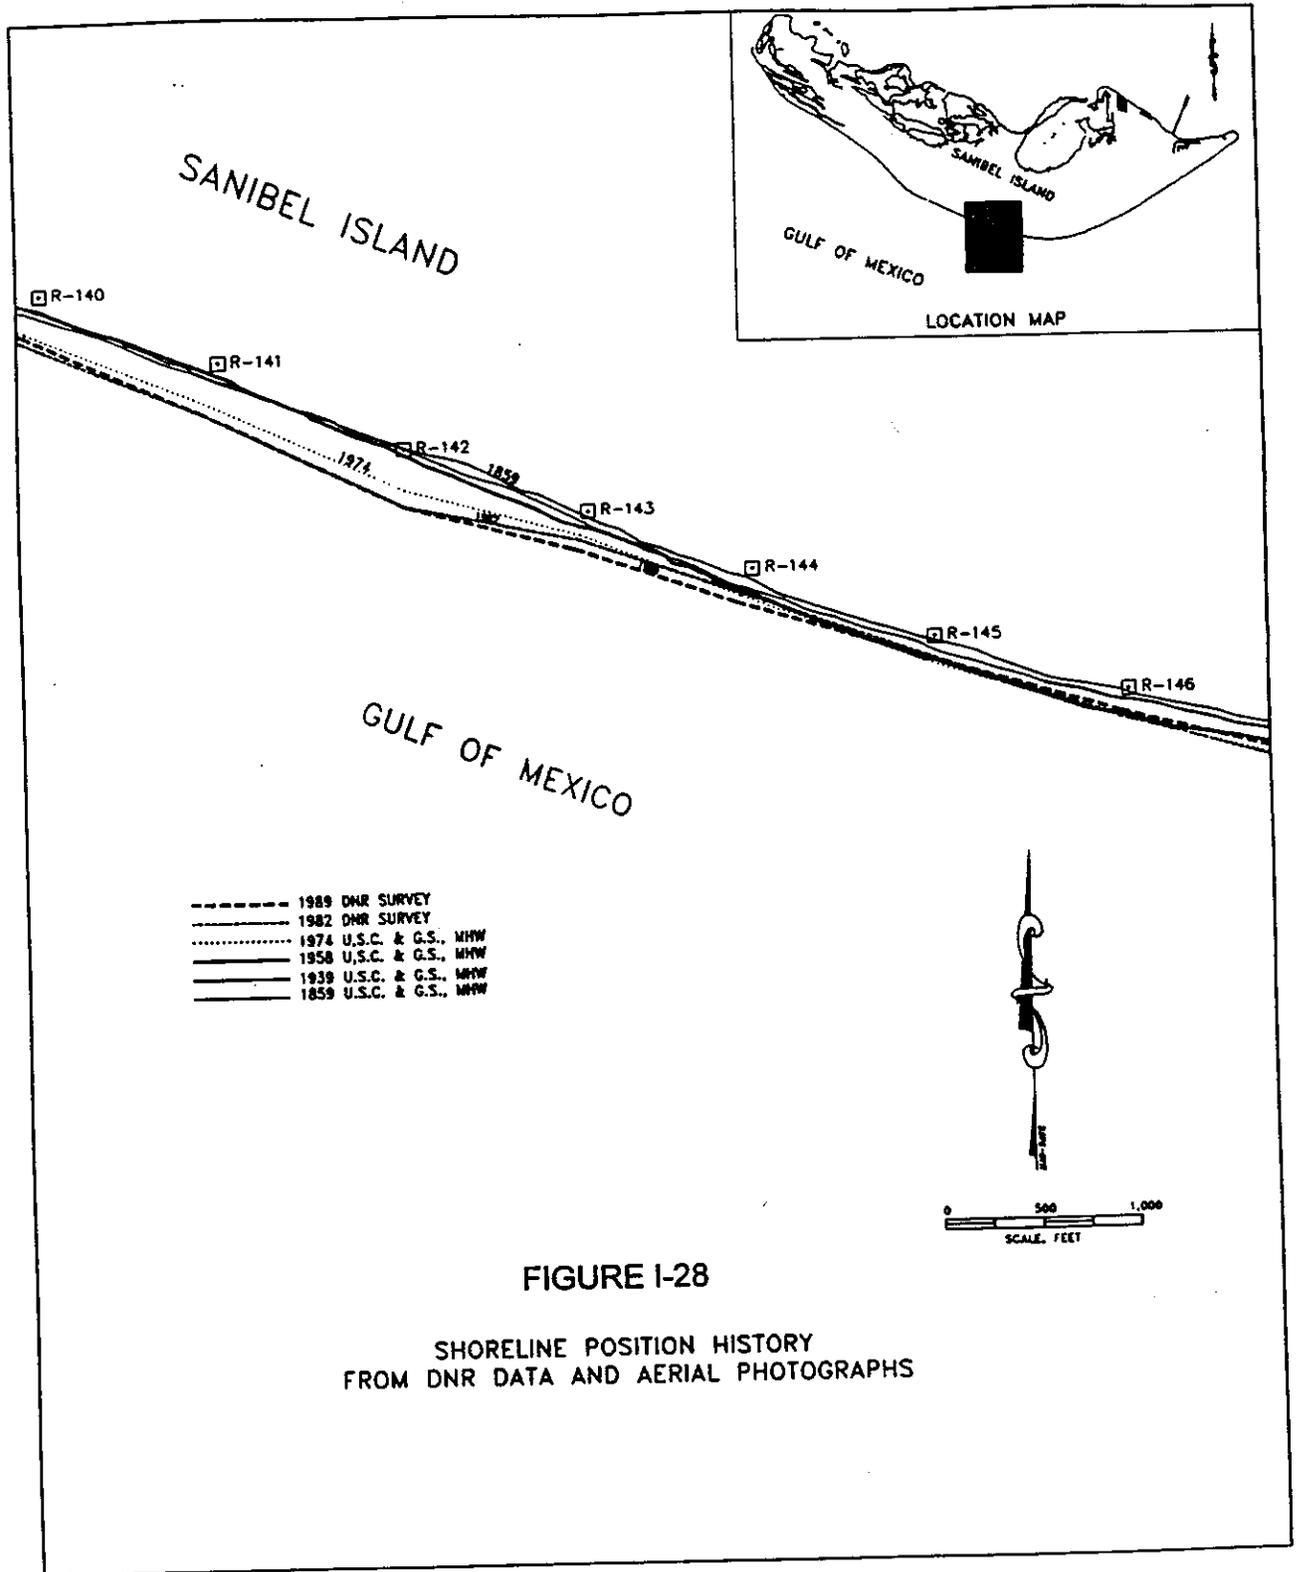
FIGURE I-28

**SHORELINE POSITION HISTORY
FROM DNR DATA AND AERIAL PHOTOGRAPHS**

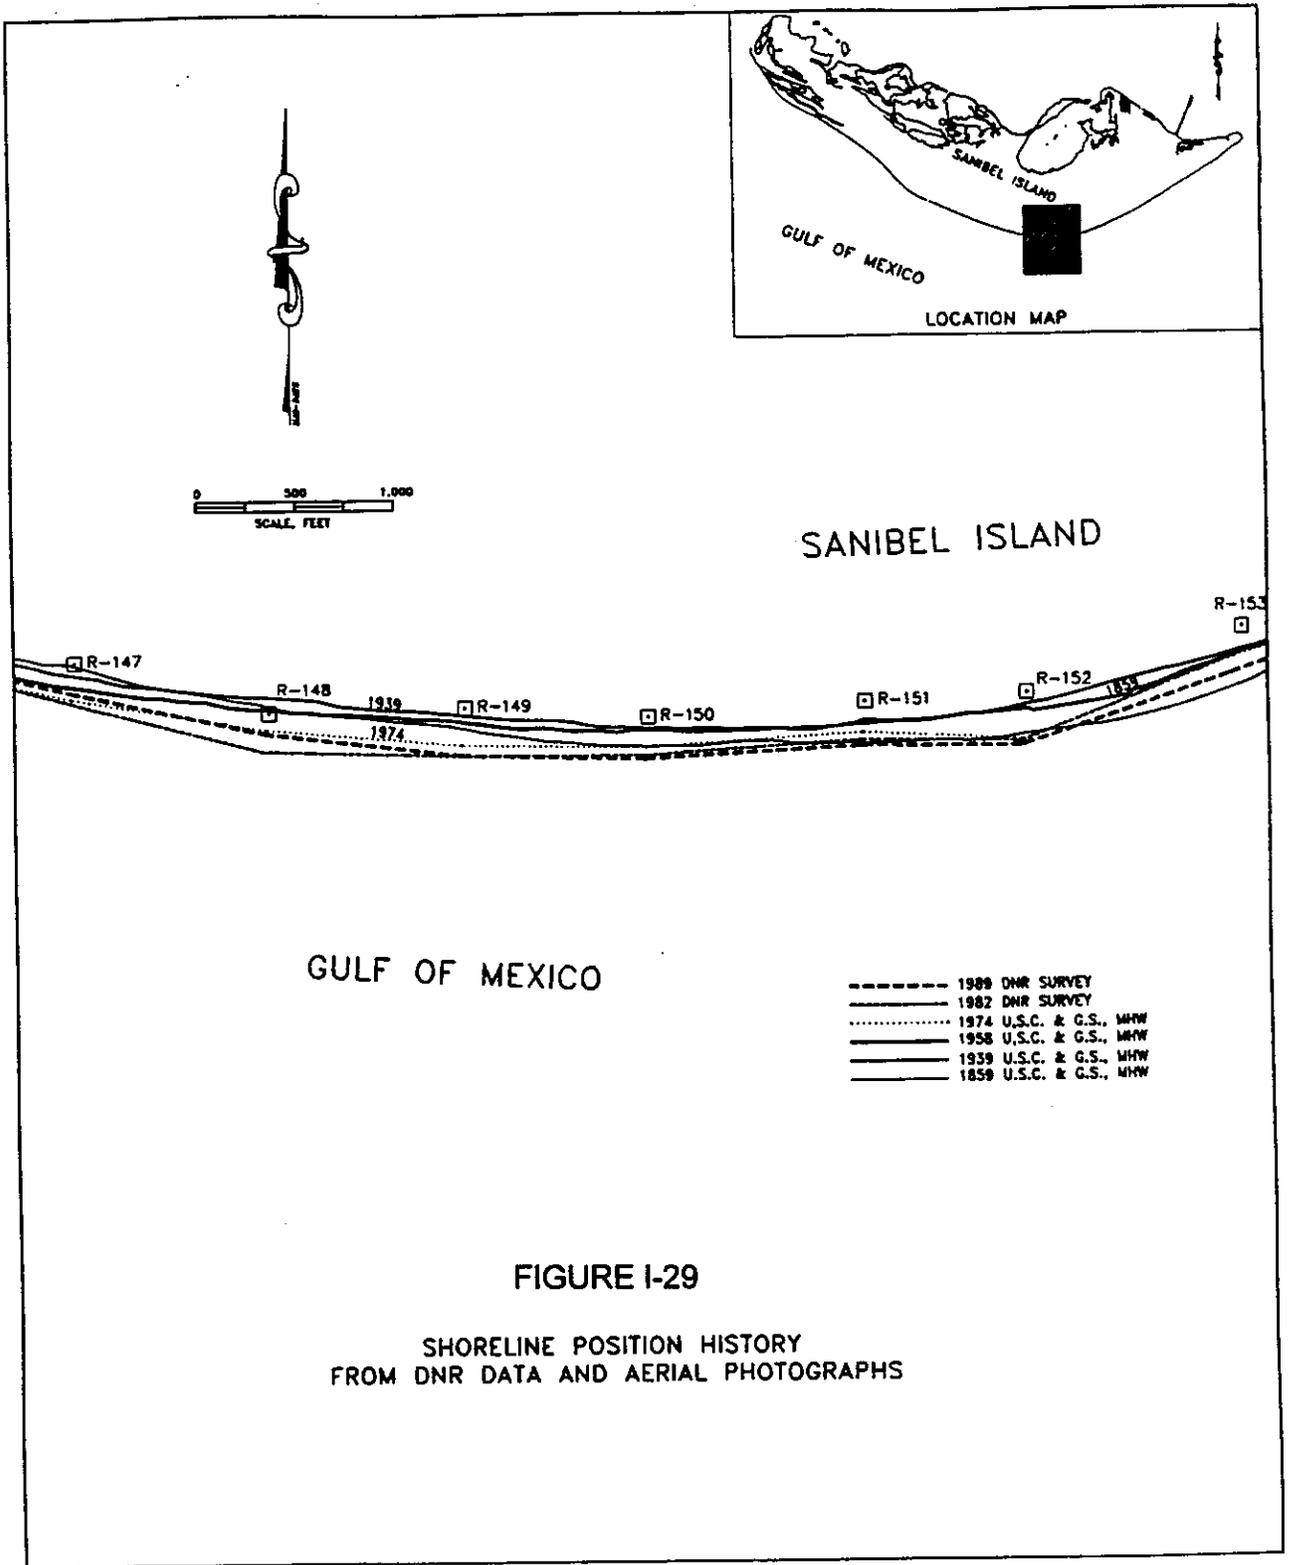
FIGURE I-29

SHORELINE POSITION HISTORY
 FROM DNR DATA AND AERIAL PHOTOGRAPHS

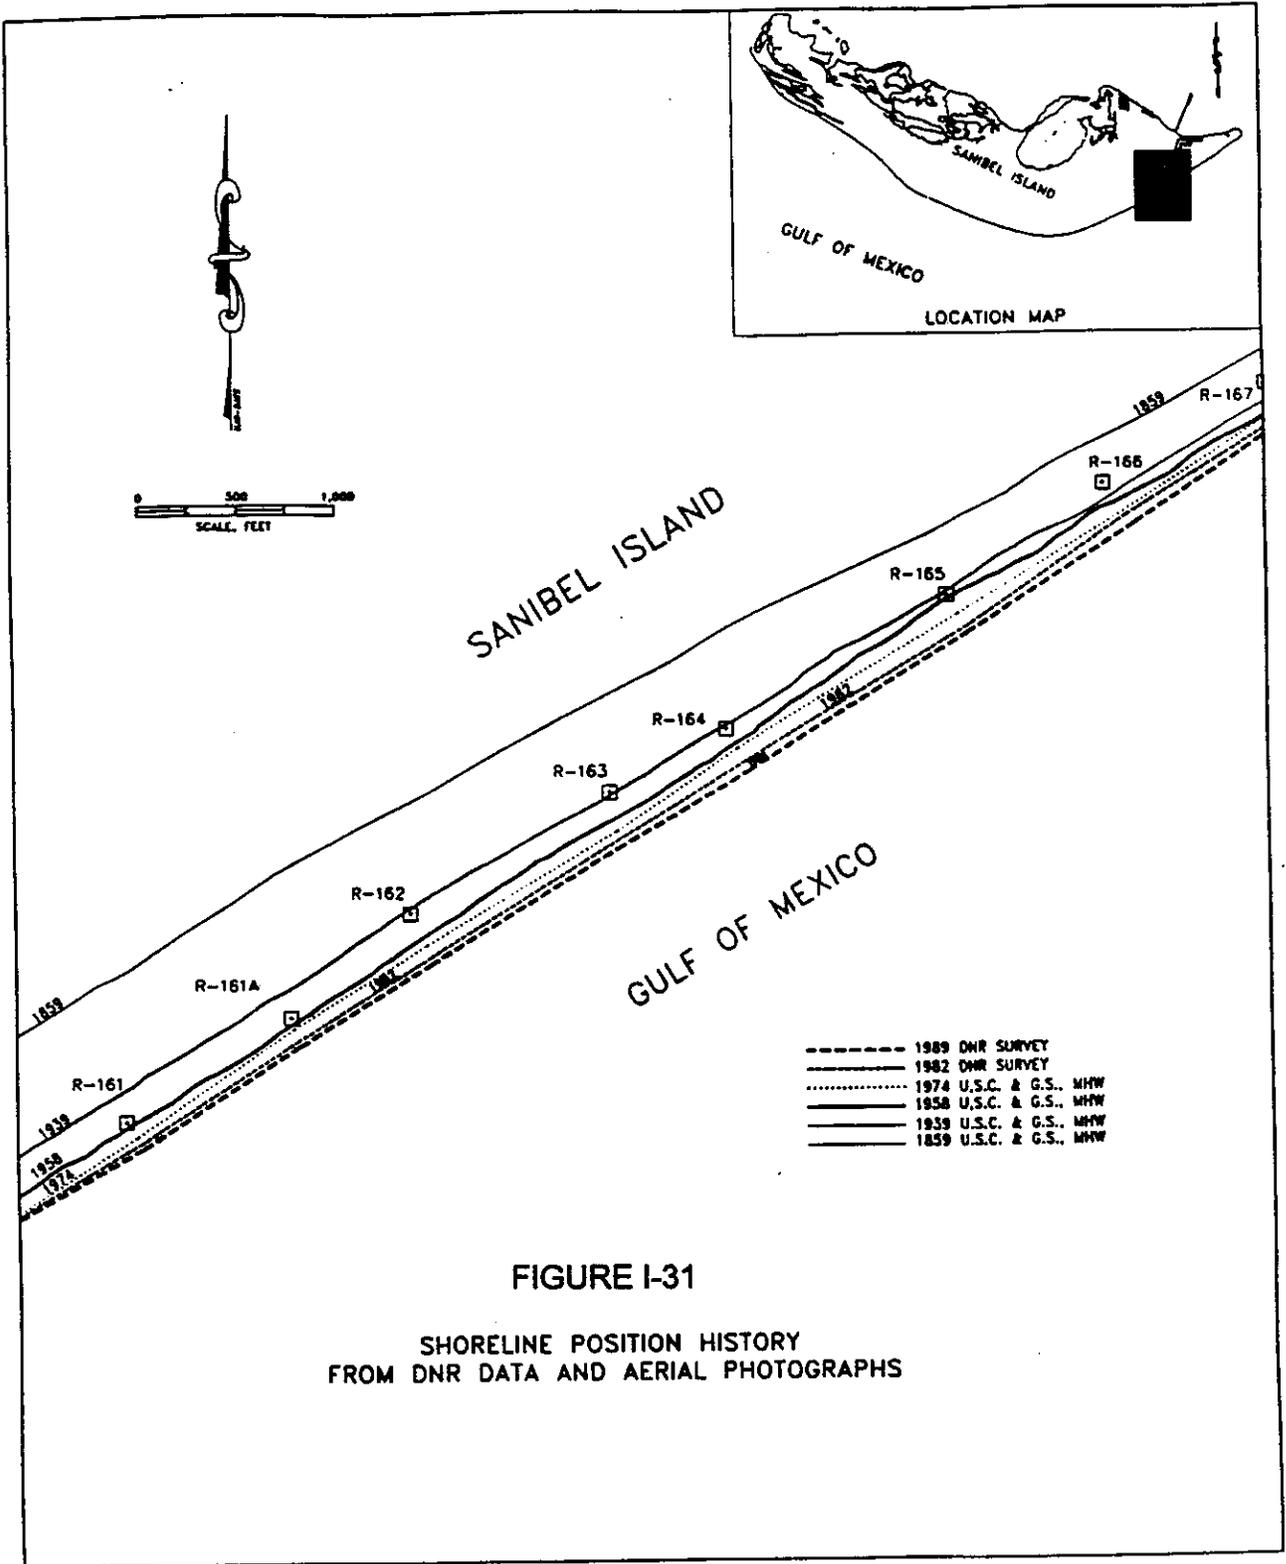
FIGURE I-31

SHORELINE POSITION HISTORY
 FROM DNR DATA AND AERIAL PHOTOGRAPHS
