CITY OF SANIBEL

SANIBEL ISLAND WIDE BEACH MANAGEMENT PLAN

APRIL 1995

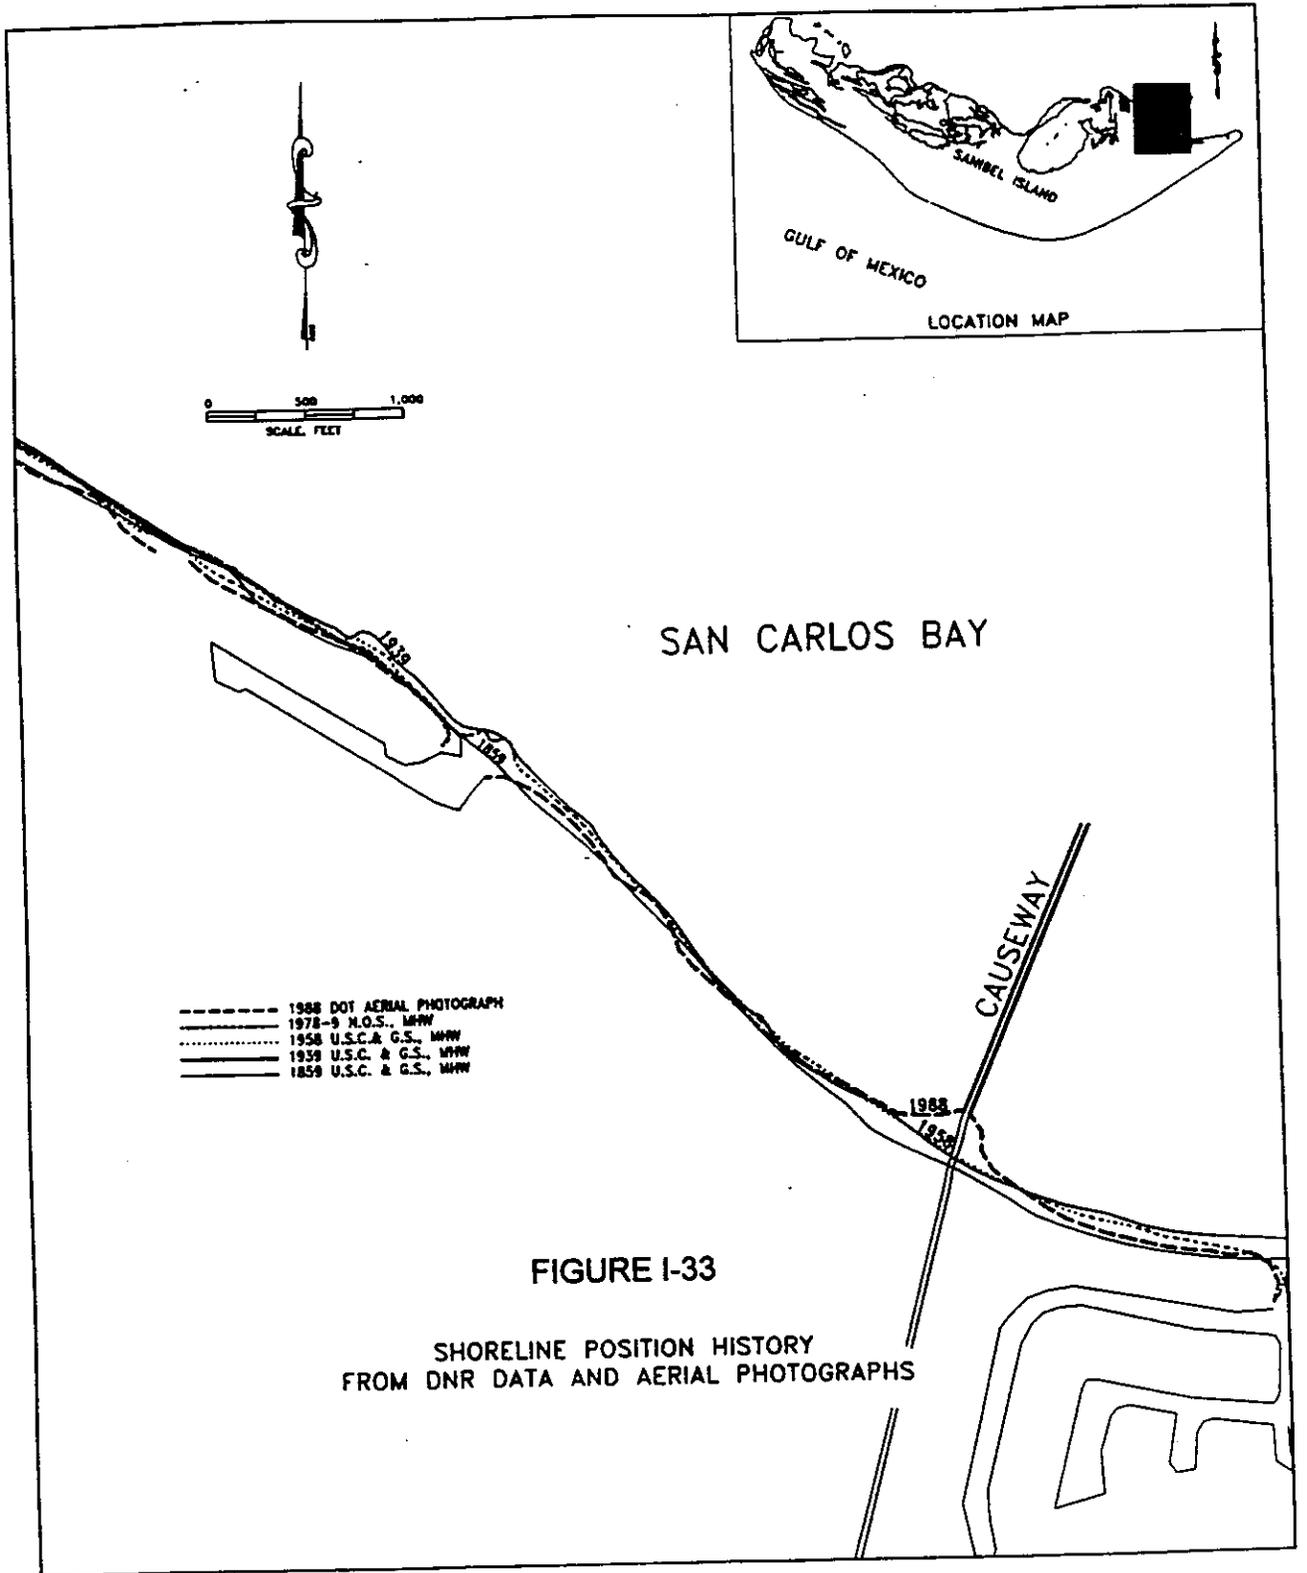
FIGURE I-33

SHORELINE POSITION HISTORY
FROM DNR DATA AND AERIAL PHOTOGRAPHS

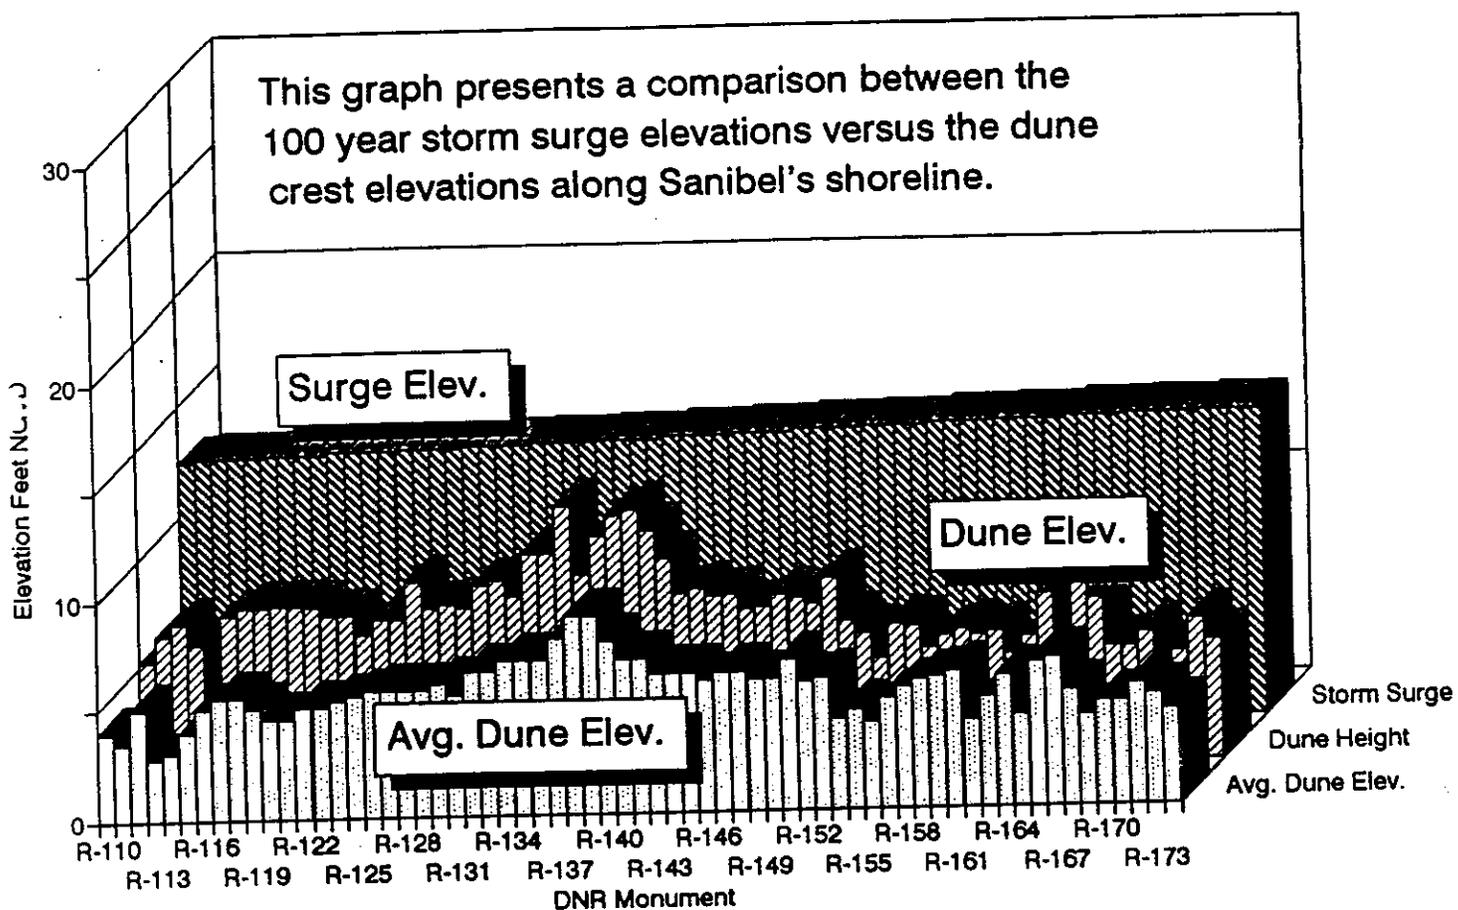
FIGURE I-35

Sanibel Beach Management Plan
Storm Surge vs Dune Elevation

The results of the storm surge analysis indicate minor erosion from a 100-year storm. This is because the low dune system is overtopped by the storm surge. Being totally inundated, the dune is

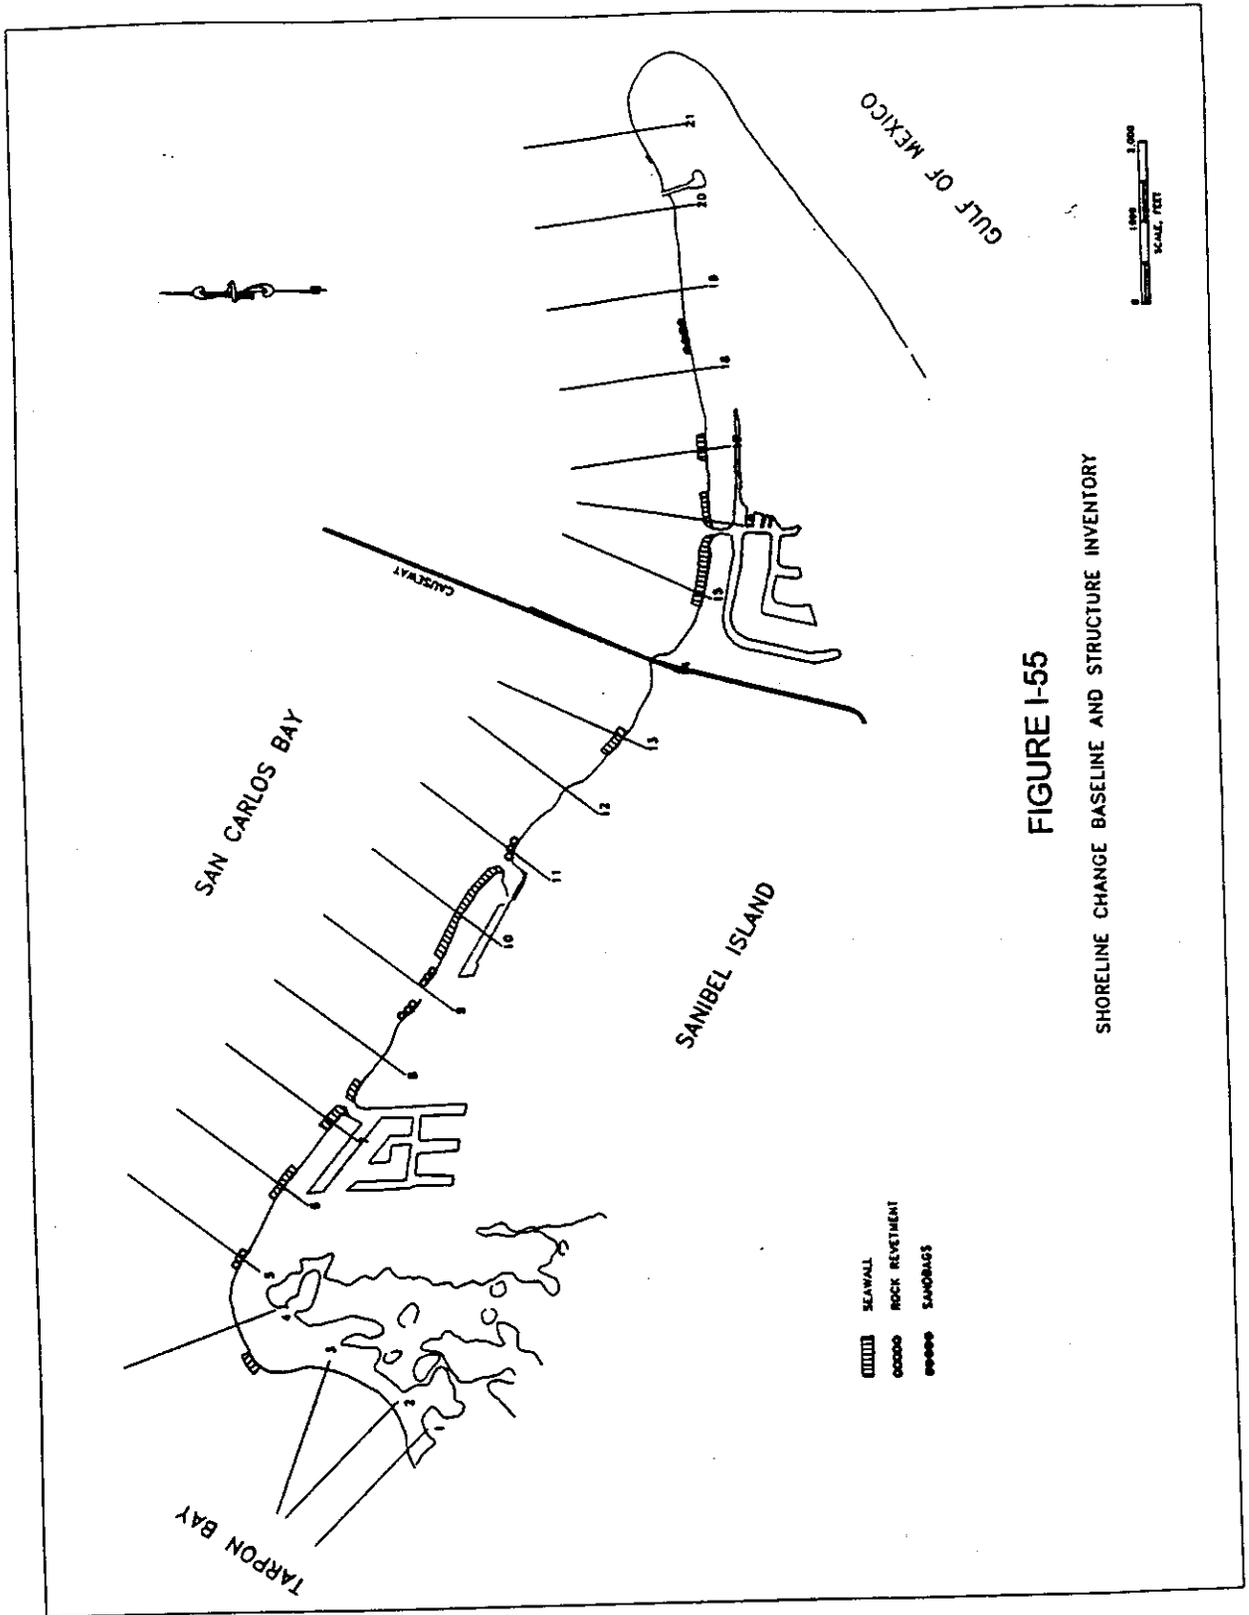
FIGURE I-55

Figure I-55 shows the approximate location and type of armoring prevalent along this section of Sanibel Island's bay shoreline. The information on this drawing was derived from a site inspection and aerial photographs and therefore the location and extent of the shoreline armoring is approximate. It is intended here to illustrate the prevalence and relative distribution of armoring as an indication of the erosion problems along this section of the shoreline.

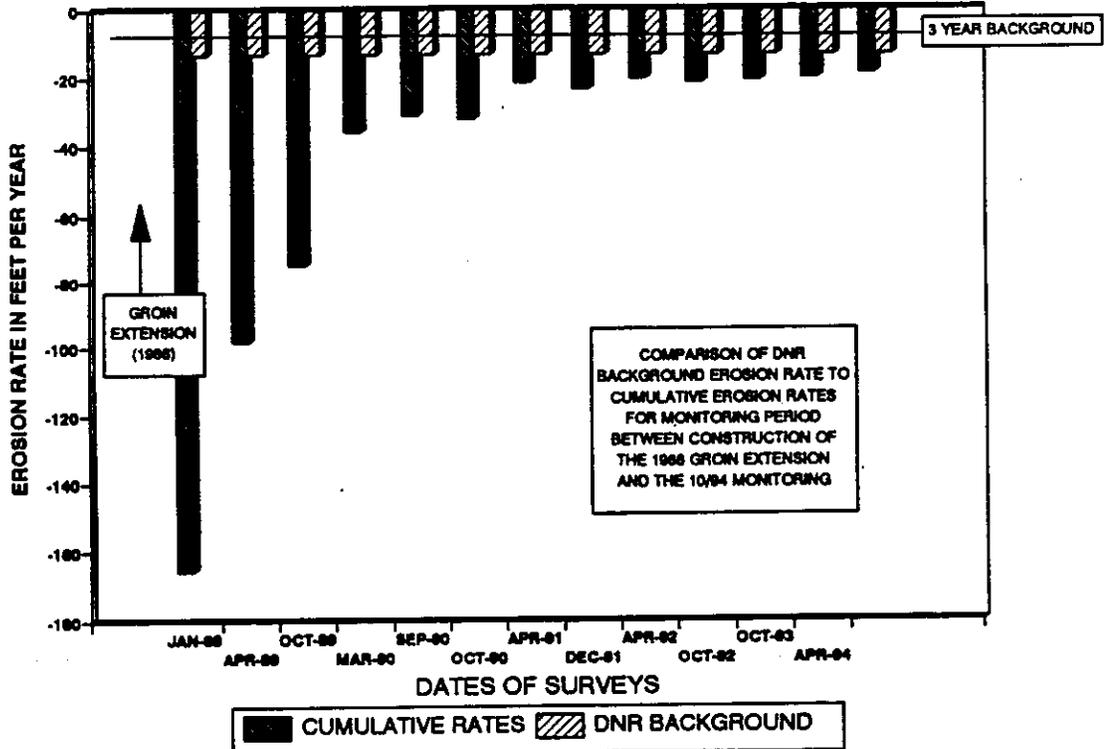
FIGURE I-57

EROSION RATES SOUTH OF BLIND PASS
CUMULATIVE RATES FROM 1988 TO 1994

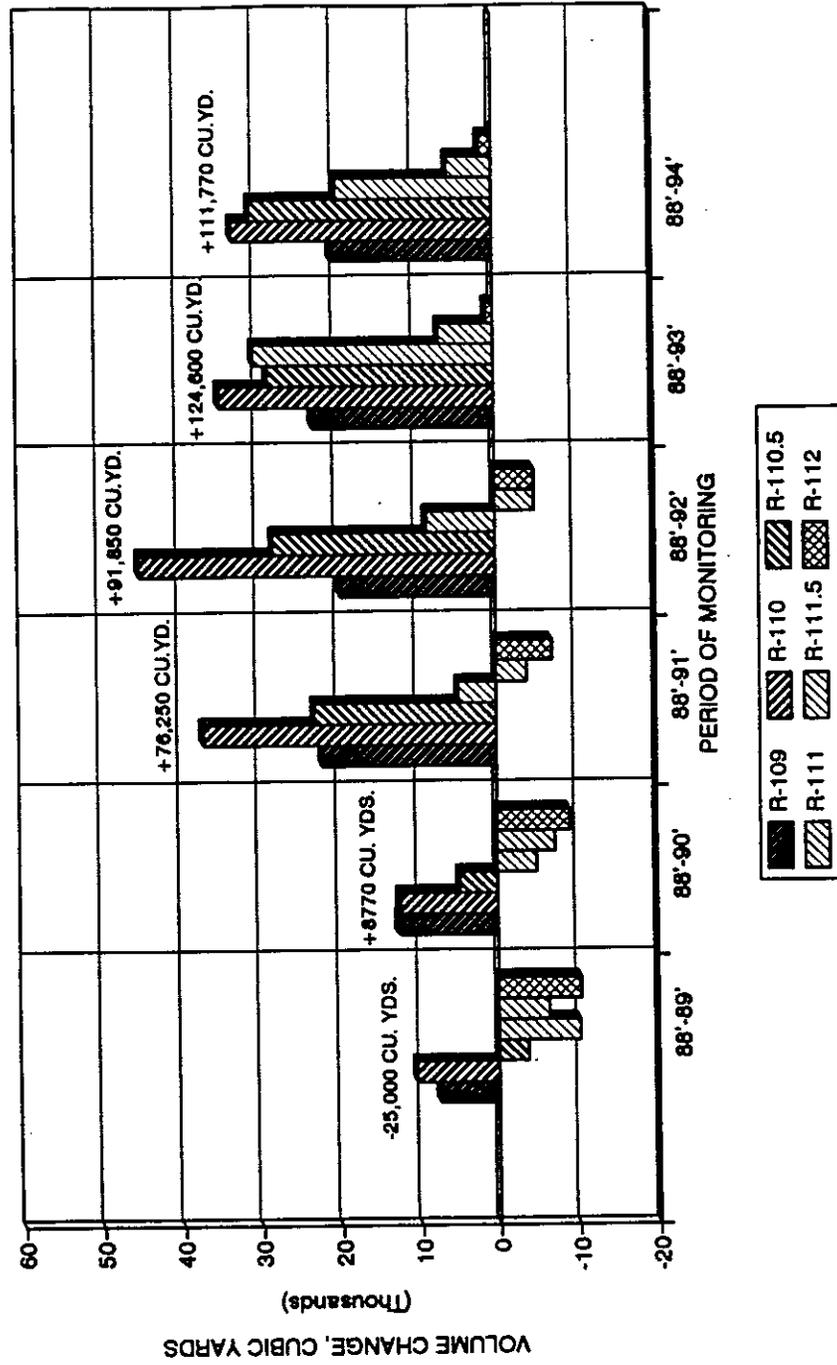
FIGURE I-66

**BLIND PASS CUMULATIVE SHOAL GROWTH
SINCE JETTY CONSTRUCTION IN 1988**

The Blind Pass ebb shoal grew persistently over the first five years after the groin was extended, for a net increase in sand volume of over 124,600 cubic yards. There was a decrease in shoal volume over the most recent year of monitoring. This decrease was

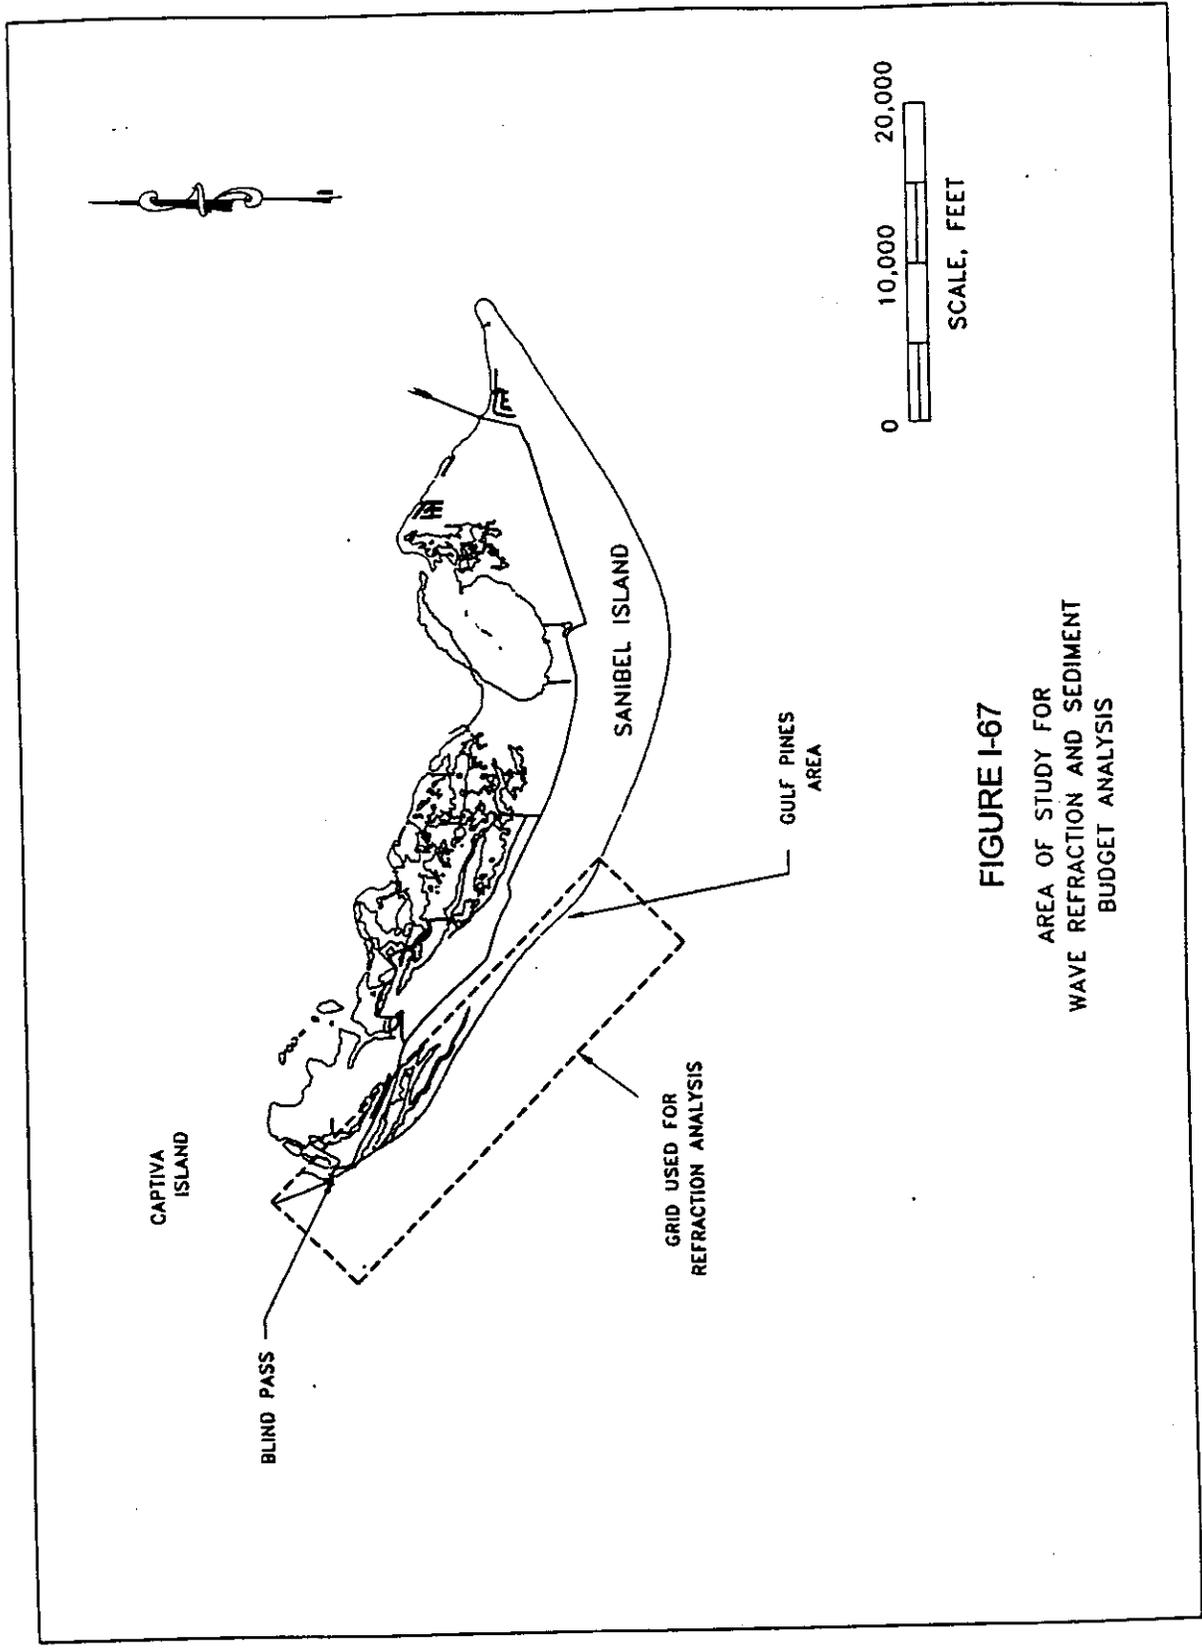
FIGURE I-67
 AREA OF STUDY FOR
 WAVE REFRACTION AND SEDIMENT
 BUDGET ANALYSIS

Wave Data. Model wave data input came from the U.S. Army Corps of Engineers Wave Information Study (WIS) 1989 Report 18, entitled, "Gulf of Mexico Hindcast Wave Information." Hindcast wave data consists of wave heights, directions, and periods, which would theoretically have been generated by meteorological conditions covering some previous time period. The WIS report contains twenty years of hindcast wave data based on wind data collected at a series of offshore stations between 1956 and 1975. The information used for this analysis is from WIS Station No. 42, which is located approximately twenty (20) miles offshore from Sanibel. In order to input this twenty years of hindcast wave data to the refraction model, the data were first broken down into two categories: normal waves and storm waves. The wave data were then

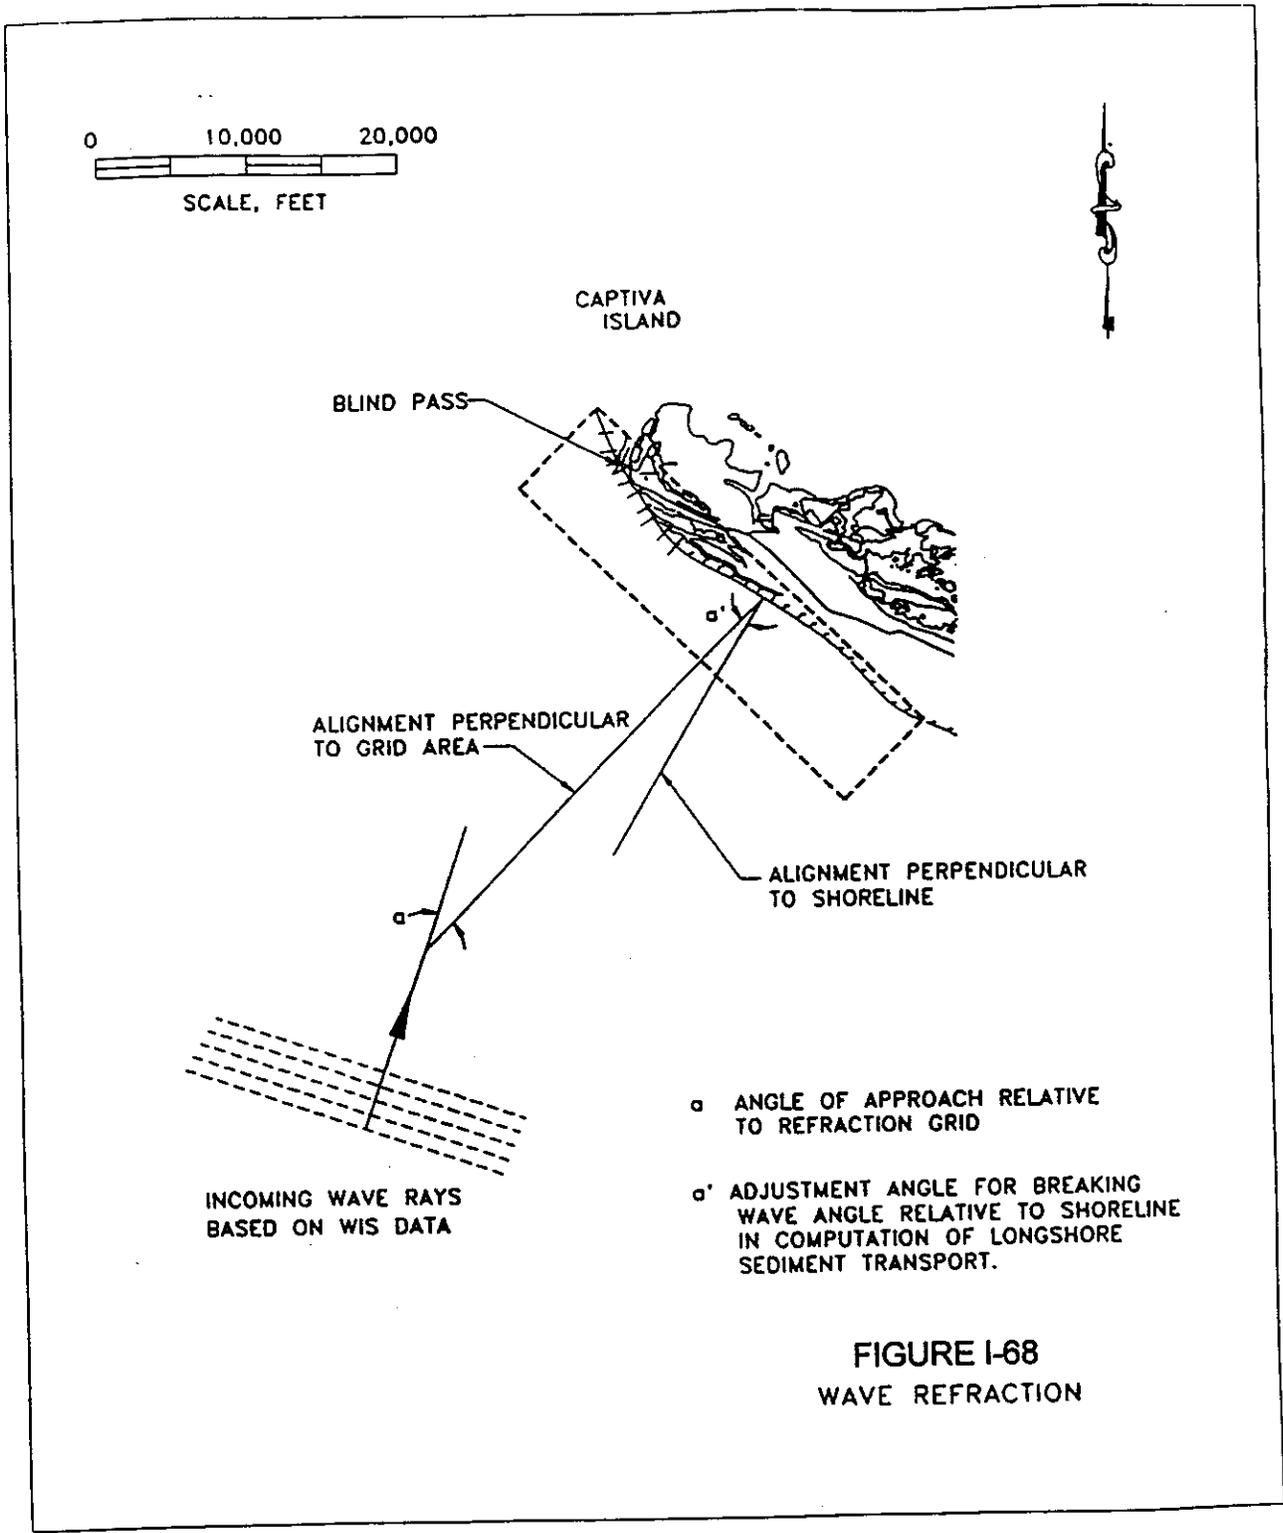
- α ANGLE OF APPROACH RELATIVE TO REFRACTION GRID
- α' ADJUSTMENT ANGLE FOR BREAKING WAVE ANGLE RELATIVE TO SHORELINE IN COMPUTATION OF LONGSHORE SEDIMENT TRANSPORT.

Sand Transport. The results of the wave refraction model were used with empirical relationships presented in the U.S. Army Corps of Engineers Shore Protection Manual to compute longshore wave energy flux. The energy flux can be used to compute average longshore sand transport rates, which provide estimates of volumetric change rates in the study areas.

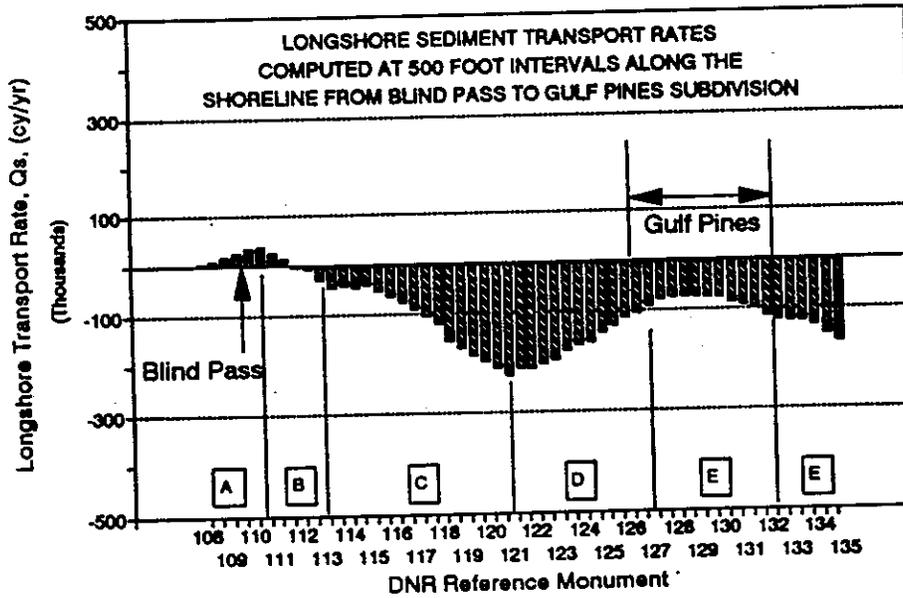
FIGURE I-72

Sanibel Island Beach Management Plan
Wave Refraction Study

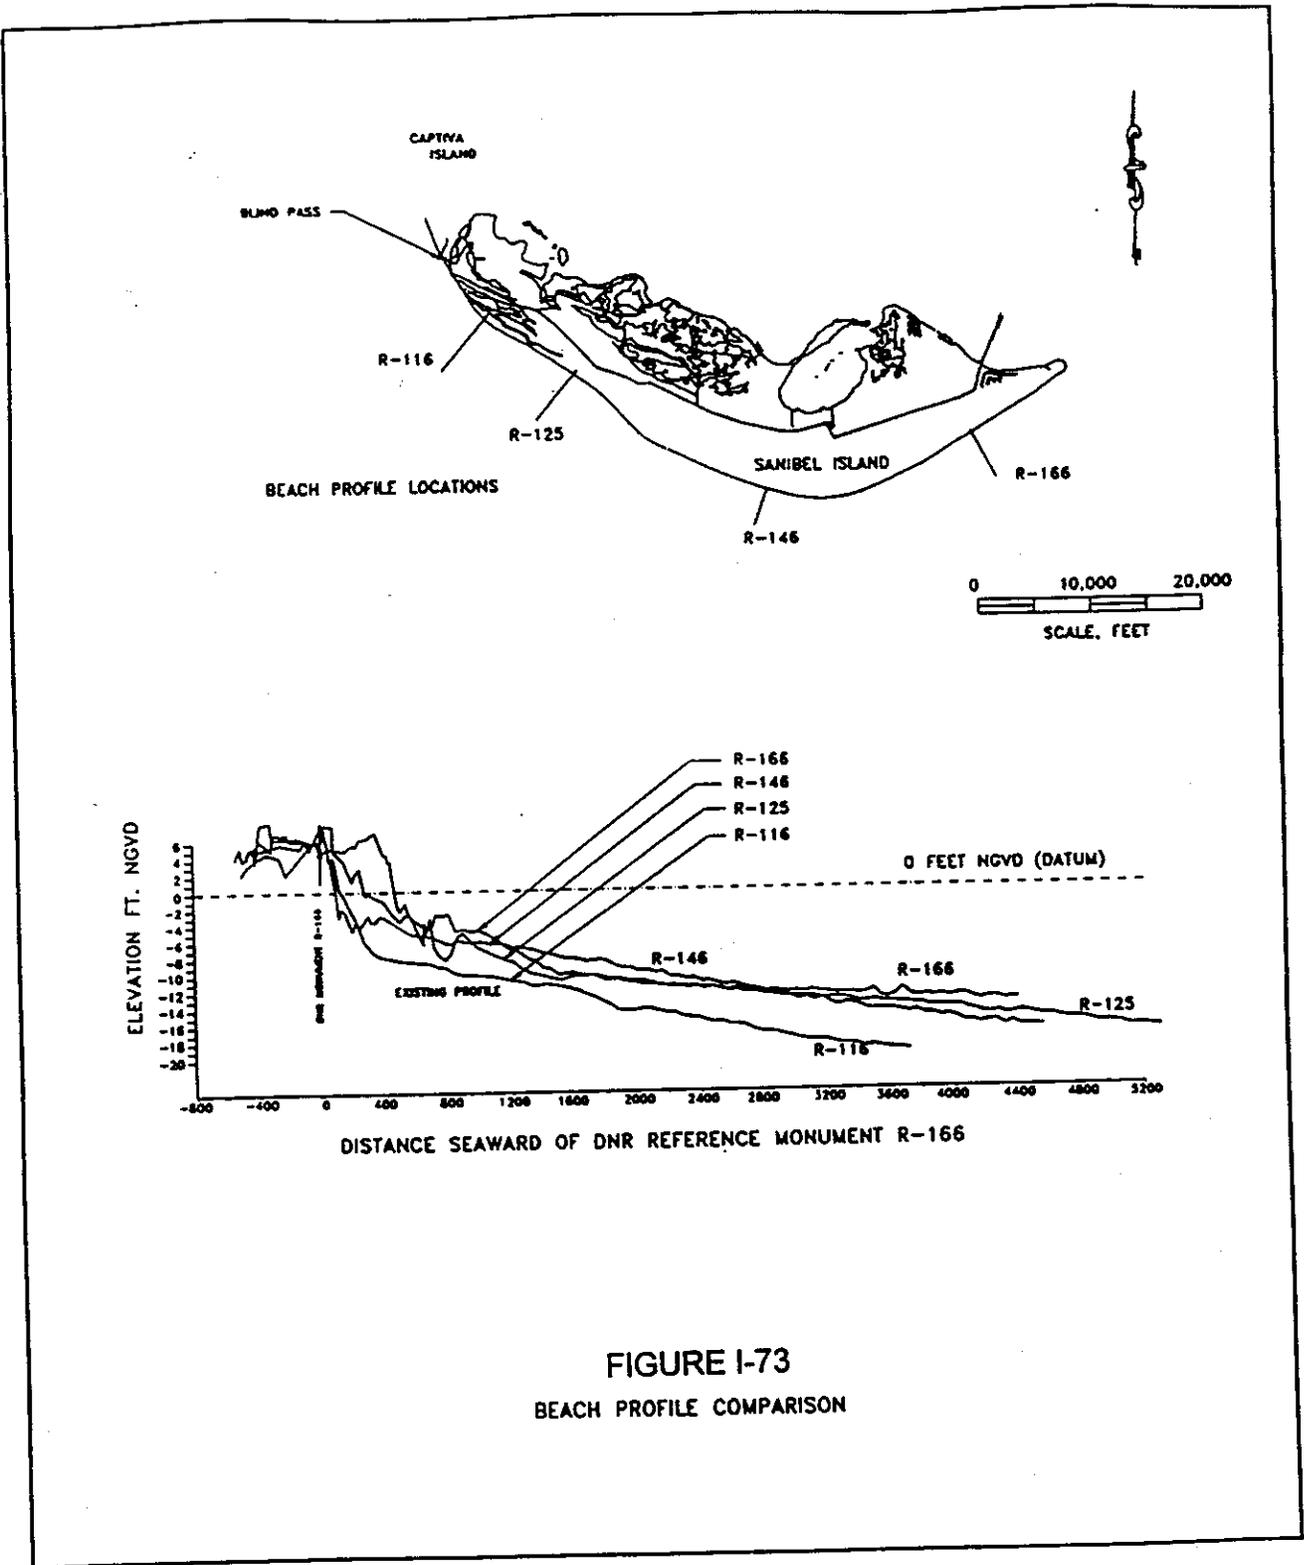
Figure I-73 presents a comparison of beach profiles extending out to 3500 feet offshore. The four profiles presented are from DNR reference monuments R-116, R-125, R-137 and R-148. The monument notation increases north to south. Figure I-73, illustrates that the offshore profiles become flatter toward the south. As waves approach the Sanibel coastline from the west, they begin to slow down in the shallower waters due to the friction they encounter from the bottom. This results in a general breaking angle directed to the south. Because of this, the remainder of Sanibel's shoreline, south of the area included in the forgoing refraction modeling, would in general be expected to experience southward transport toward Point Ybel. Of course nearshore variations in the bottom contours have significant effects on the final breaking angle as discussed above.

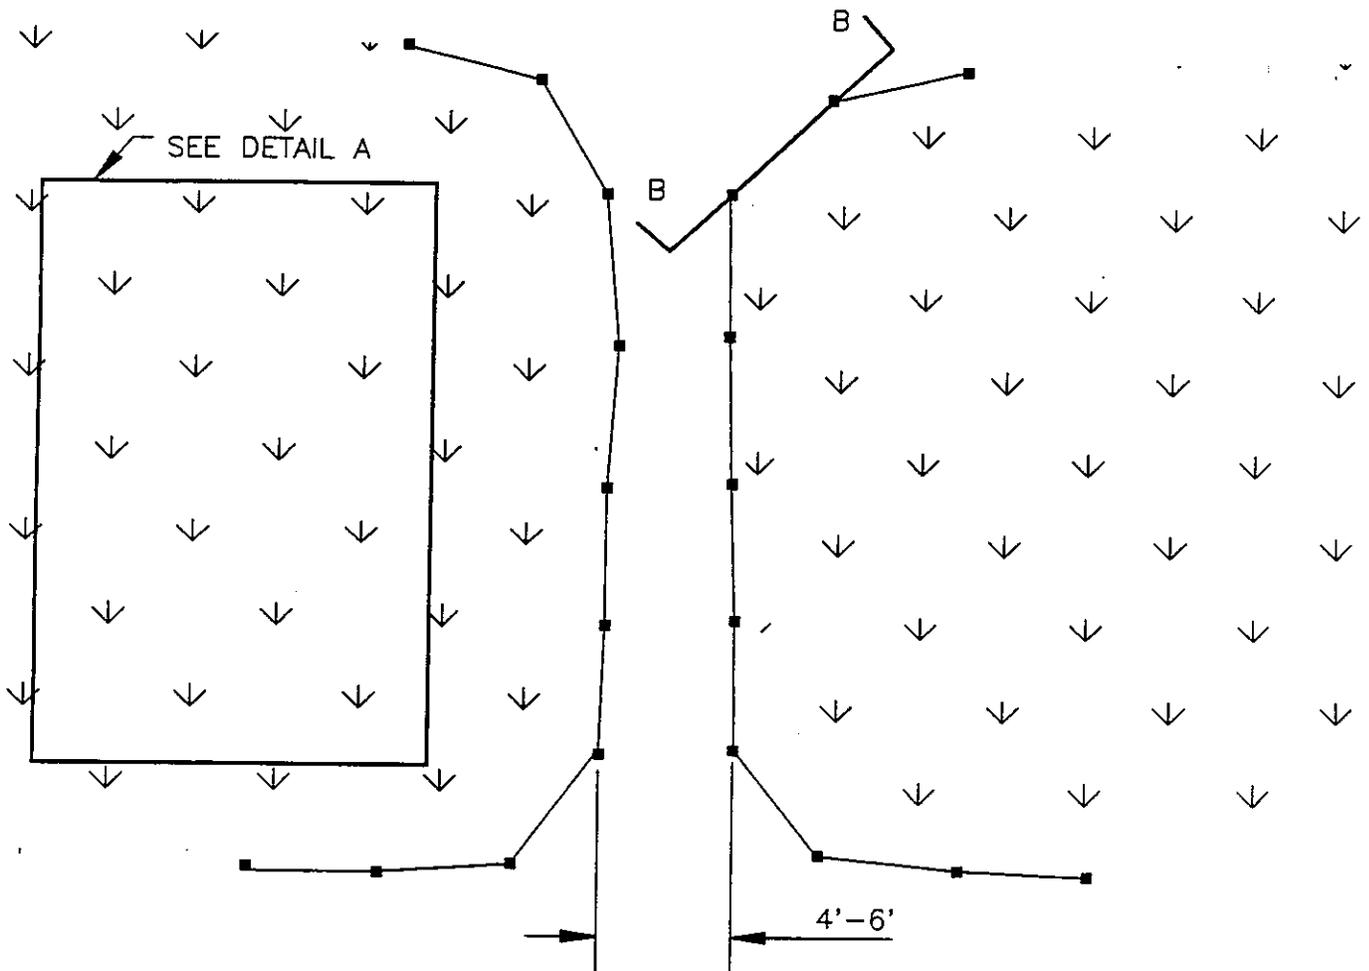
BEACH RESTORATION
PLAN VIEW

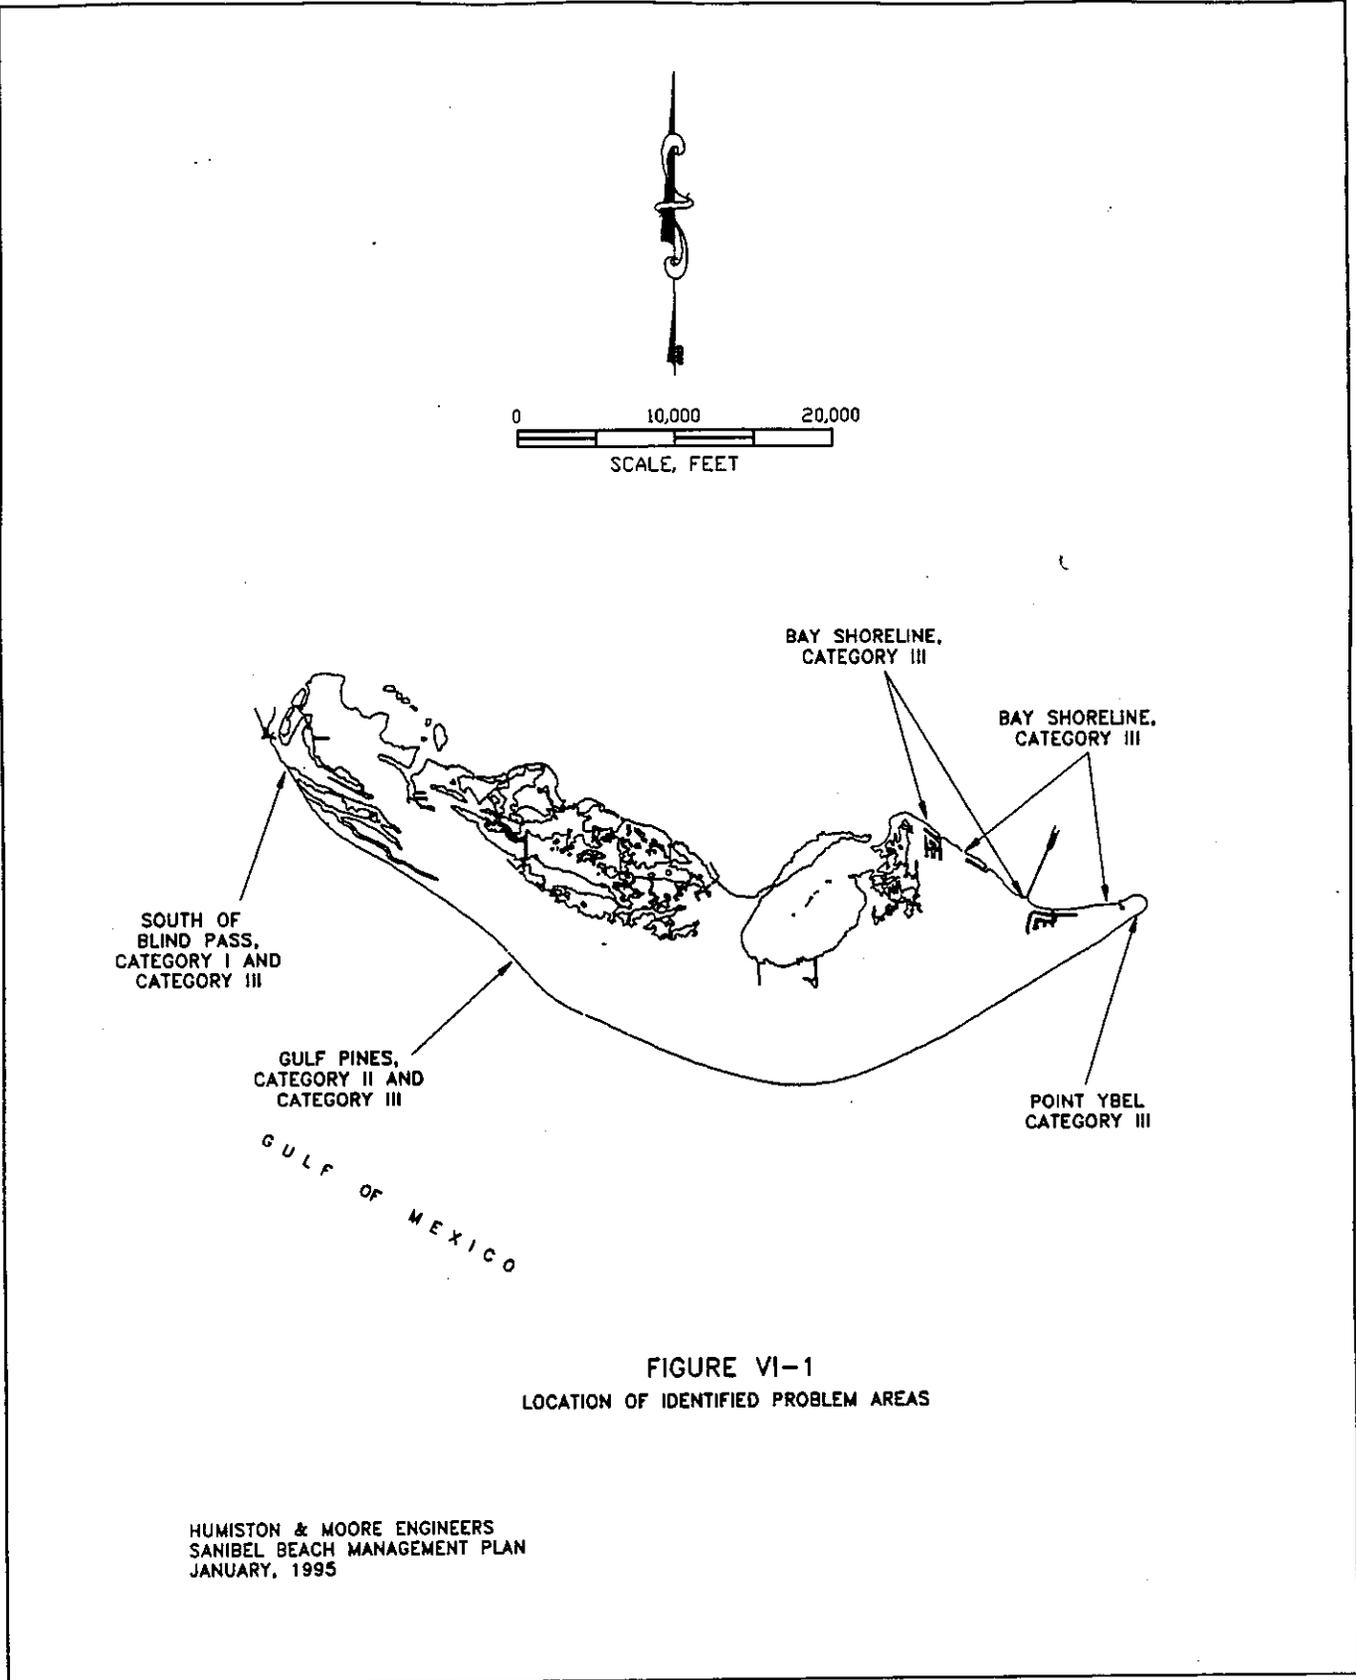
FIGURE VI-1
LOCATION OF IDENTIFIED PROBLEM AREAS
