Miscellaneous Structural Engineering Services
Sanibel Bridge Beam Inspections

Bridge No. 124115 - Structure B Sanibel Causeway over San Carlos Bay

January 2013

BRIDGE INSPECTION REPORT

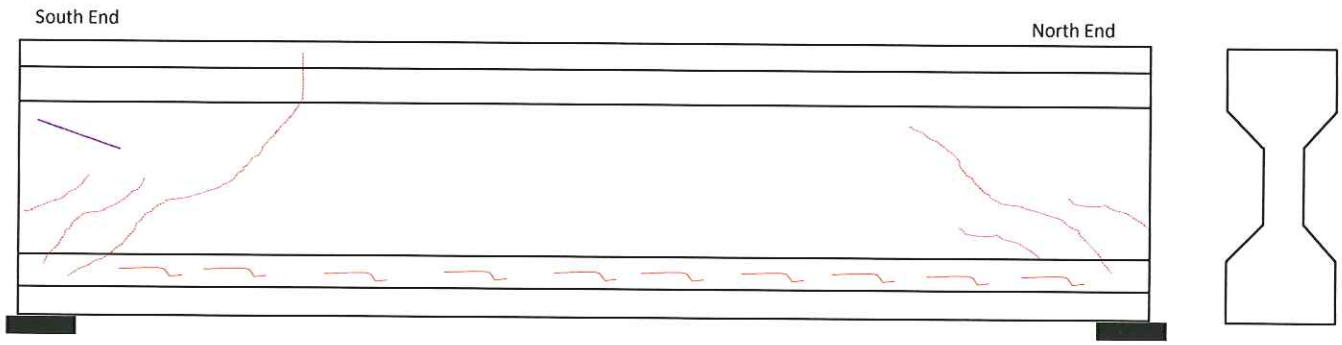
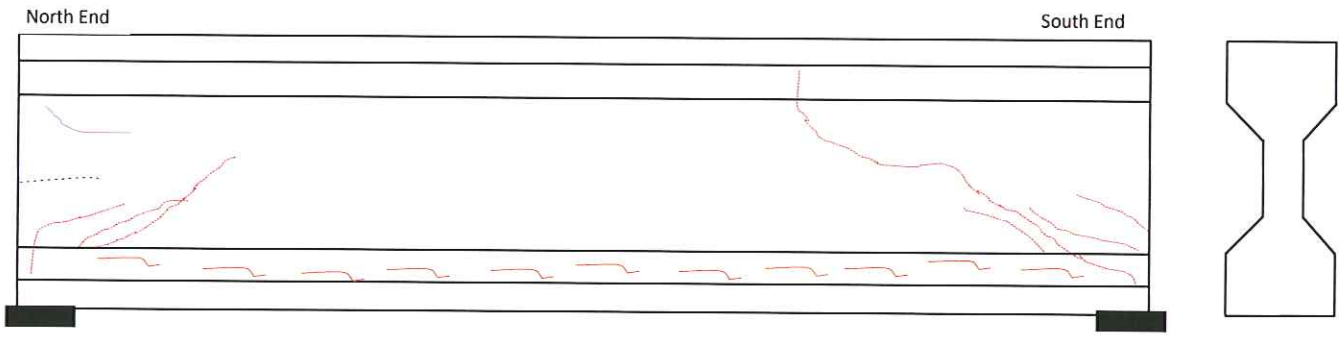
BEAM SKETCHES

Note: The following shows the general direction and locations of the cracks in the beam webs and flanges:

Blue line (-·-·-·-·-) indicates horizontal crack extending from beam end near mid height of web.

Gold line (solid) indicates short longitudinal cracks along bottom flanges.

Purple line (———) indicates diagonal cracks from top of web down and away.

Red Line (----------) indicate diagonal/shear cracks in beam webs extending from bearing areas or beam ends.

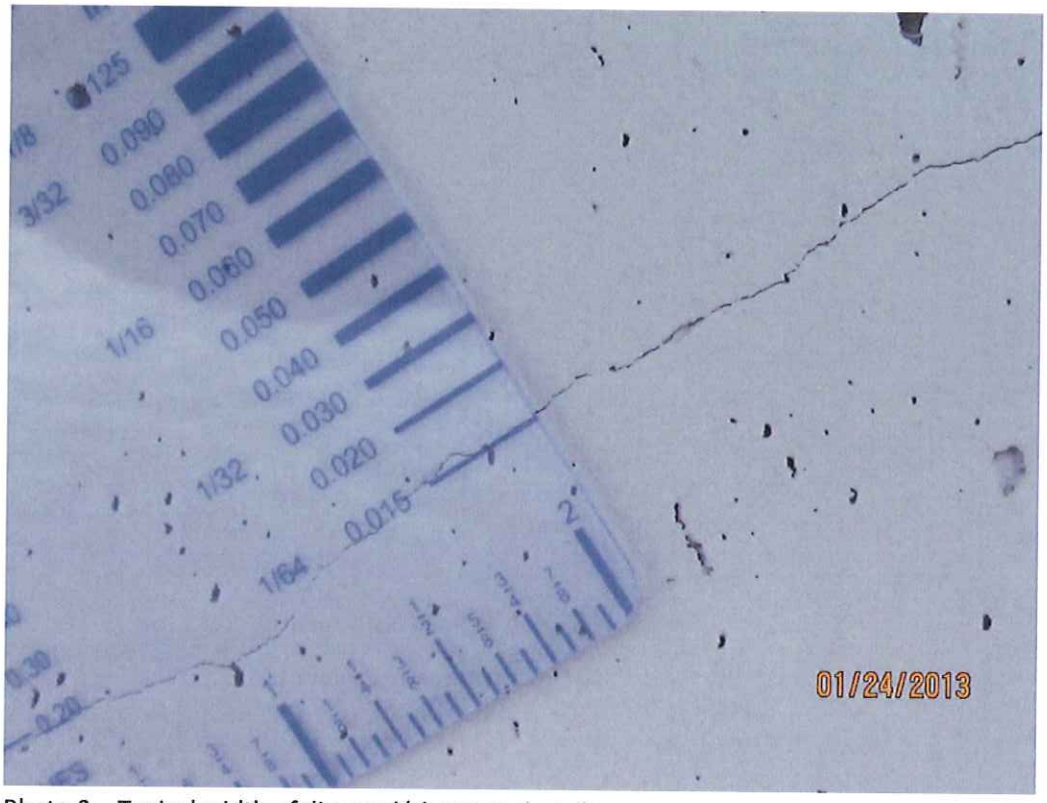
The bottom flange has intermittent length longitudinal cracks that are less than 0.01in. wide throughout. These cracks are most evident in the exterior beams possibly from exposure to adverse weather conditions. Refer to Photo 1.

Photo 1 – Typical longitudinal cracks in bottom flanges of beams
