BRIDGE INSPECTION REPORT

BRIDGE OWNER: LEE COUNTY

BRIDGE NO. 124115 | **CONTENTS OF REPORT** | **INSPECTION DATE:** 11/16/2011

STRUCTURE B SANIBEL CAUSEWAY OVER SAN CARLOS BAY | **2ND STRUCTURE SOUTH OF TOLL PLAZA**

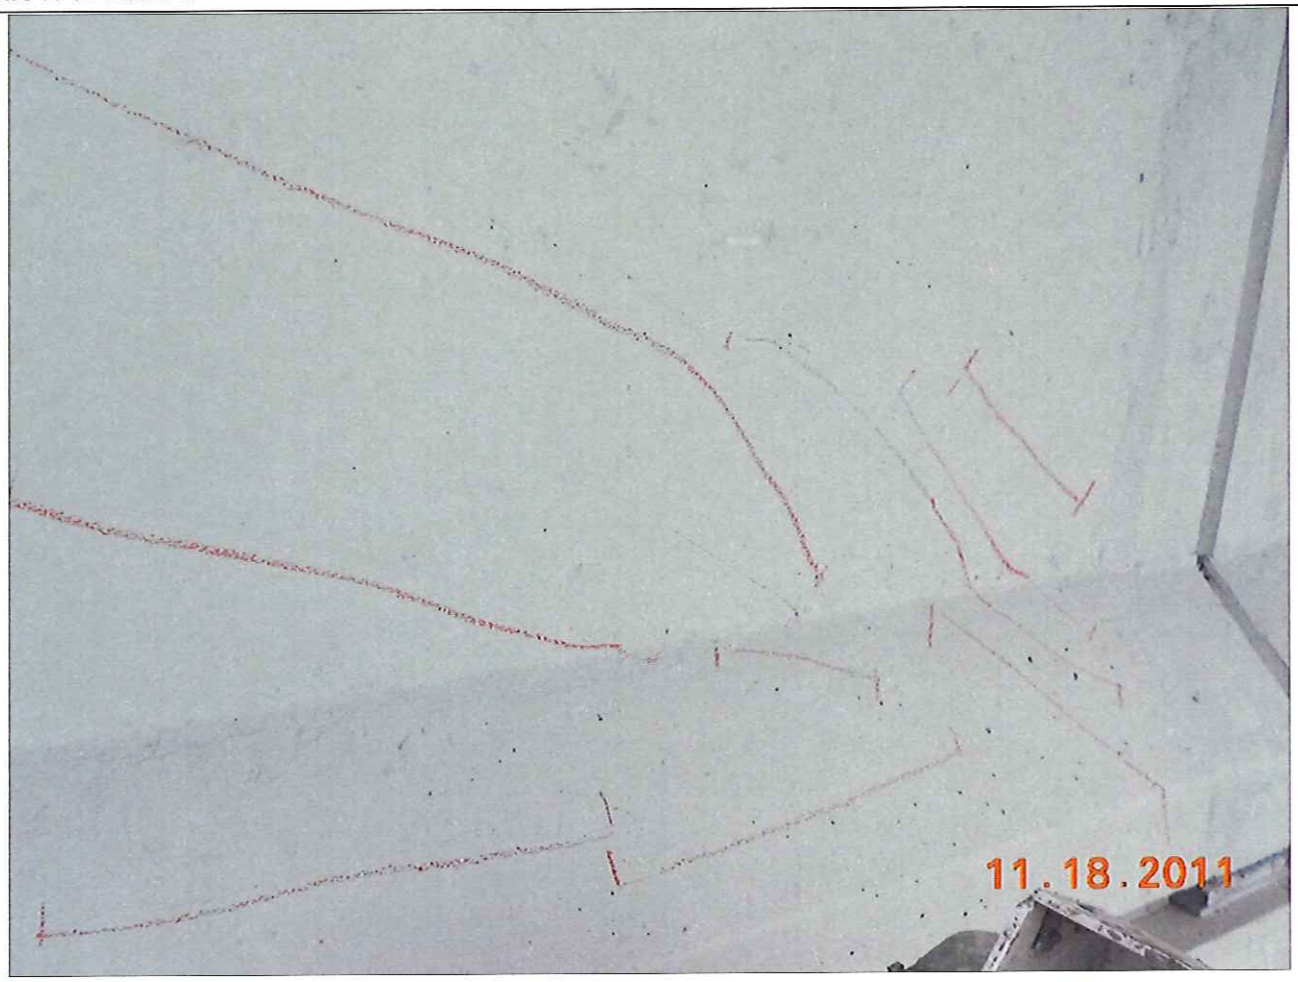
PHOTO 3: 109 P/S CONC OPEN GIRDER

CS1: The beams have multiple hairline diagonal cracks in the lower flange and web up to 8ft. long near the bearing areas, extending up and away from the supports - INCREASED. These cracks vary in length number of cracks and exact location and are predominately in the exterior beams. The cracks on Beam 12-1 were marked with a red paint stick to track the general trend in crack lengths. Refer to Photo 3.

Typical diagonal cracks in the exterior beams (Beam 2-1 marked in red shown).

REPAIR RECOMMENDATION:
None
