Miscellaneous Structural Engineering Services  
Sanibel Bridge Beam Inspections

Bridge No. 124114 - Structure C Sanibel Causeway over San Carlos Bay  
3rd Structure South of Toll Plaza

Prepared For:  
Lee County

Prepared By:  
T.Y. Lin International

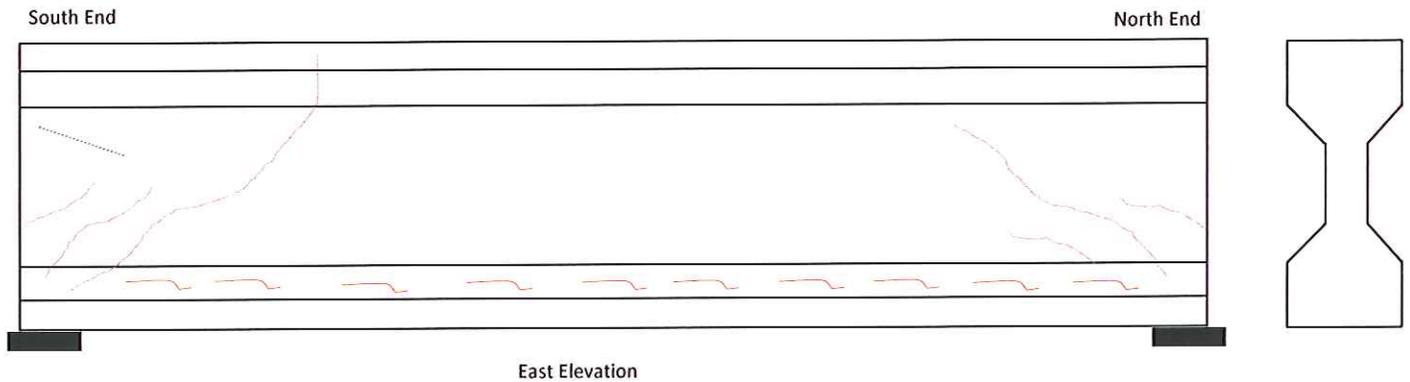
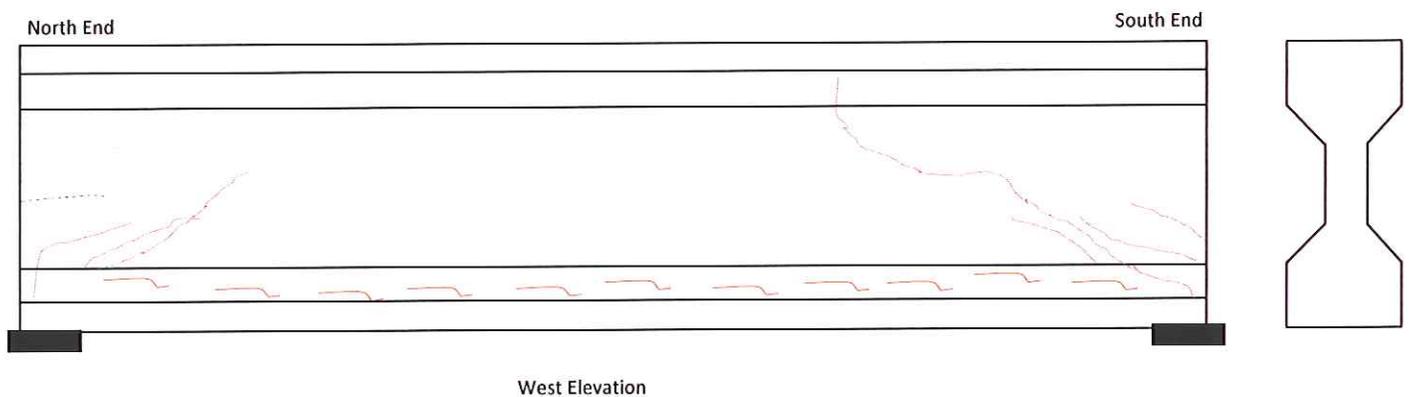
## BEAM SKETCHES

The beams are in overall good condition. Several beam webs have diagonal cracks which have a shear direction appearance. These cracks primarily extend from the bearing areas and/or near the beam ends and extend south or north in direction. The general appearances of the cracks in the exterior beams which are painted make the condition look worse than the cracks in the interior faces. The more significant lengths and any additional length of cracking were marked with a permanent marker and dated 07/13.

Note: The following shows the general direction and locations of the cracks in the beam webs and flanges:

T. Y. Lin. recommends continuing to monitor the cracks for any increase and/ or growth in crack size. If findings show an increase in severity after the next inspection, then a repair recommendation would most likely be warranted.
